Technical Service Bulletin

69 Airbag warning light on, DTC B1225F1 stored in the airbag control module

69 19 40 2051242/4 June 26, 2019. Supersedes Technical Service Bulletin Group 69 number 19-39 dated April 26, 2019 for reasons listed below.

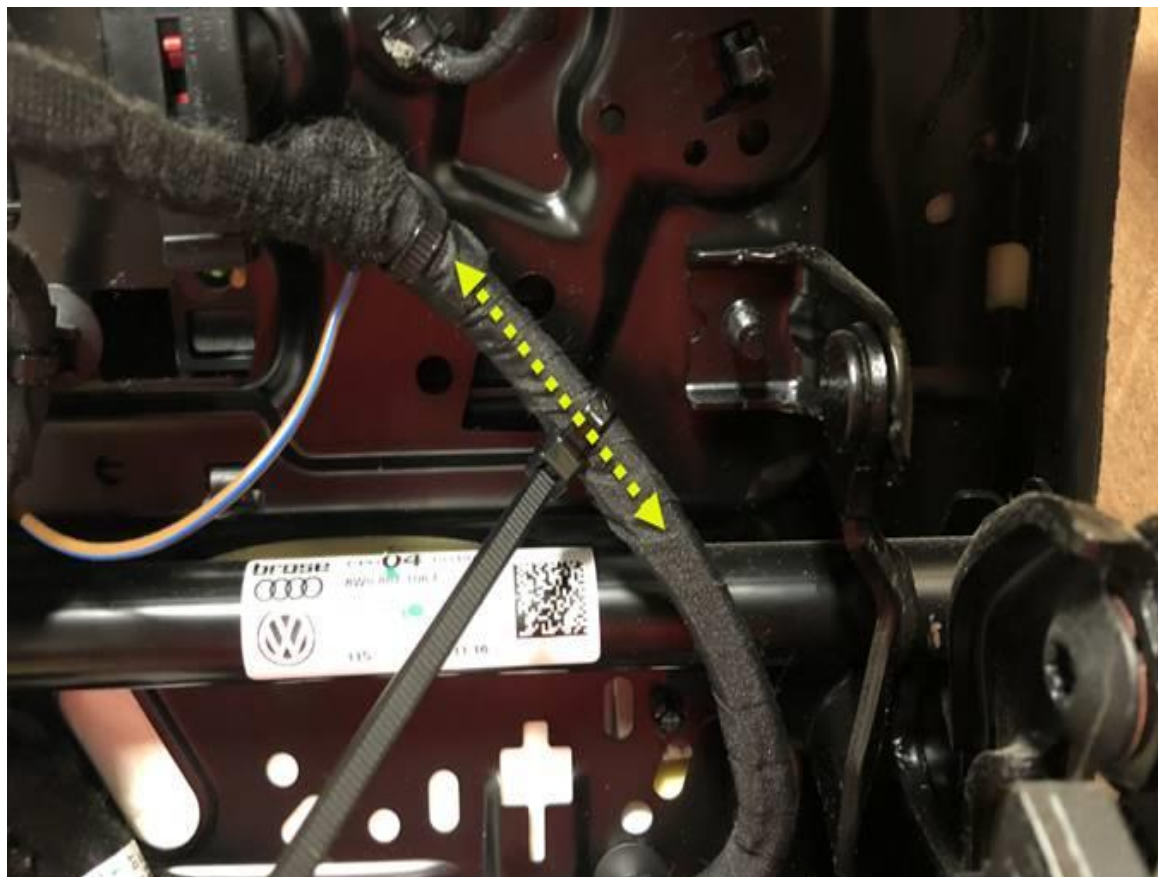
2. You will attach the first cable tie in the yellow marked area on the harness between the cable tie clip and the crossbar tube as shown below (Figure 2).

Figure 2. Attach the first cable tie in the yellow area.

2. You will attach the first cable tie in the yellow marked area on the harness between the cable tie clip and the crossbar tube (Figure 2).
3. The second cable tie position is to the rear of the black 8-pin connector (T8m) for the backrest and lumbar adjustment and in front of the harness push pin (Figure 6).

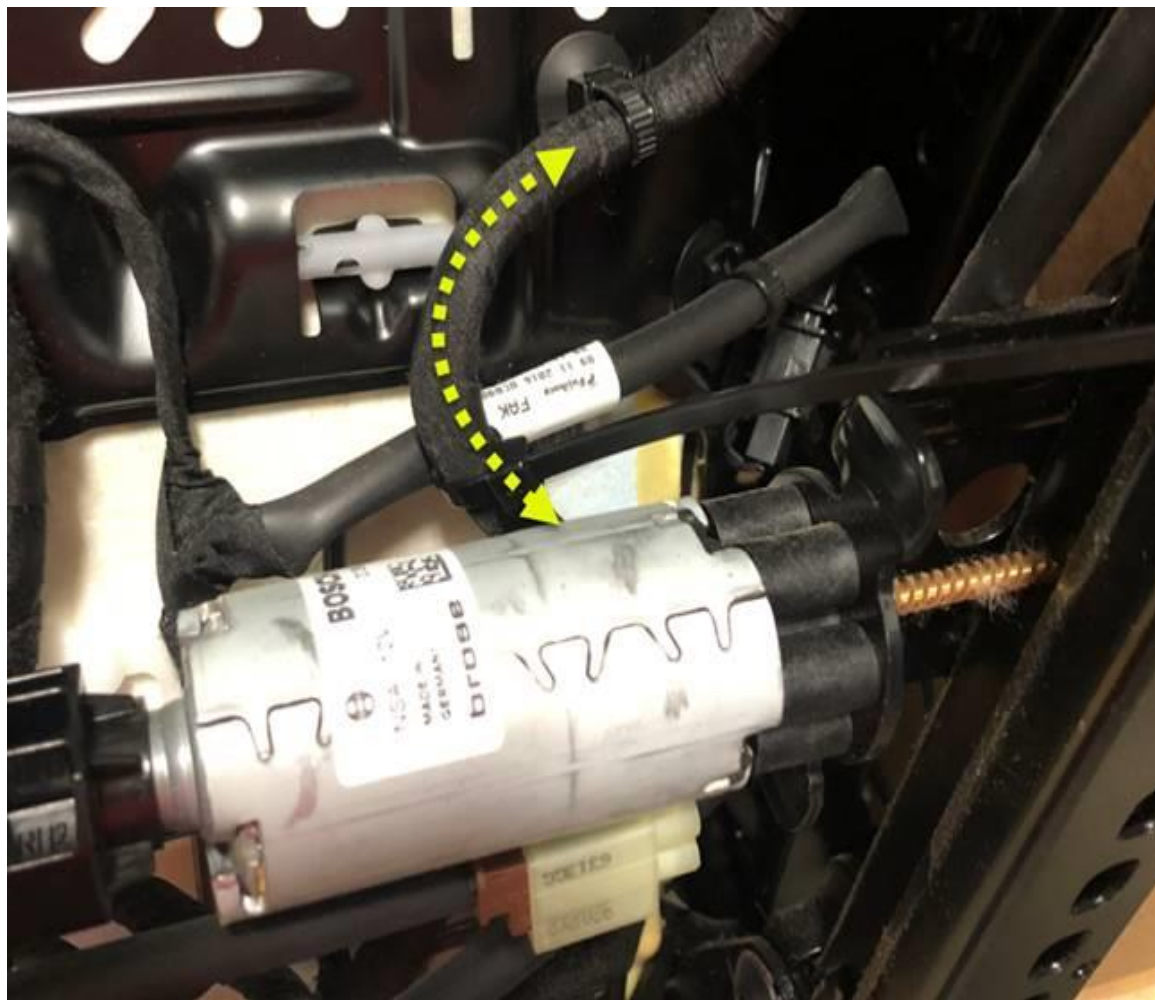
3. The second cable tie position is to the rear of the crossbar tube where the harness drops down from the frame. Place the cable tie in the yellow marked area shown below (Figure 3).

Figure 3. Attach the second cable tie to the yellow marked area.

When tightening the cable ties, only tighten them with your hands, do not use any tools to tighten the cable tie as this can damage the harness. Check that the cable ties cannot be rotated on the harness by hand, to ensure that proper tension is achieved. Then cut off the excess length from the tie wrap.
