**THIS IS A TECH TIP, NOT A TECHNICAL BULLETIN.  
TECH TIPS ARE NOT ASSOCIATED WITH WARRANTY CLAIMING.**

Model(s)	Year	Eng. Code	Trans. Code	VIN Range From	VIN Range To
Atlas, Tiguan LWB	2018-2019	All	All	All	All

Instance Number	Published Date	Version Number	Reason For Update
2055485/1	6/27/19	55-19-02TT	Original publication.

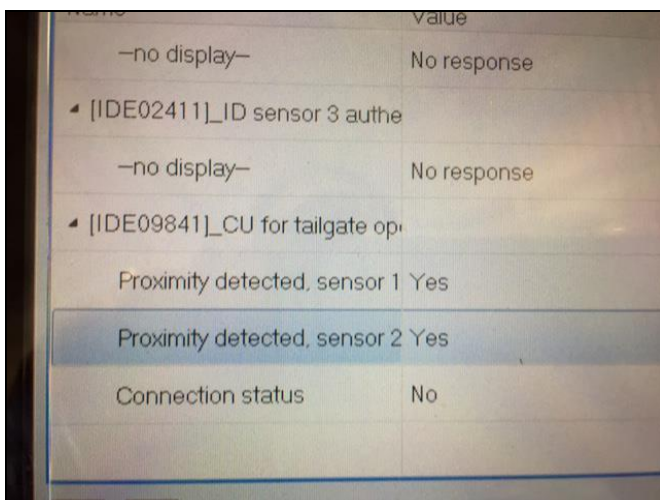
Scan Tool MVB display for **-G750-** Power Rear Lid Opening Sensor status on known good vehicle.

There are 2 blocks within this MVB (Proximity detected, sensor 1 and sensor 2). When a foot is under the bumper to activate the easy open function, both sensors should read yes when functioning properly.

When testing the rear lid easy open operation using measured values, connect a scan tool, go to OBD, select measured values in address word 6D Rear Lid Electronics. Select measure value IDE09841 CU for **-G750-** Power Rear Lid Opening Sensor status.
