Service Product Journal

Not possible to left click ECUs in the network image for non-SPA cars

REF NO: US34753.1.0 en-US	ISSUING DEPARTMENT: Service Operations			REFERENCE BULLETINS:	
CATEGORY:	SUBCATEGORY:			CAR MARKET: United States and Canada	
Service Personnel: Read and initial	SERVICE MANAGER	SERVICE WRITER	WARRANTY ADMINISTRATOR	ISSUE DATE: 2019-05-07	STATUS DATE: 2019-05-09
				Page 1 of 3

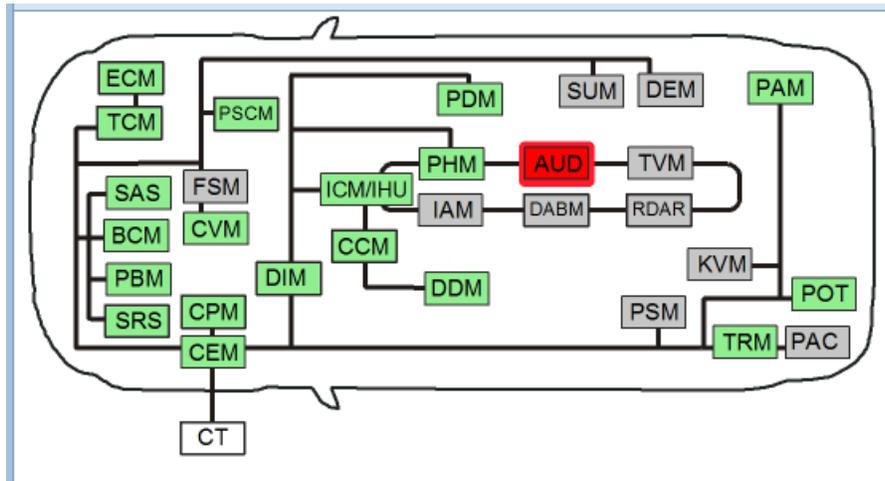
File Name	File Size
Network_Image.PNG	0.0204 MB

Only applies for Non-SPA vehicles which has the old network / topology image.

In the following locations in VIDA you will find a network map/image of the ECUs in the car.

See attached screenshot for clarification.

Clicking any of the ECUs in this network image might not work due to a compatibility issues mostly found in Windows 10 but possibly also in Windows 7.

The problem is occurring when performing a regular left-click on the ECUs.

Instead of using the left button on the mouse, use the right click button and the selection is possible.
