Technical Journal

TITLE:
DIM message, "Climate System - Internal Cooling"

REF NO: TJ 34850.1.0	ISSUING DEPARTMENT: Technical Service	CAR MARKET: United States and Canada	
PARTNER: 3 US 7510 Volvo Car USA		ISSUE DATE: 2019-05-24	STATUS DATE: 2019-05-30
FUNC GROUP: 3810	FUNC DESC: Combined instrument	Page 1 of 3

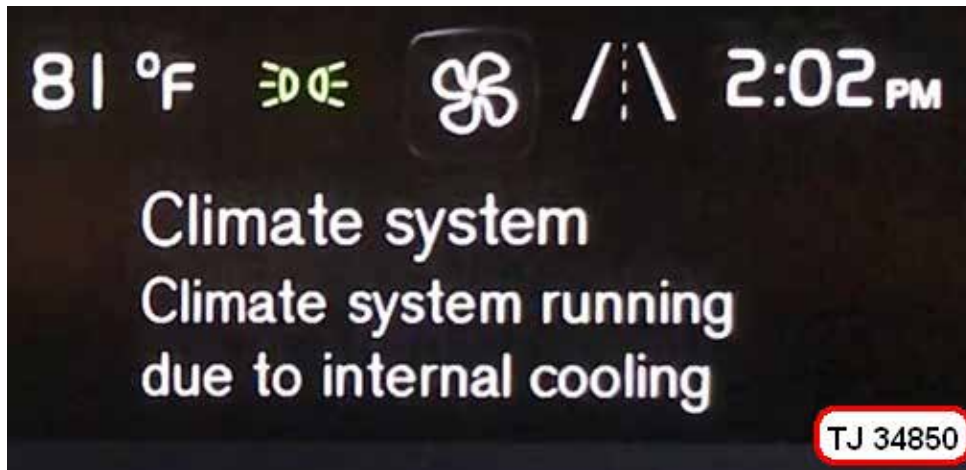
File Name	File Size
TJ 34850.jpg	0.0369 MB

If the customer reports that the message “Climate system running due to internal cooling” has appeared in the DIM and/or CCD display (see attachment TJ 34850.jpg), this is a normal function of the car, see text under “Service”.

Verify with the customer that the message they have seen matches the image in attachment TJ 34850.jpg.

This message will appear in the DIM and/or CCD displays to inform the customer when this system is operating. The customer should be advised that this is normal operation.

Please do NOT perform any fault tracing or replace any components due to this message. It is a normal function and does not indicate a fault with the vehicle:

This message appears due to a function called Active Cooling:

If the climate control system in the vehicle is switched OFF during high ambient temperature conditions, the blower fan may need to come on periodically to circulate air behind the dashboard in order to cool down electronic components such as the IHU, DIM, or CCD, when needed.
