Technical Service Bulletin

Topic	Air spring fault finding
Market area	Bentley: worldwide (2WBE)
Brand	Bentley
Transaction No.	2053492/3
Level	EH
Status	Released for publishing
Release date	May 6, 2019

Section 1 - Front suspension air spring fault finding

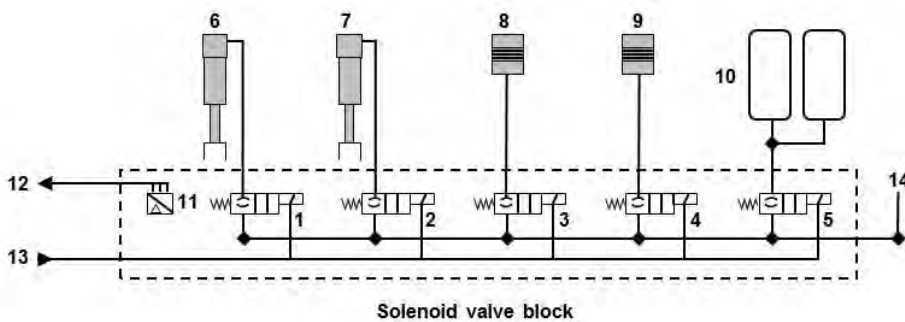
Reference chart

Please use this generic "Reference Chart" in conjunction with the customer description of the fault and the "Standard Ambient Conditions" of the DTC's if present, to focus on the relevant area (ie: if a DTC is pointing out to the accumulator and the event data from the DTC and the customer description explains that the issue appear while the vehicle was driving, then the potential source of the leak well might be in between reservoir, valve unit or compressor as these three components are active in these particular conditions).

Component	Description
1 - 5	Solenoid valves
6 & 7	Front axle suspension struts
8 & 9	Rear axle suspension units

10	Pressure accumulator
11	Pressure sensor
12	Pressure reading
13	Electrical activation of solenoid valves
14	Compressor connection

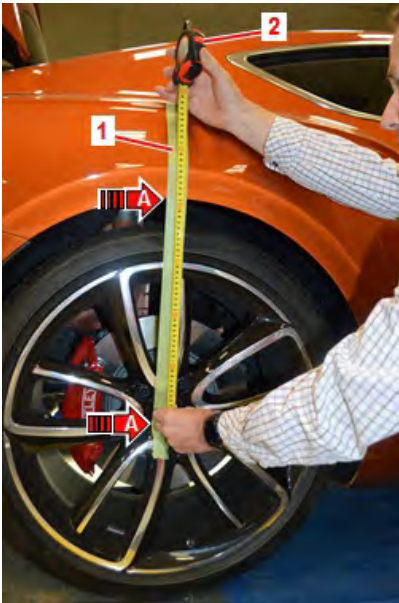
Figure 1

Adhere strips of masking tape (1) from the centre of each wheel to the highest part of the wheel arch as shown, making sure they are applied taut.

Using a tape measure (2), also measure and take note of the ride heights (A-A) at all four corners of the vehicle. See Figure 1.

Leave the vehicle overnight and again measure the ride heights (A-A) at all four corners of the vehicle. Compare these values with those taken previously.

If there is **NO** difference in ride heights, and the strips of masking tape are still 'taut' then no air leak is present. Please explain to the customer the long term storage or changing climate conditions would cause a drop in ride height which is normal. As soon as the vehicle is started, the compressor will level the vehicle automatically. No further action is required.

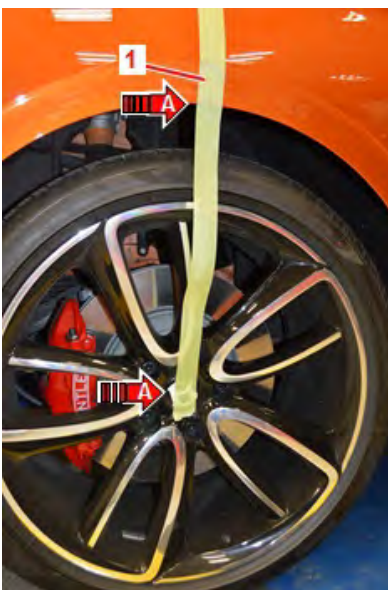
Figure 2

If there **IS** a difference in ride heights, and the strips of masking tape (1) have 'sagged' (shown in Figure 2), then refer to the following leak finding procedures below.

It should be noted that if these checks involve a claim through warranty then photographic evidence of the vehicle sagging and air leak should be included.

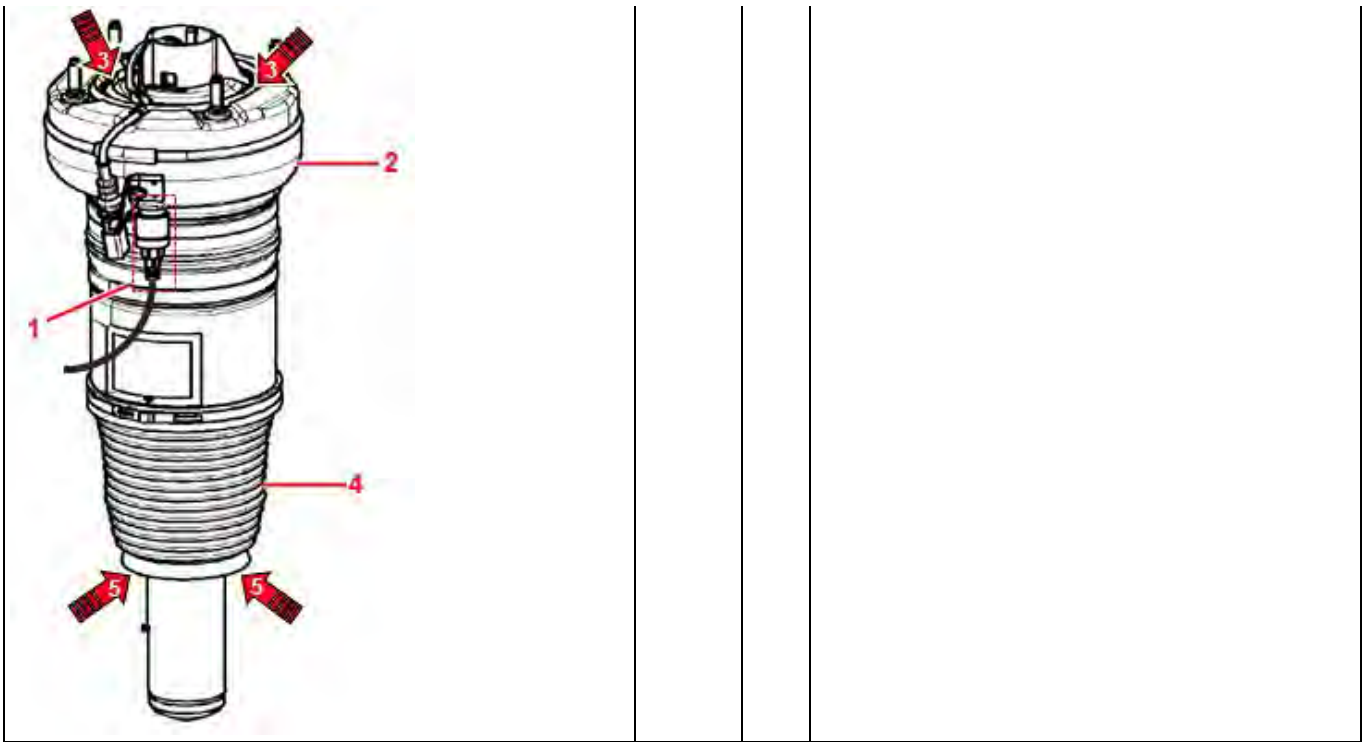
Front air spring check points – Mulsanne

Check	Yes	No	Comments
Air connection to air spring (1) Upper air spring (2) Top of air spring (3) Air spring gaiter condition (4) Bottom of the air spring (5)
