## Technical product information

| <b>Topic</b> | Air suspension warning - Air hoses chaffing on rear subframe - Leaking |
| <b>Brand</b> | Bentley |
| <b>Transaction No.</b> | 2054643/1 |

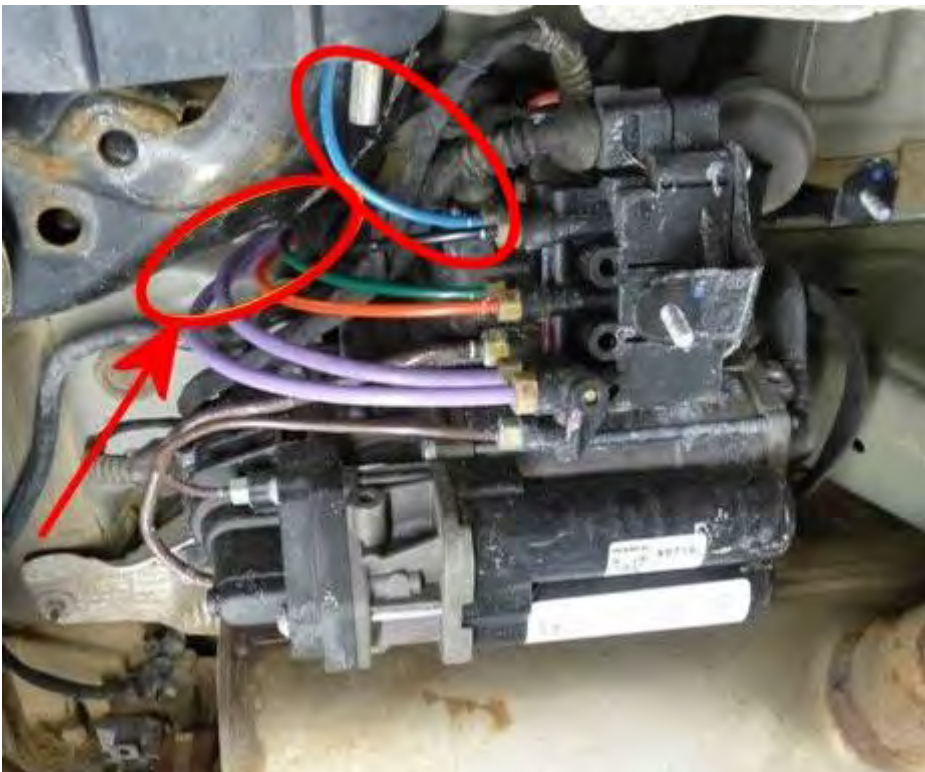
The air hose cluster which connects to the solenoid block can contact the rear subframe resulting in air leaks from one or more air hoses

3) Referring to Figure 1 (circled) - Check the following air suspension hoses for air leaks due to contact/chaffing with the right hand side of the rear axle subframe/nearby components

- Red hose
- Green hose
- Both violet hoses
- Blue hose
- Black hose

NOTE: If there are issues relating to hoses contacting the subframe which result in an air leak carry out the following instructions from step 4

If there are NO leaking hoses or NO hoses which have signs of damage/chaffing, Check the pneumatic components of the running gear with Guided Fault Finding and special tool VAS 751 001 - Refer to Repair manual Rep.Gr 43 Air suspension - To check

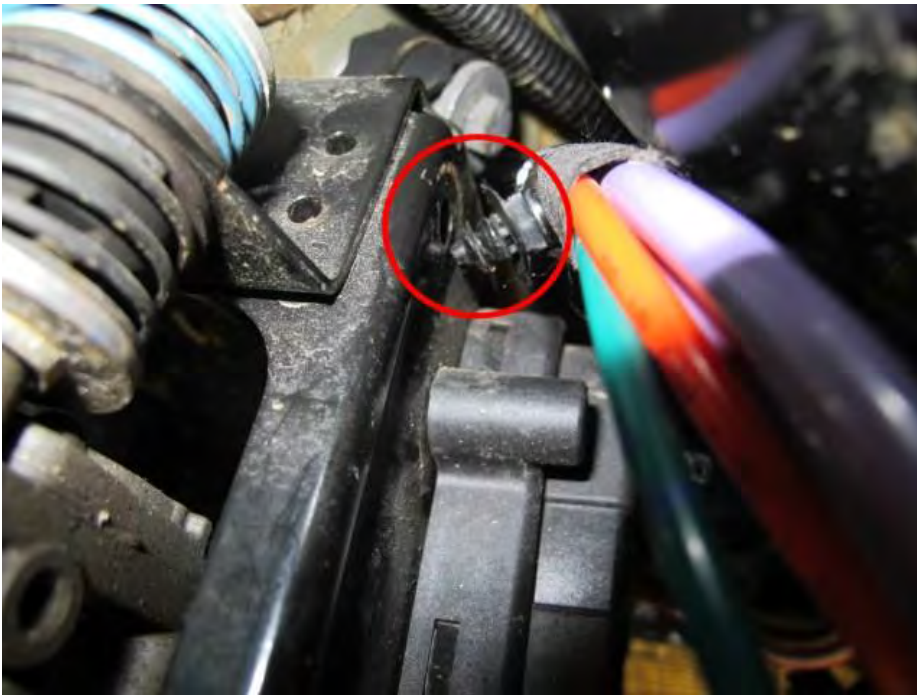
9) Disconnect the clip shown in Figure 3 from the air supply unit/solenoid block

- Once disconnected carefully manoeuvre the air pipes away from air supply unit/solenoid block **NOTE:** Do Not disconnect any further air pipe securing clips
- 10) Clean the area of the hose in which the air leak is evident **NOTE:** Any dirt entering the system can cause malfunctions or failure
- Using VAS 6228 or similar (Figure 4) cut the hose (at a right angle) as shown in Figure 5, take care not to unnecessarily shorten the hose as it may then be too short when refitting back into the solenoid block
  - **CAUTION:** Ensure that the damaged section of the hose is removed, should the hose/s require lengthening the same instructions apply, Repair kits containing replacement hose and connections are available - see Parts information

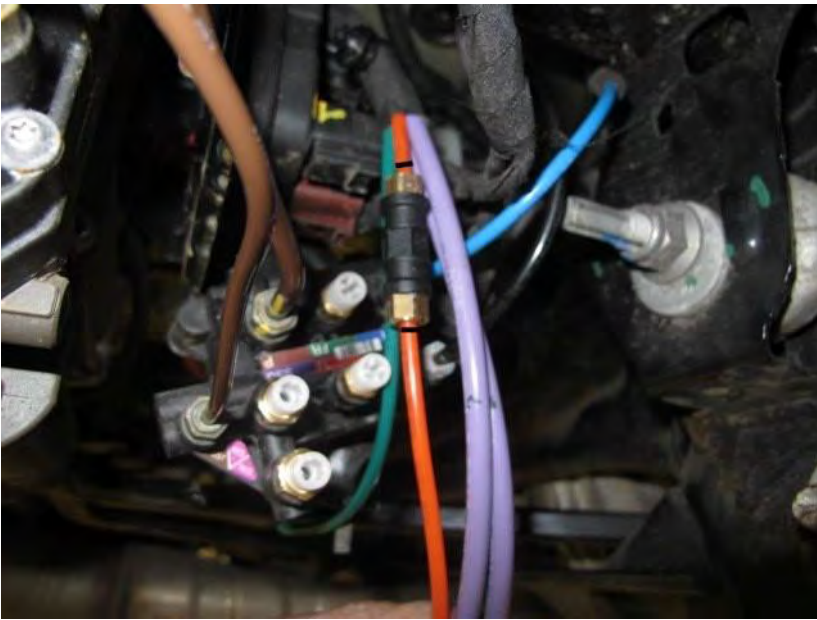
- Figure 8 shows the connection piece fitted

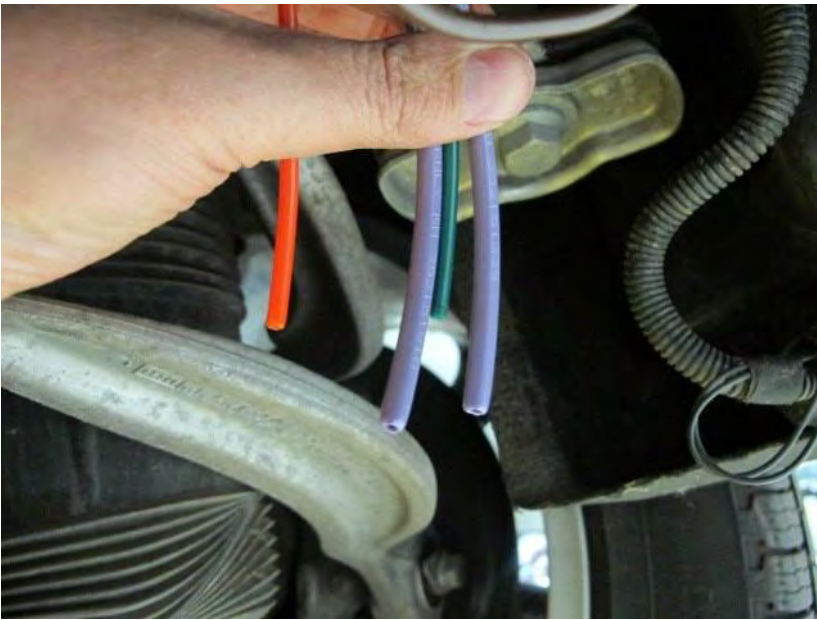
Figure 12

14) Figure 12, Shows the four hoses cut to their specified lengths

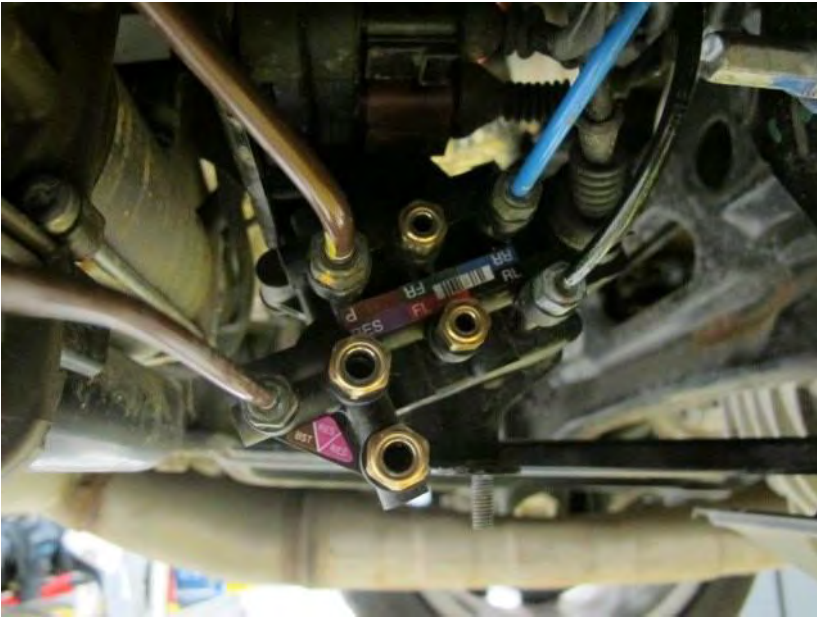
Figure 13

15) Remove the caps from the solenoid block connectors (Figure 13)
