Title: Steering Shake, Shimmy, Shudder, Steering Vibration

Applies To: Prostar/Lonestar and LT/RH with 14k front weight rated axles and below

Steering intermittently goes into a shimmy after hitting a bump.

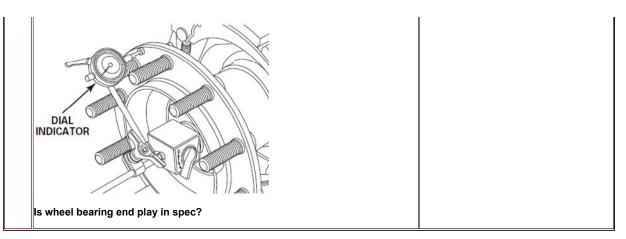
Step	Action	Decision
5	DIAGNOSTIC: Wheel Bearing End Play	Yes: Please proceed to step 6.
	Measure wheel bearing for excessive end play	<b>No:</b> Replace or adjust the wheel bearings
		as needed and reevaluate for steering wobble.
		Refer to <u>ConMet Service Manual</u>

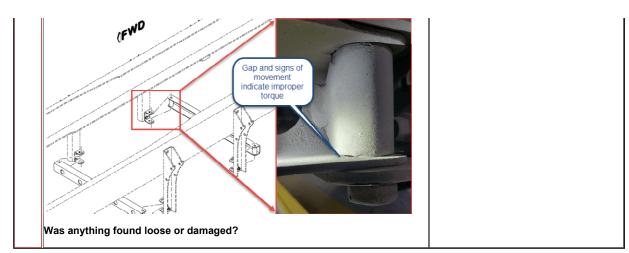
Step	Action	Decision
	DIAGNOSTIC: Spring Hangers, Cab Mounts, Engine Mounts and Frame Fasteners	Yes: LT/RH refer to 0000885380
		Prostar/LoneStar refer to 0000863170
	Inspect the spring hangers, shackles, and bushing for looseness, play and fastener torque.	Repair, torque, or replace fasteners and
	•	suspension components as needed and
	Inspect cab and engine mounts for excessive wear, being degraded and/or looseness.	reevaluate for steering wobble.
		No: Please proceed to step 8.
	Failed engine mount, Inspection may require a mirror.	
	Confirm fastener torque on all steering system, frame rail and crossmember, and fuel tank mounting brackets/supports.	
	Example of a loose fuel tank support.

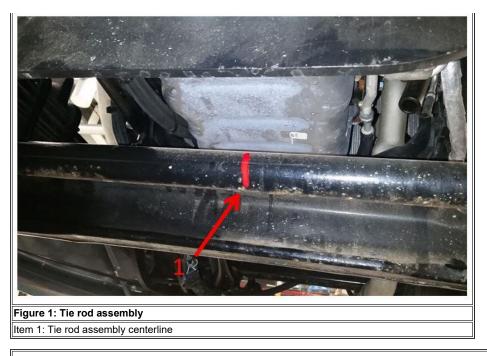
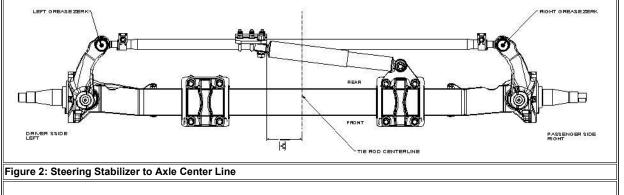
- 1. Bring vehicle into the shop and park on flat hard surface.
- 2. Shift transmission to Park or Neutral, set parking brake, and install wheel chocks.
- 3. Remove the front U-bolt from the passenger side steer spring and discard.
- 4. On the tie rod assembly, measure the distance between the right and left grease zerks.
- 5. Divide your measurement from step 4 by two. (This will help locate the centerline of the tie rod assembly)
- 6. Mark the centerline of the tie rod assembly per figure 1 & 2.

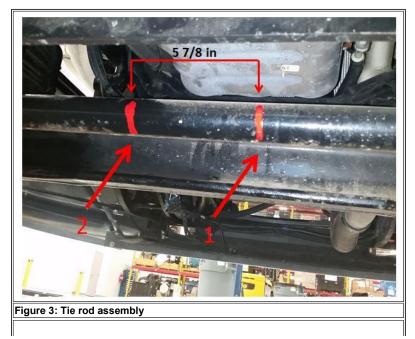
7. From the tire rod assembly centerline, make a second mark 5 7/8in towards the driver's side per figure 3. This will be the mounting location of the tie rod mounting plate.

Item 1: Tie rod assembly centerline (first mark) Item 2: 5 7/8 from tie rod assembly centerline (second mark)

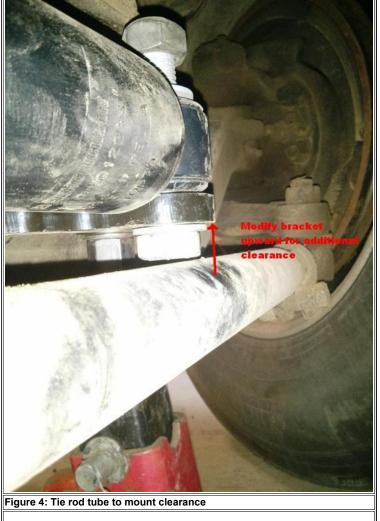
9. Ensure proper clearance between the tie rod tube and the shock mount at the U-bolt per figure 4. If required modify the mounting bracket to provide the needed clearance.
