Preliminary Information

PIP5658 Heat Shrink Hose Clamp Information

| Brand: | Model: | Model Years: | VIN: | | Engine: | Transmissions: |
|---|---|---|---|---|---|---|
| Chevrolet | Silverado 4500HD 5500HD 6500HD | 2019 | All | All | 6.6L L5D | All |

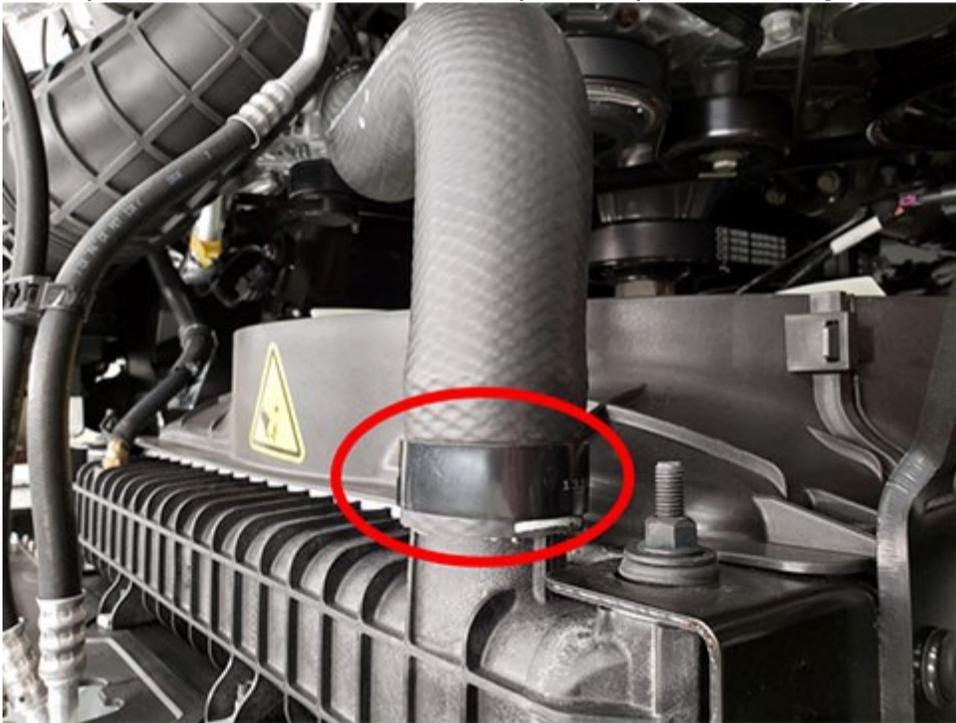
| Condition | There may be a concern where coolant heat shrink clamps need to be replaced for a coolant leak and/or for a service repair. |
| Cause | Difficult to get the heat shrink clamps to seal the coolant hose. |

Heat shrink clamp

When possible use the heat shrink clamps in the places that they are called for.

There may be location that may not be accessible to get a heat gun to.

For locations that are inaccessible to a heat gun, use hose clamp p/n 1518389C1, torque @ 9-11 Nm (79 - 97 lb in).
