## Message "Mercedes me connect services limited. See owner's manual" in instrument cluster multifunction display

Topic number	LI54.30-P-066410
Version	3
Function group	54.30 Instrument cluster, display instruments, hazard warning device
Date	05-21-2019
Validity	Model 117, 118, 156, 176, 177, 242, 246, 247, 172, 190, 231, 205, 253, 166, 167, 292, 213, 218, 238, 222, 217, 257, X290, 293, 463 with HERMES communication module (code 360, 362, 364)
Reason for change	Extension: Model series validity and distribution (worldwide)
Reason for block

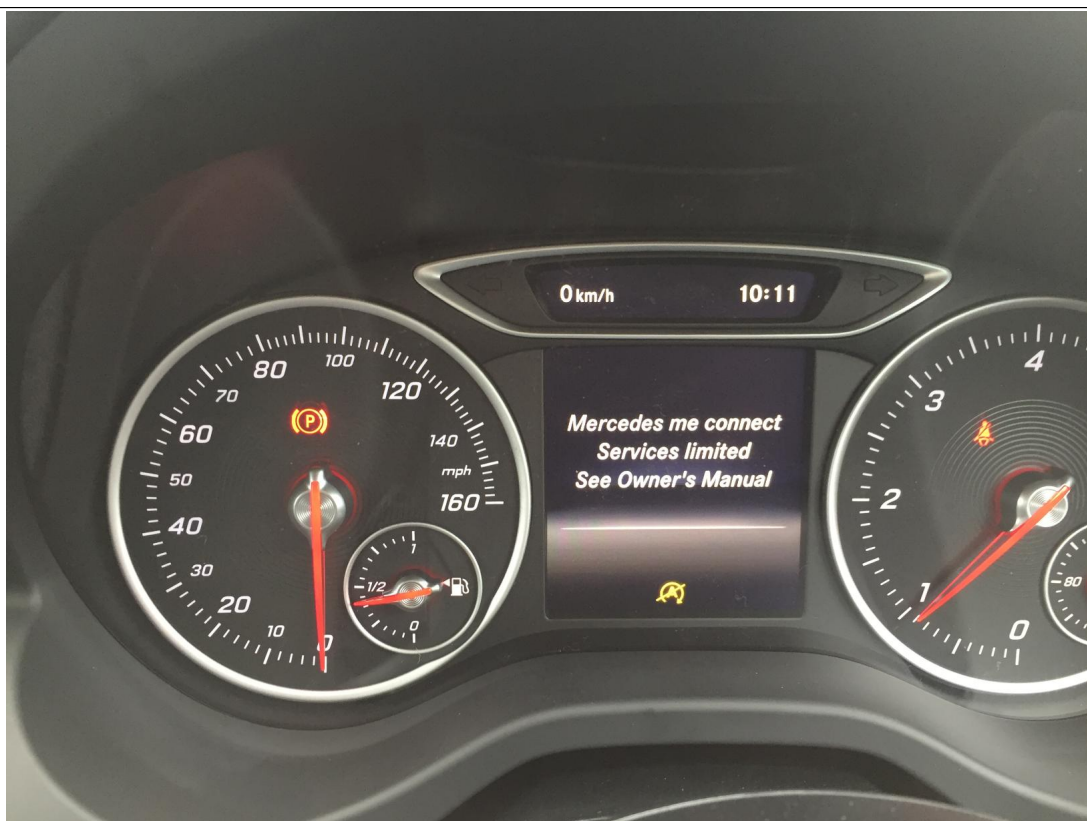
picture limitedservices.JPG:

After every ignition cycle, the multifunction display in the instrument cluster may show the message "Mercedes me connect services limited. See owner's manual" (see picture in attachment).

Attachments	
File	Description
picture limitedservices.JPG	Picture: Limited service message in instrument cluster

This is a status message. It appears whenever a diagnostic unit, e.g. XENTRY Diagnostics or a third-party adapter from the free accessories trade, is connected to the on-board diagnosis (OBD) interface, triggering diagnostic queries on the diagnostics CAN.

The message informs the driver that in this state the Mercedes me connect basic services, such as maintenance management, telediagnosis and other services, no longer function or function only to a limited extent.

Check whether a third-party adapter is being used in the vehicle (visual inspection of OBD interface/ ask the customer if necessary).

If a third-party adapter is being used in the vehicle, explain the reason for the message to the customer.

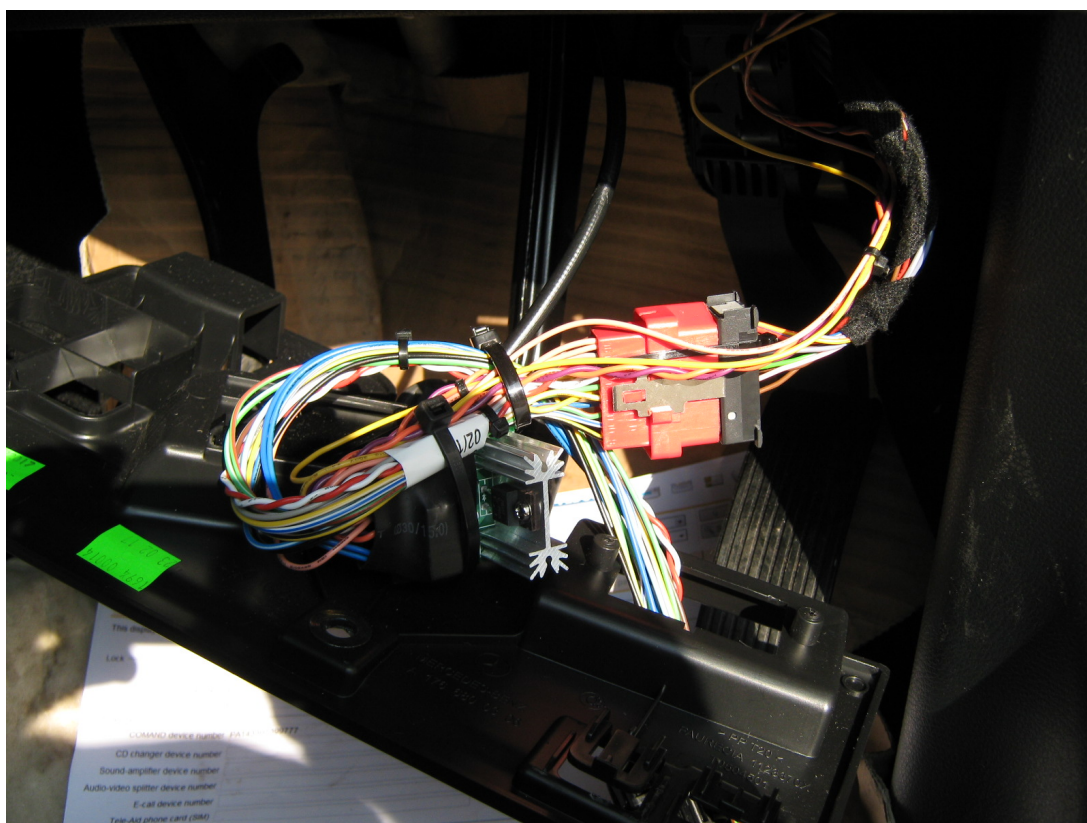
picture\_adapter.JPG:

NOTE: In some cases, third-party adapters may also be connected in series with the OBD socket behind the paneling (see picture in attachment). In seldom instances a third-party hardware is detected, although none is installed in the vehicle. There is no impairment to the vehicle function with one-time detection. In this case, the message is no longer shown after bus idle (ignition off, vehicle locked for approx. 30 minutes).

Picture: Third-party adapter installed behind paneling  
Picture: Third-party adapter installed behind paneling.

NOTE: Please do not remove/install/replace any control units
