5/24/2019  
CAL FTL 54-003

**Subject: Enabling the Radio Mute Feature for  
Lane Departure Warning on New Cascadia  
Vehicles**

**Models Affected: New Cascadia vehicles with Lane Departure  
Warning enabled**

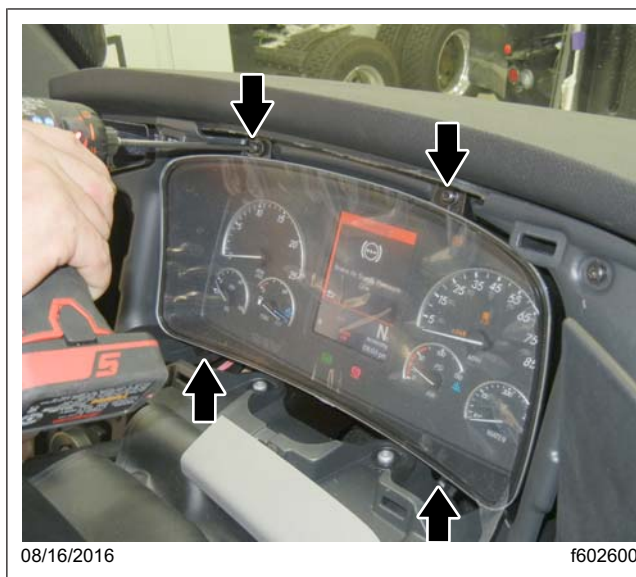
**Fig. 1, ICU Mounting Screws**

1. Park the vehicle, apply the parking brakes, and shut down the engine. Chock the tires.
2. Remove the yellow and red MV3 brake control knobs by turning counterclockwise.
3. Remove the auxiliary switch panel, the Qualcomm display, the B-panel bracket, the ICU trim panels. Refer to Secion 60.06 in the *New Cascadia Workshop Manual* for instructions.
4. Remove the four screws that attach the ICU to the dash. See [Fig. 1](#).

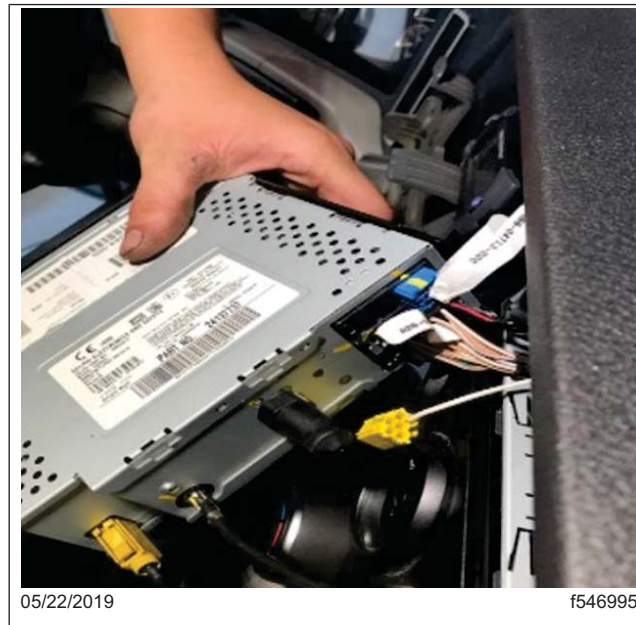
**Fig. 3, Connectors on the Reverse Side of the Radio**

6. Insert the radio removal tools into radio-assembly until they lock into place, then gently pull radio out of the mounting bracket.
7. At the back side of the stereo, unplug the radio antenna cable, the satellite antenna plug, the black main harness connection, and the blue microphone harness connections. See [Fig. 3](#). Set aside the radio to prevent any damage.
