Inspect For Missing High Voltage (HV) Battery Breather Valves

| Classification | Campaign Bulletin | Section/Group | 16 - Battery System | Country/Region | United States, Canada |
| Year | 2017, 2018 | Model | Model 3 | Version | All |

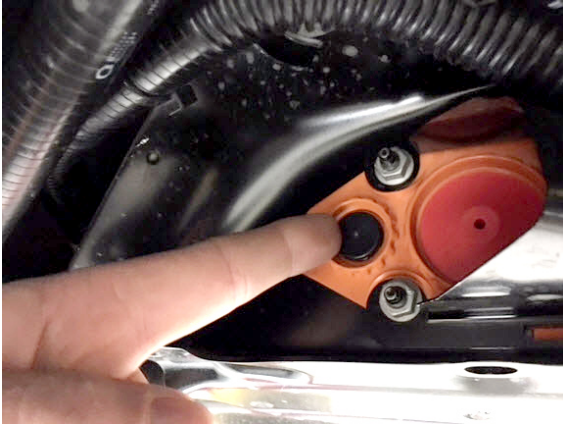
✓ **Figure 1 (LH vent shroud with breather)**

- If both HV battery breather valves are present and properly installed (the HV battery breather valve should be flush with the HV battery vent assembly), discontinue this procedure.

1. Raise and support the vehicle (refer to Service Manual procedure 10000205).
2. Insert a video scope through the mid aero shield to inspect the LH and RH HV battery vent assemblies (Figures 1 and 2):

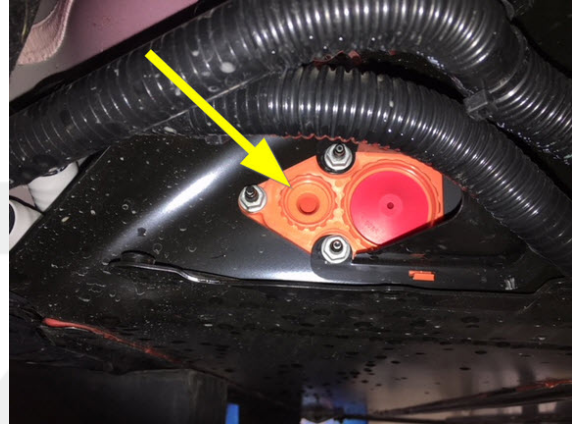
✗ **Figure 2 (LH vent shroud without breather)**

- If any HV battery breather valves are missing or improperly installed (i.e., not flush or parallel with the HV battery vent assembly), continue to the next step.

3. Inspect the vent hole for evidence of water or debris ingress (Figure 2).
 - If evidence is found, create a Toolbox session, add photos of evidence, and escalate the session.

- LH breather water/debris entry.
 - RH breather valve absent.
 - RH breather water/debris entry.
 5. Replace any HV battery vent assemblies that are missing HV battery breathers.
NOTE: Only install 1098630-00-G or newer.
NOTE: New HV battery vent assemblies do not come with HV battery breather valves preinstalled. For every HV battery vent assembly ordered, also order 1 HV battery breather valve.

- LH HV battery vent assembly (Service Manual procedure 16102102).
 - RH HV battery vent assembly (Service Manual procedure 16102112).
