| REFERENCE: | Nova Bus Manuals |
| SECTION: | 16: Electrical System |
| RS N°: | MQR 7621-1566 |

| SUBJECT: | Bracket available to improve routing of the Niehoff alternator regulator connections. |

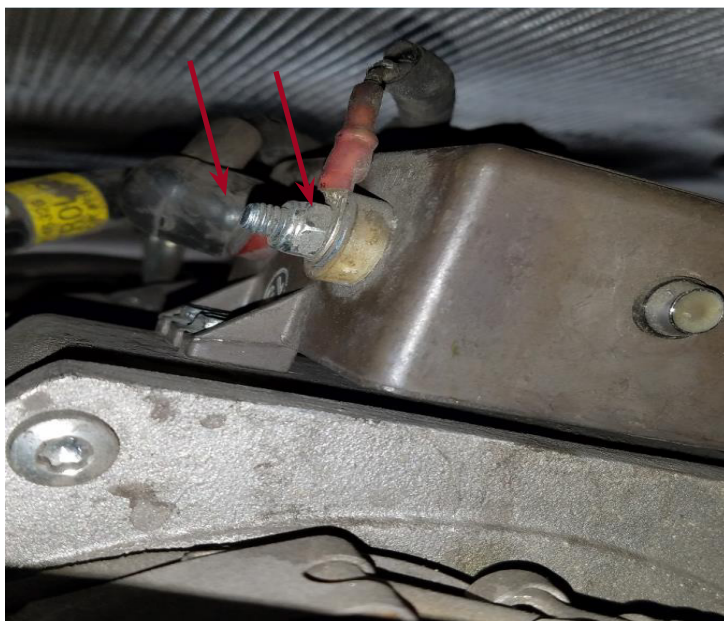
*Figure 3 - View of Regulator D+ / IGN Terminals*

- 1.4. Remove existing D+ and IGN connections on voltage regulator. Inspect and replace terminals if damaged (see Figure 3).
  - 1.4.1. D+ (front). Use 10mm socket. Terminal: N15140-04. Wire: 95-347
    - 1.4.1.1. For certain configurations (L858, L891 and L935), regulator stud "P" (Alt In Load) is used instead of D+. Terminal N15140-04. Wire: 95-273
  - 1.4.2. IGN (rear). Use 8mm socket. Terminal: N15140-03. Wire: 95-272

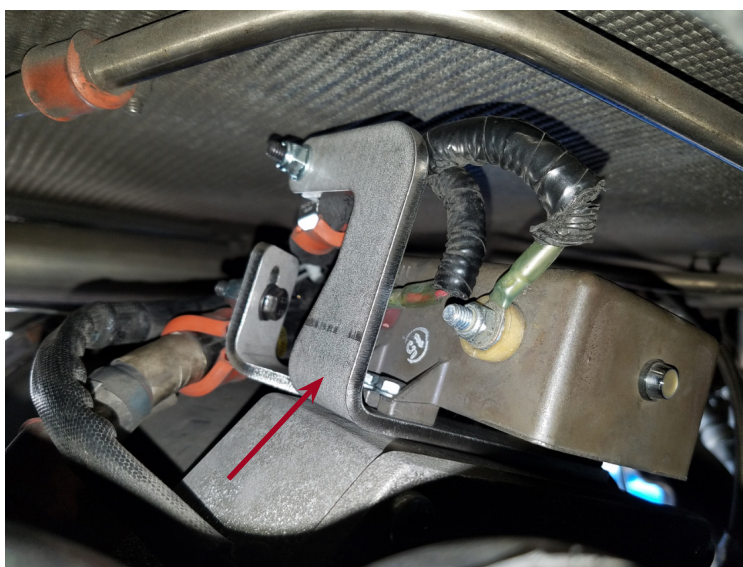
*Figure 4 - Installation of Strain Relief Bracket on Regulator*

- 1.5. Install new strain relief bracket on regulator (see Figure 4).
  - 1.5.1. Remove the four bolts holding the regulator.
  - 1.5.2. Install the new bracket (N94643) under the regulator with four new bolts (N93898) - Use 8mm deep socket. Apply two drops of Loctite 220 to bolt threads. Torque to 8.5Nm.

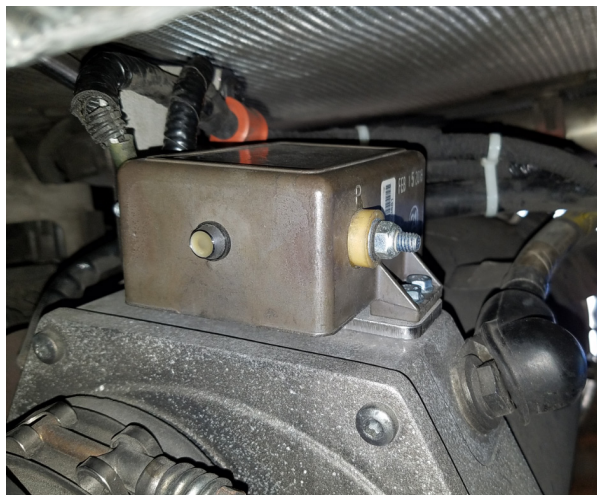
Figure 5 - Installation of P-clamp

- 1.6. Route D+ and IGN wires in p-clamp as shown in Figure 5. If extra length is needed, follow the harness until over-length bundle is found, cut tie wrap, pull extra length and re-attach to power cable.

- 1.7. Install p-clamp mount (N84090-04), M6 bolt (N40492), M6 Locknyl (N38593).
- 1.7.1. Torque p-clamp M6 bolt to 11Nm
- 1.7.2. +MT-MS95D2: D+ (or P) on front connection in image above. Torque to 4.5Nm
- 1.7.3. +MT-MS95D2: IGN on rear connection in image above. Torque to 4.5Nm

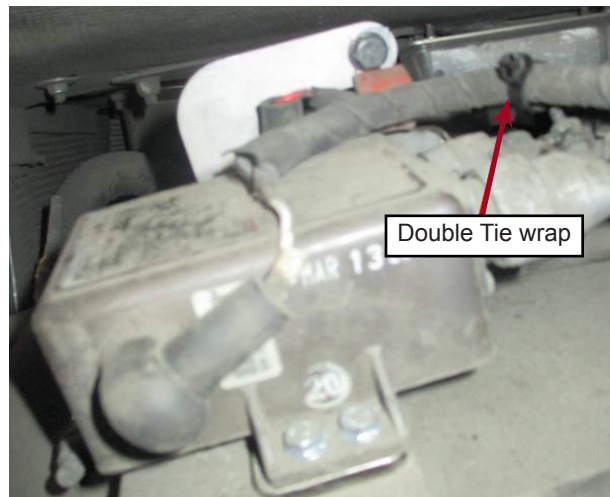
Figure 6 - Installation of Double Tie Wrap

If configuration has the P wire, secure it to the IGN wire using a double tie-wrap as close as possible to the P-clamp. (see Figure 6).

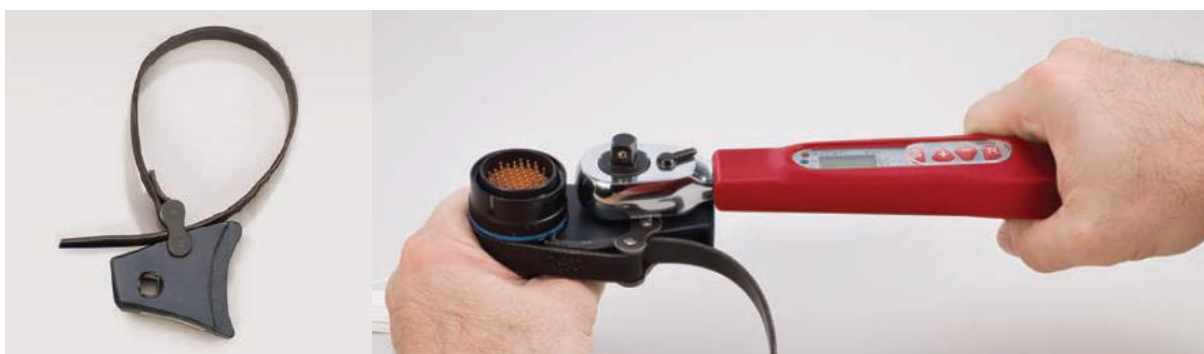
*Figure 11 - Tightening the Connectors on Regulator*

- 1.14. Inspect the two circular connectors on the regulator to ensure they are properly locked (top connector). For bottom connector (Niehoff harness), hand-tight + ¼ turn using strap wrench or similar. (see Figure 11).

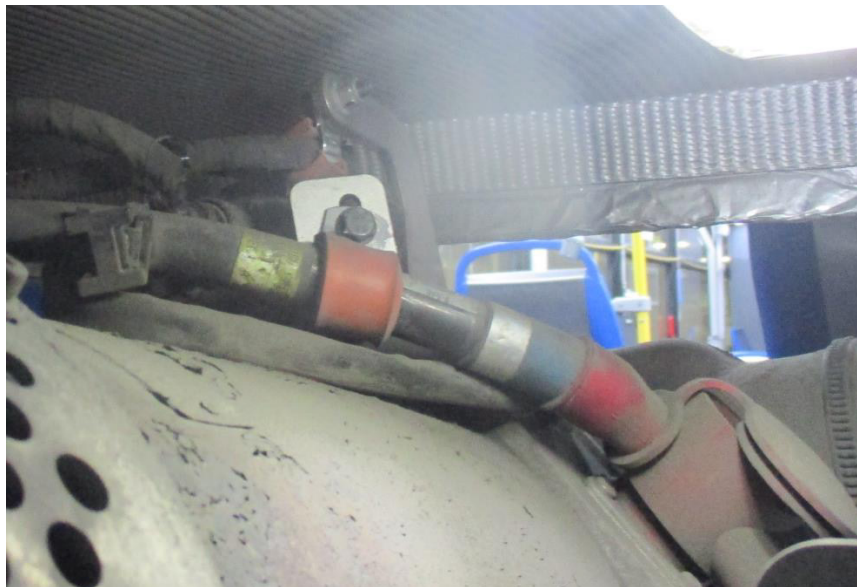
*Figure 12 - Installation of P-clamp to the Alternator*

- 1.15. Install P-clamp (N84090-05), M6 bolt (N40492), M6 Locknyl (N38593) to secure 0000 AWG positive power cable going to the alternator B+ terminal. (see Figure 12).
