TECHNICAL SERVICE BULLETIN

DOCUMENT CREATION DATE:	4/29/2019
SERVICE CAMPAIGN SUBJECT:	Catalyst Radiator Wiring Retrofit
VINs or MODELS AFFECTED:	Service Specified Catalyst Buses
SERVICE CAMPAIGN #:	SC-19-69

CATALYST RADIATOR WIRING RETROFIT

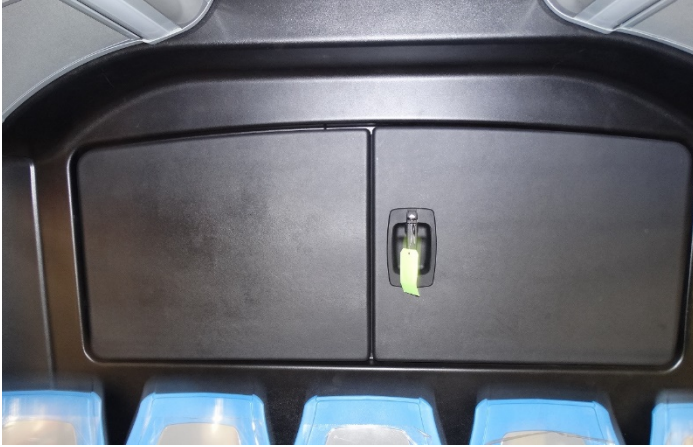
1. If you are working on a Catalyst 40 bus, proceed to the next section of this procedure.
2. Complete the Proterra approved Lockout/Tagout procedure to make the bus safe for work.
3. Open the doors at the rear of the bus to access the rear ECAB on the bus.

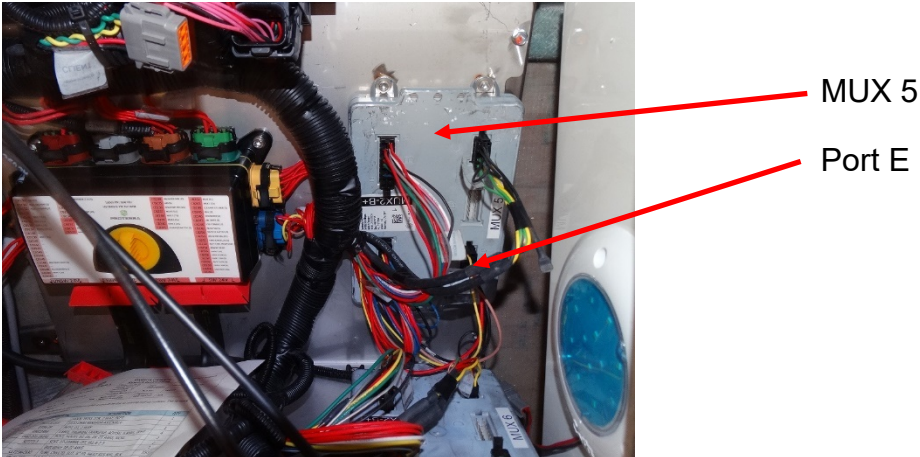
4. Locate MUX5 on the rear ECAB.

5. Remove the connector from Port E of the MUX.
6. Using a Pin Extractor Tool, remove the wire and pin that are in Cavity 17 of this connector.
7. Measure 50mm back from the pin. Using Wire Strippers, cut the wire 50mm from the pin. Discard the wire and pin that were cut.
8. Using wire strippers, strip the end of the wire that was just cut.

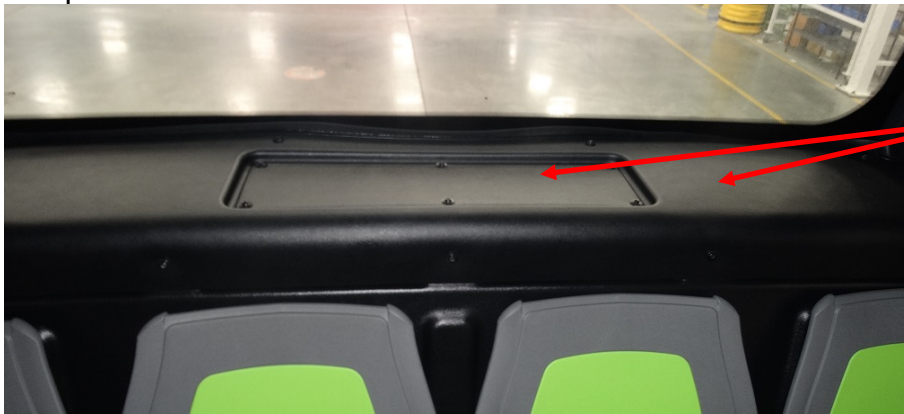
Remove Panels

1. Complete the Proterra approved Lockout/Tagout procedure to make the bus safe for work.
2. Using a T-30 Torx Driver, remove the panels shown to access the Rear Deck electronic components.

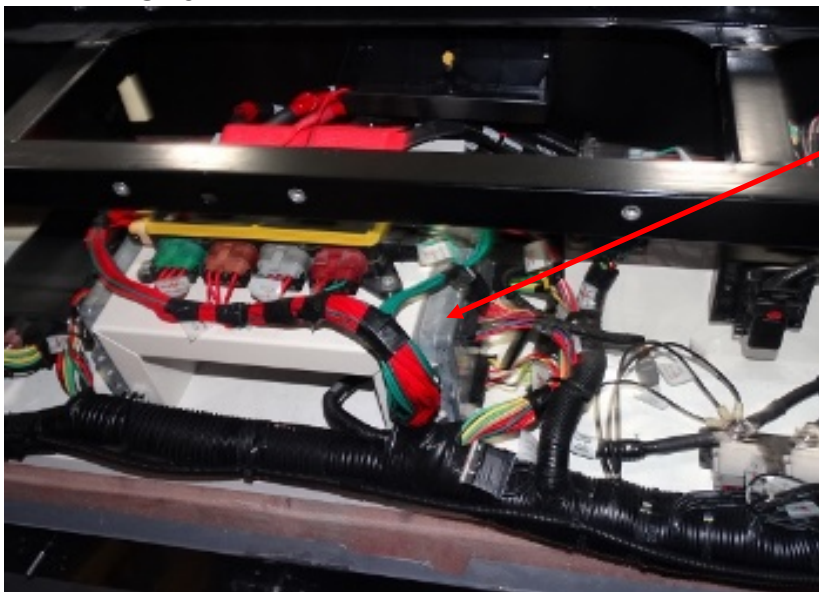
MUX 5

3. Locate MUX5 on the rear deck.

4. Remove the connector from Port E of the MUX.
5. Using a Pin Extractor Tool, remove the wire and pin that are in Cavity 17 of this connector.
6. Measure 50mm back from the pin. Using Wire Strippers, cut the wire 50mm from the pin. Discard the wire and pin that were cut.
7. Using wire strippers, strip the end of the wire that was just cut.
8. Insert this stripped wire into the Butt Splice labeled SP2147 on the new Harness (044525). Using a Crimp Tool, crimp these wires in the splice.

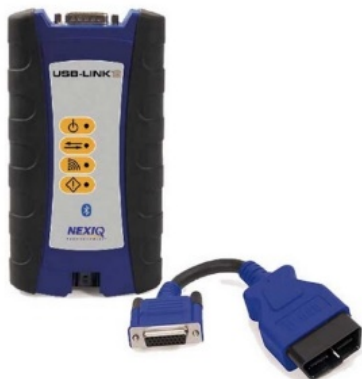
1. Access the following folder to obtain the new configuration file:
[\\BUS.Local\files\Engineering\Service Bulletins\Service Bulletin Files for SC-19-69\](#)
2. Copy the software file **XXXXXX.ZR32A_A** to a known location on the service technician's computer (Folder or Desktop).
IMPORTANT! NEVER access the software from the USB memory device, ALWAYS copy the software files to your computer hard drive and access the software from this location.
3. Turn **ON** the 12/24V rear Master Disconnect located behind the vehicle curbside rear upper access panel.
4. Turn **OFF** the bus High-Voltage Master Switch at the Driver's Workplace and ensure the Dash screen is **OFF**.
5. Turn **ON** the bus "programming switch" at the streetside wheel well box.
6. Power up (boot) the Proterra-supplied laptop containing the Proterra Diagnostic Tool.
7. Connect the Nexiq USB Link to the laptop.

Note: Using a USB cable connection, rather than Wi-Fi, is highly recommended.

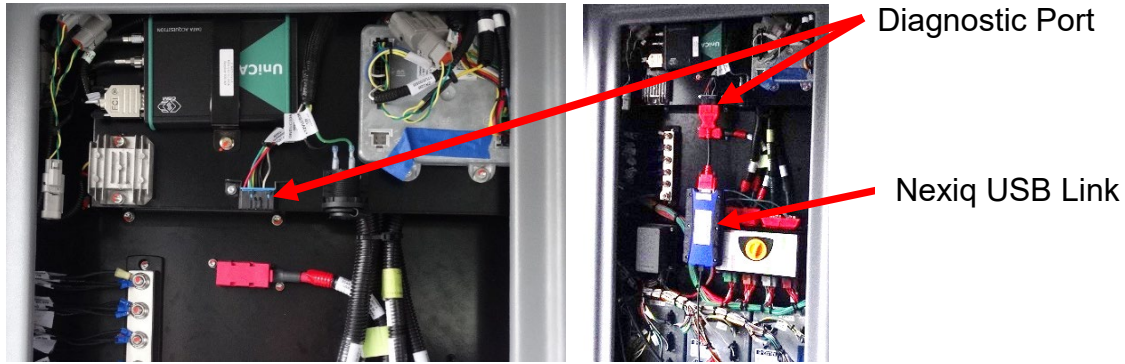
8. Connect the Nexiq USB Link to the Diagnostic Port located on the street side wheel well electronics cabinet (eCab).

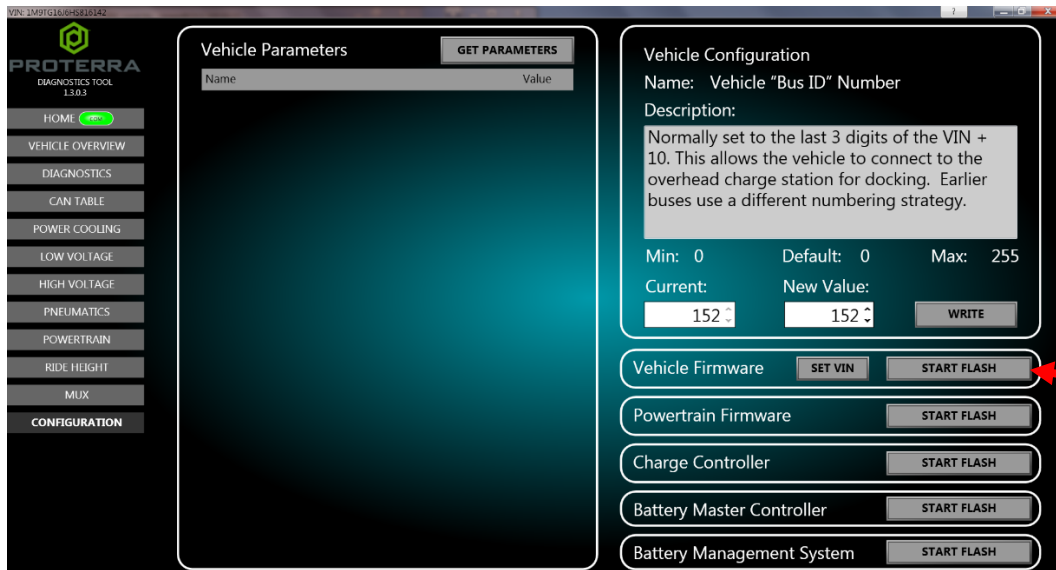
Beside Vehicle Firmware, Click Start Flash

13. After the parameters file is saved to your desktop, click the Vehicle Firmware “Start Flash” Button.

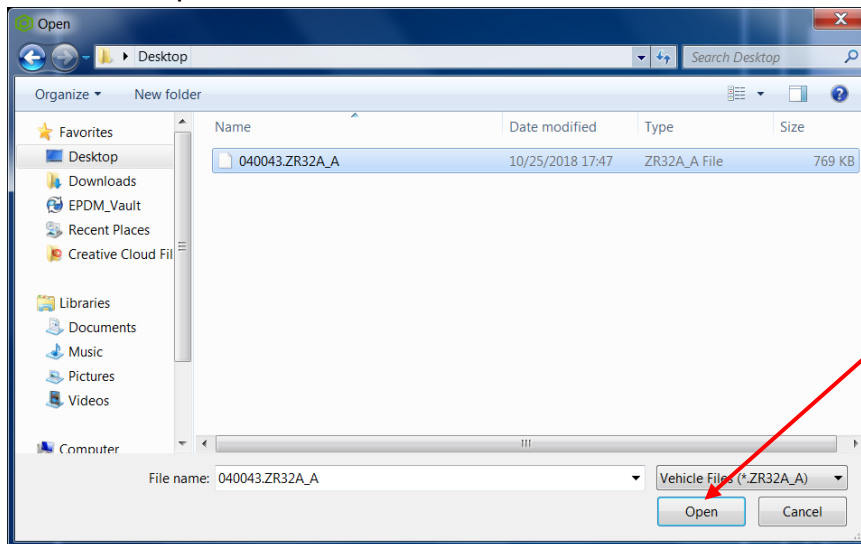
Select the file and Click Open

14. The following screen will be displayed. Navigate to the location where you stored the configuration file earlier. Select the software file **XXXXXX.ZR32A_A** downloaded previously and click “Open” to load the file.
