NUMBER: 21-021-19

Transfer Case Oil Leak

This bulletin involves removing and replacing six of the transfer case extension housing bolts.

2019 (JL) Jeep Wrangler

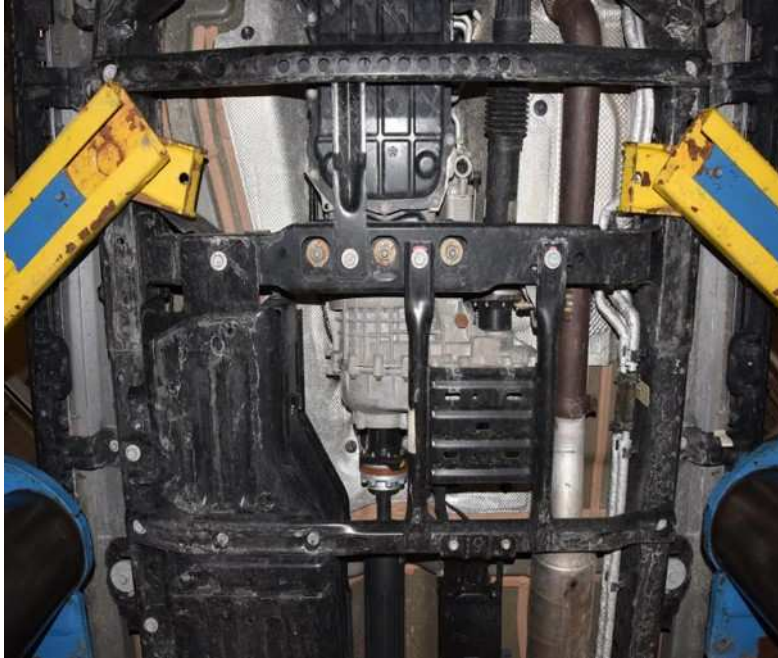
Fig. 1
Cross Member

1. To gain access to the extension housing bolts remove the transmission cross member (Fig. 1) . Refer to the detailed service procedures available in DealerCONNECT> Service Library under: 13 - Frame and Bumpers / Frame / Cross member, Transmission / Removal.

3. Install the transmission cross member. Refer to the detailed service procedures available in DealerCONNECT> Service Library under: 13 - Frame and Bumpers / Frame / Cross member, Transmission /Installation (**Fig. 1**) .

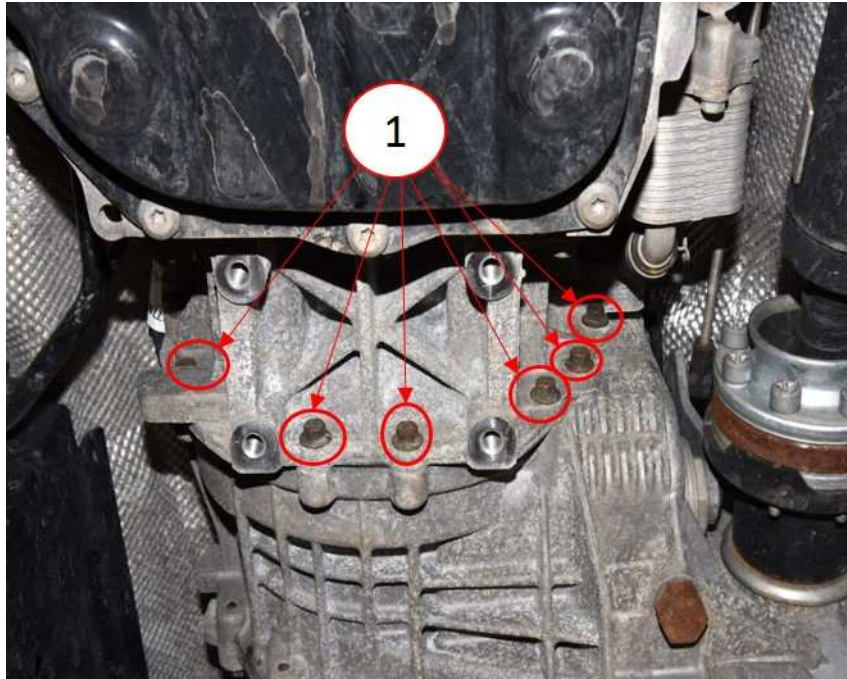
Fig. 2
Extension Housing Bolts To Be Replaced

Customers may notice a fluid leaking on the ground from the middle of vehicle.

1 - Six Transfer Case Bolts To Be Replaced

NOTE: Remove, replace and re-torque one extension housing bolt at a time (**Fig. 2**) no particular order is required, suggested order is clockwise. This will help prevent a fluid leak.

2. Remove and discard the old bolts (**do not reuse**), replace with new bolts and re-torque the six extension housing bolts, one at a time. Torque bolts to 26 N·m (19 ft. lbs.) (**Fig. 2**) .
