Head-up display (HUD) code 463 – lines on the display, display flickers

| Topic number | LI54.30-P-069742 |
| Function group | 54.30 Instrument cluster, display instruments, hazard warning device |
| Validity | Model series 205 with code 809+463 and not 464 Model series 253 with code 809+463 |

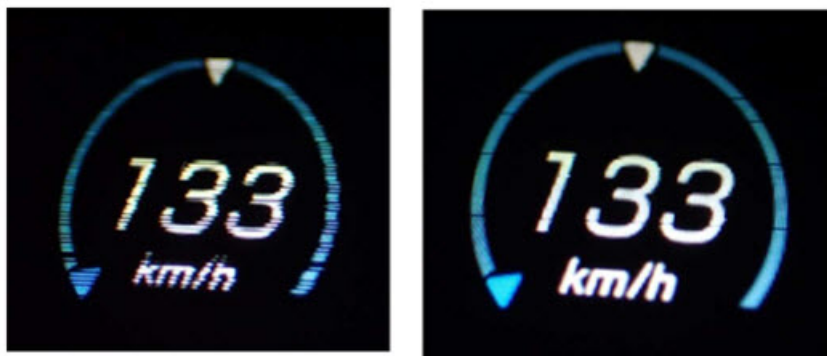
HUD image quality complaint.jpg:

The image in the head-up display (HUD) flickers and/or has lines on it. See attachment for details.

Signal from instrument cluster (IC entry) to head-up display not within specification.

Please replace the instrument cluster. Do not replace the head-up display.
