# SERVICE BULLETIN

Classification: EL18-033a	Reference: NTB18-076a	Date: June 28, 2019
------------------------------	--------------------------	------------------------

## 2018-2019 KICKS; REAR SONAR DOES NOT WORK WITH HEADLAMPS AND/OR PARKING LAMPS ON

**APPLIED VEHICLES:** 2018-2019 Kicks (P15)

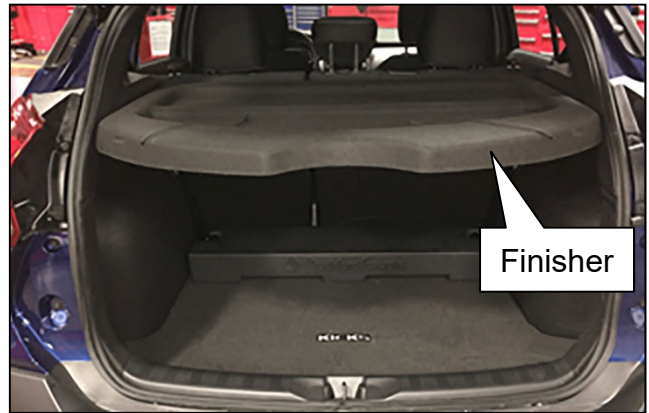
Figure 1

6. Disconnect the parcel shelf finisher straps from the back door, and then remove the parcel shelf finisher.

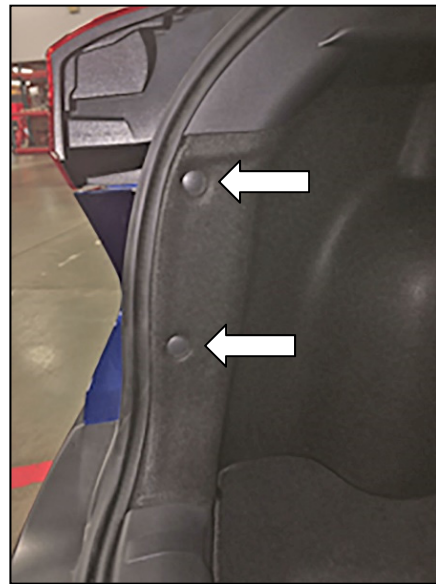
Figure 2

7. Remove the two (2) driver side luggage side lower finisher clips with a suitable plastic trim tool.

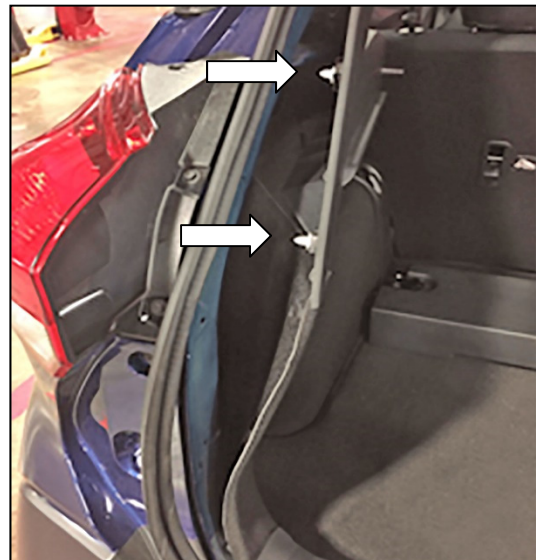
Figure 3

8. Unfasten the two (2) driver side luggage side upper finisher clips.

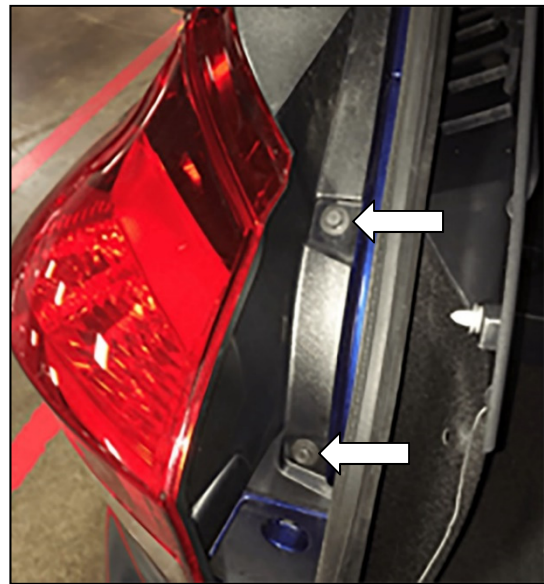
Figure 4

9. Remove the two (2) 10 mm bolts securing the driver side rear combination lamp (combination lamp).
10. Grab the combination lamp, and then carefully pull it off the vehicle body.
  - The combination lamp is fastened to the vehicle body by the 2 bolts and 2 push pins.

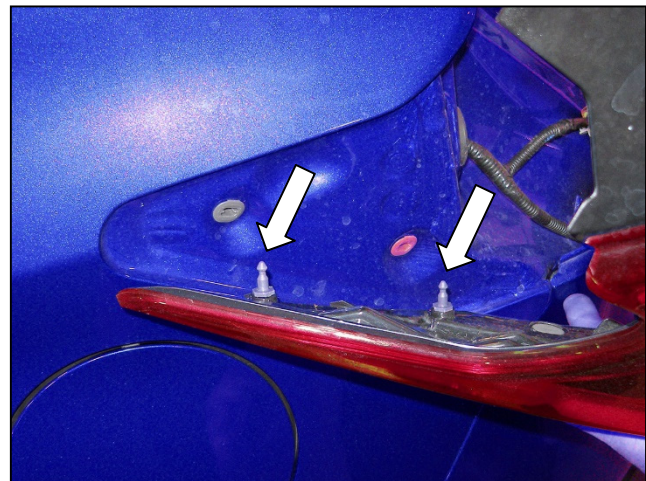
Figure 5

**NOTE:** The push pins are part of the combination lamp.

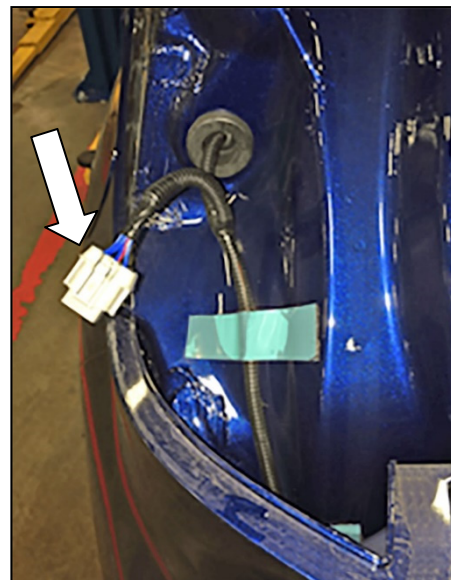
Figure 6

11. Disconnect the combination lamp harness connector, and then remove the combination lamp.

**NOTE:** To keep the orientation of the combination lamp harness connector consistent, hold it with the lock at the top.

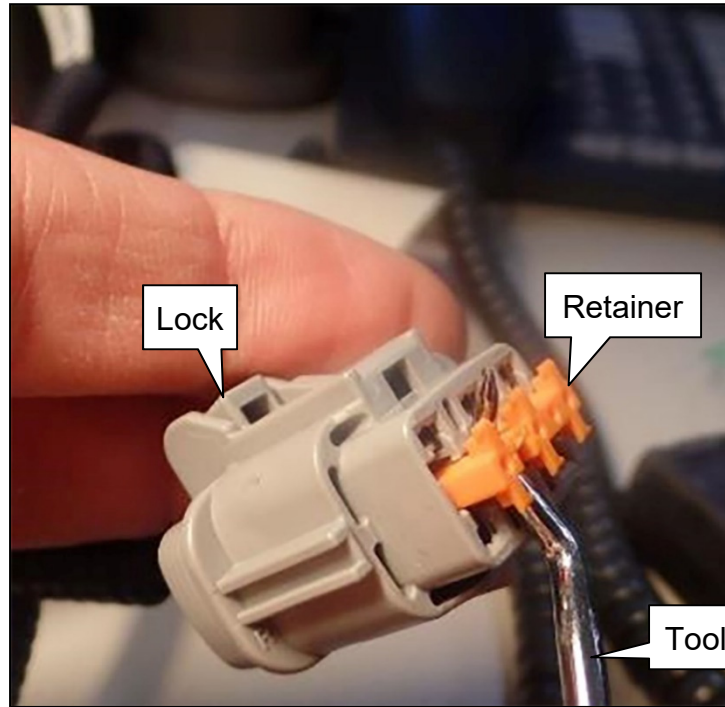
Figure 7

12. Remove the retainer by inserting a suitable pick in the notched hole and carefully prying out.

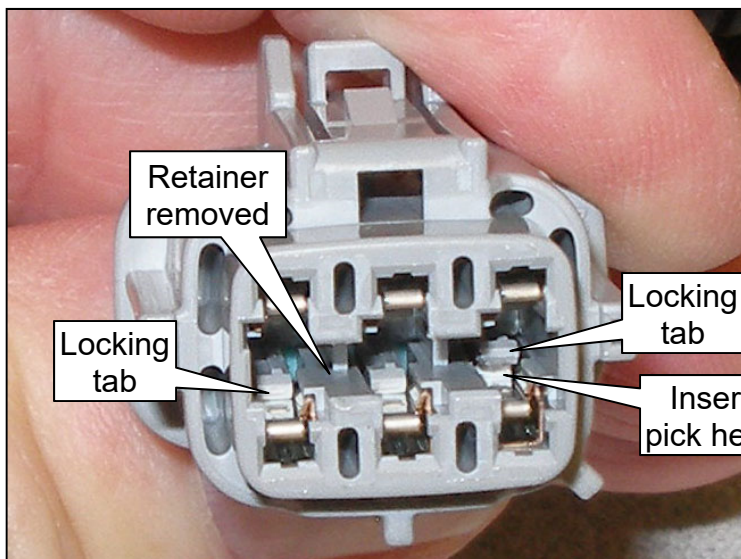
13. Remove the terminals of the **blue** and **black** wires from the combination lamp harness connector (see Figure 10 and 11 for selecting the correct **blue** wire).
  - Using a suitable pick, pry inward on the locking tabs, and then pull out the wires from the harness side of the connector. A flashlight may help see the tabs better.
  - The right side locking tab in Figure 8 is shown in the unlocked position.

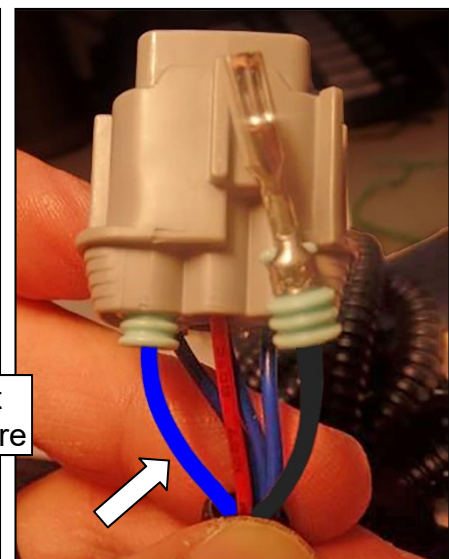
**NOTE:** The color of the **blue** wire in Figure 9 is enhanced for easier viewing. Normally, it is the same shade of **blue** as the other **blue** wires.

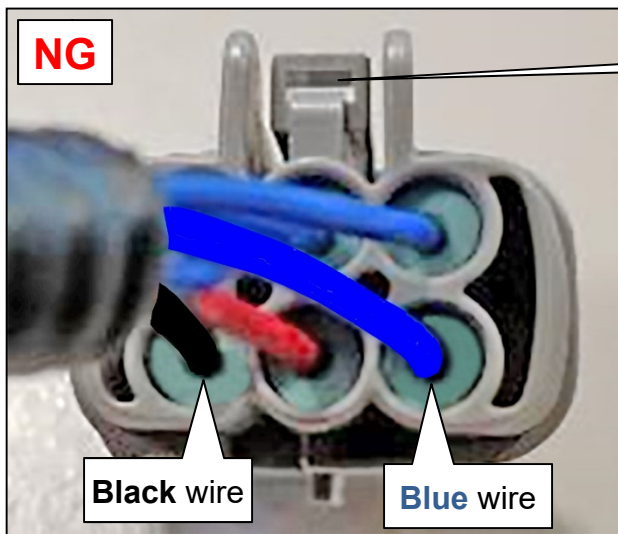
14. Insert the **black** wire where the **blue** wire was positioned.

15. Insert the **blue** wire where the **black** wire was positioned.

**NOTE:** The color of the **blue** wire in Figure 10 and Figure 11 is enhanced for easier viewing. Normally, it is the same shade of **blue** as the other **blue** wires.

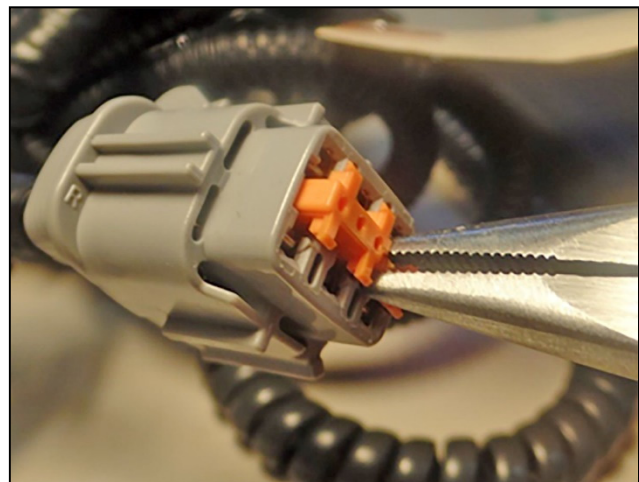
Figure 12

16. Install the retainer with a suitable pair of needle nose pliers or equivalent tool.

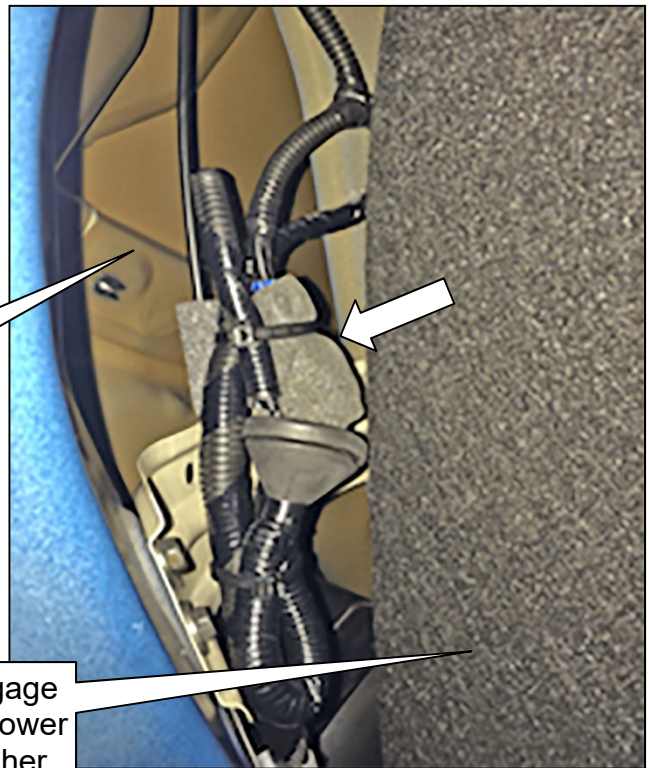
Figure 13

17. Locate the foam wrapped harness connector shown in Figure 13.
  - This connector will be rewrapped and fastened in the same position during assembly. Remember its position.

Area in front of combination lamp

Luggage side lower finisher

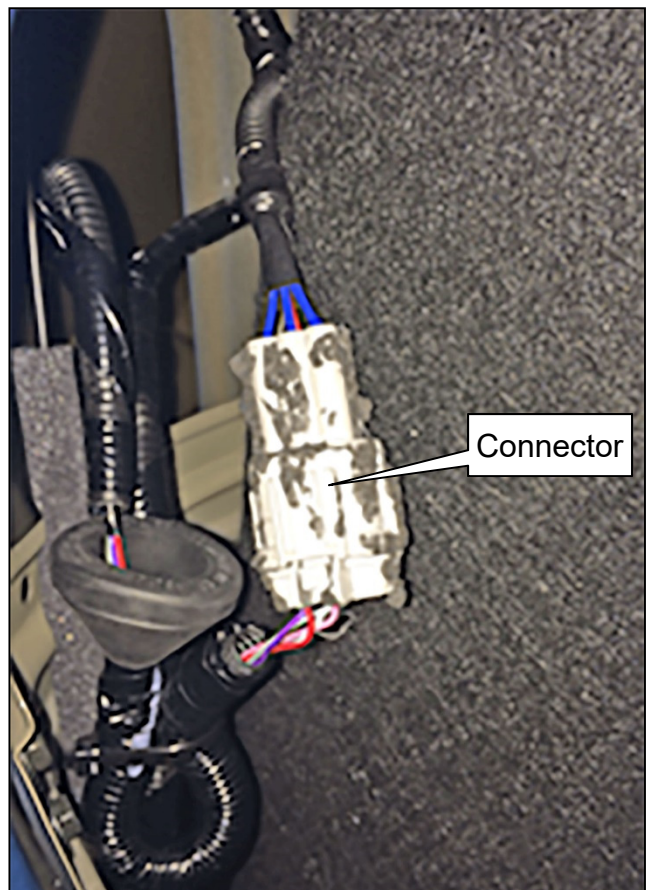
18. Using a suitable cutting tool, cut the "wire tie", and then peel off the foam from the connector.

**NOTE:** Figure 14 shows the connector with foam and "wire tie" removed.

Connector

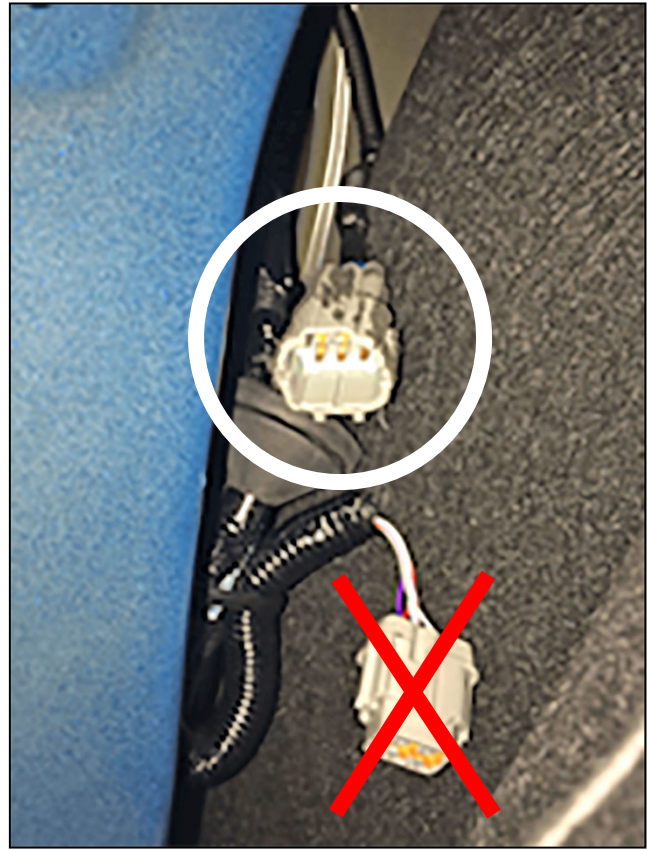
Figure 15

- Perform repairs to the circled connector, not the one with the red "X" (see Figure 15).

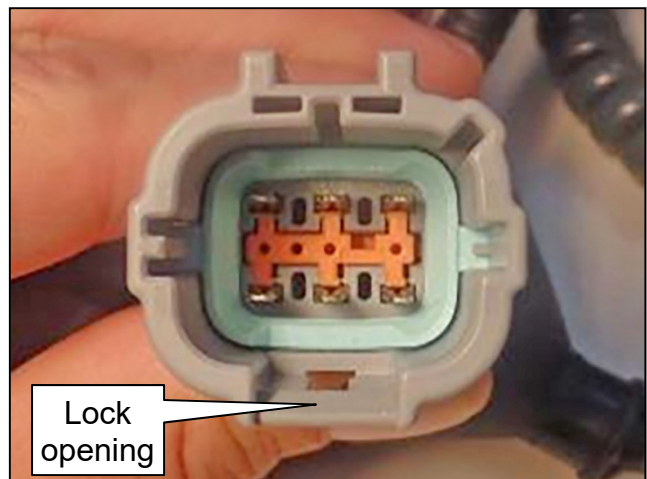
Figure 16

- To keep the orientation of the connector consistent, hold it with the lock opening at the bottom.

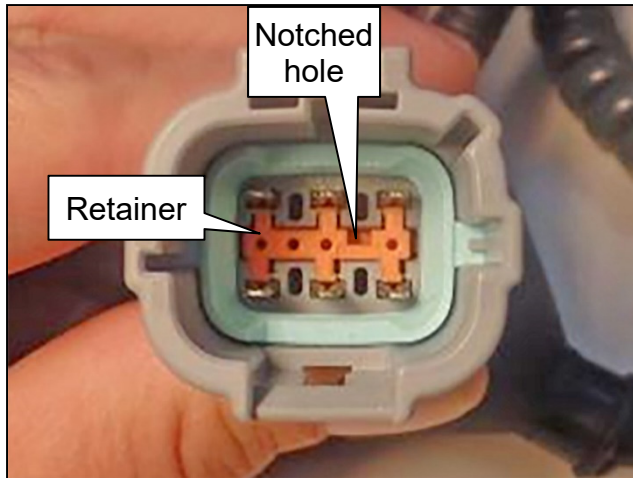
Figure 17

20. Remove the retainer by inserting a suitable pick in the notched hole and carefully prying out.

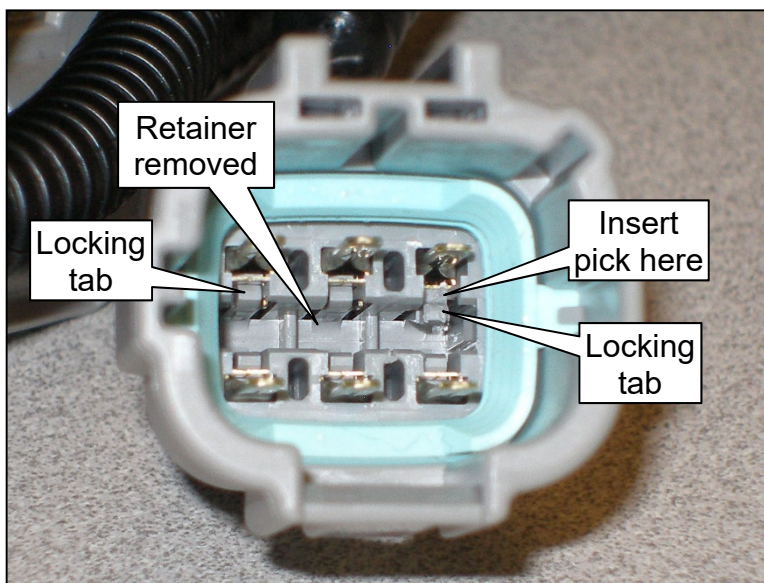
21. Remove both terminals of the **blue** and **black** wires from the connector (see Figure 21 and 22 for selecting the correct **blue** wire).
- Using a suitable pick, pry inward on the locking tabs, and then pull out the wires from the harness side of the connector. A flashlight may help you see the tabs better.
  - The right side locking tab in Figure 19 is shown in the unlocked position.

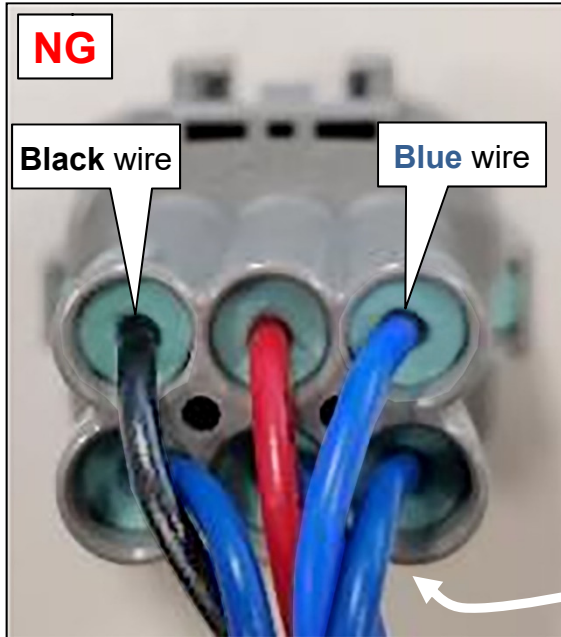
Figure 21

22. Insert the **black** wire where the **blue** wire was positioned.
  - A slight audible click is heard when the terminal locks in place. Tug on the wire to make sure the terminal is locked in.
23. Insert the **blue** wire where the **black** wire was positioned.
  - A slight audible click is heard when the terminal locks in place. Tug on the wire to make sure the terminal is locked in.

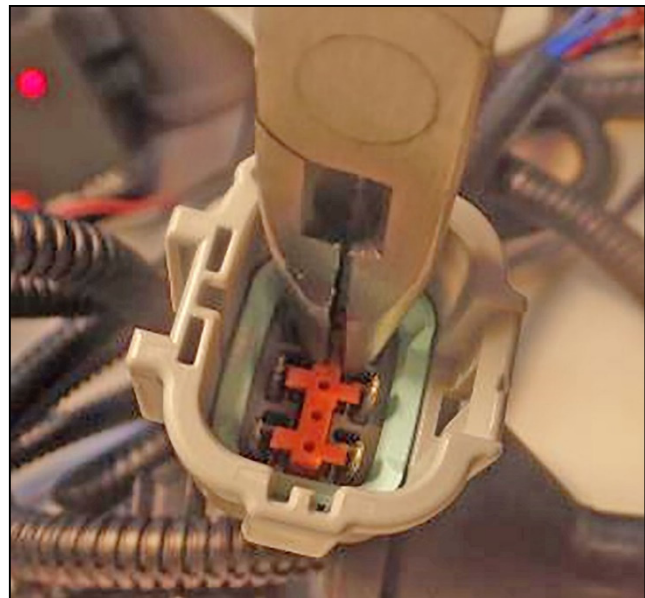
Figure 23

24. Insert the retainer using a suitable pair of needle nose pliers.

**CAUTION:** Make sure none of the pins are bent.
