# Latest Vehicle Concern Fixes

| Engine Cooling Fan Pulley | 2019 RR Sport with AJ20P6 |

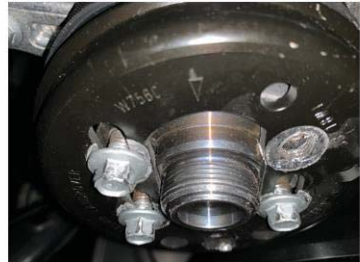
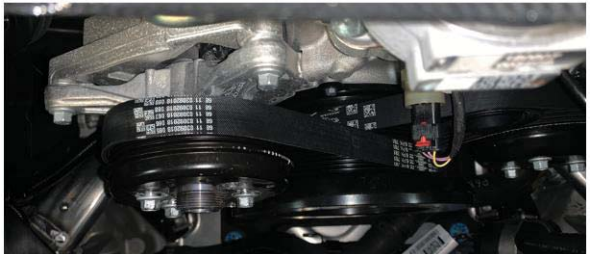
| Engine Cooling Fan Pulley | 2019 RR Sport with AJ20P6 |
|---|--|
| <p><b><u>Customer Voice:</u></b></p> <ul style="list-style-type: none"><li>• There is a noise from the engine compartment.</li></ul> <p><b><u>Technical Description:</u></b></p> <ul style="list-style-type: none"><li>• The engine fan pulley/bracket has come adrift.</li></ul> <p><b><u>Status:</u></b></p> <ul style="list-style-type: none"><li>• Make repairs necessary based on the extent of the damage that has occurred.</li><li>• Raise an EPQR as soon as the vehicle arrives including pictures showing the condition of the FEAD system.</li><li>• An ESST shipment should leave the warehouse this week which includes the P6 specific tools outlined for this repair.</li></ul> | |
