L73X-  
A.05.19

**To:** Official After-Sales Network  
**Subject:** Installation of air ducts on the floor panel  
**Date:** 29 Friday 2019  
**Pages** 4

**Campaign Description:**  
Installation of 2 air ducts on the floor panel

**Model:**  
Aventador

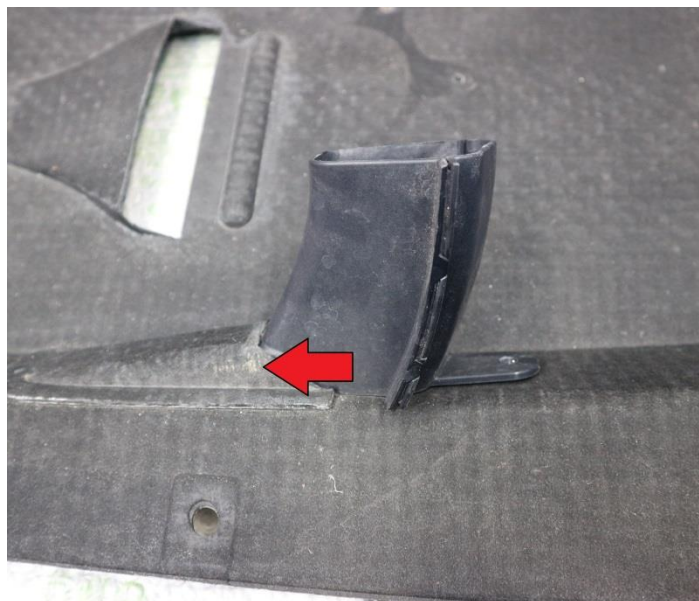
- VAS 6759 riveter or equivalent tool.
2. Position the air intake near the opening on the panel and the hole.

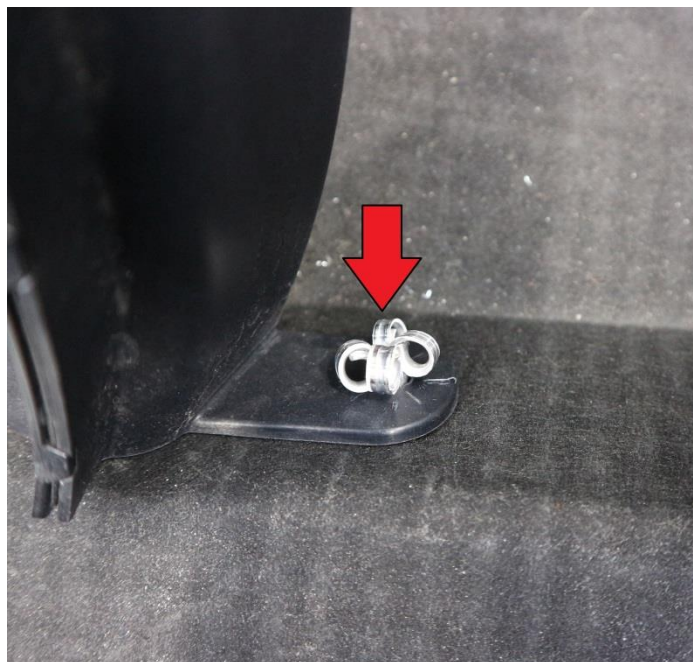
3. Position the rivet and secure it with the riveter.

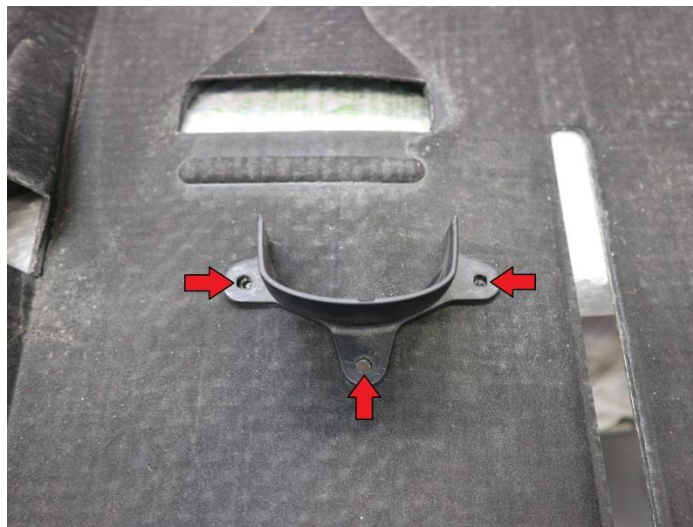
4. Position the air intake near the 3 holes.

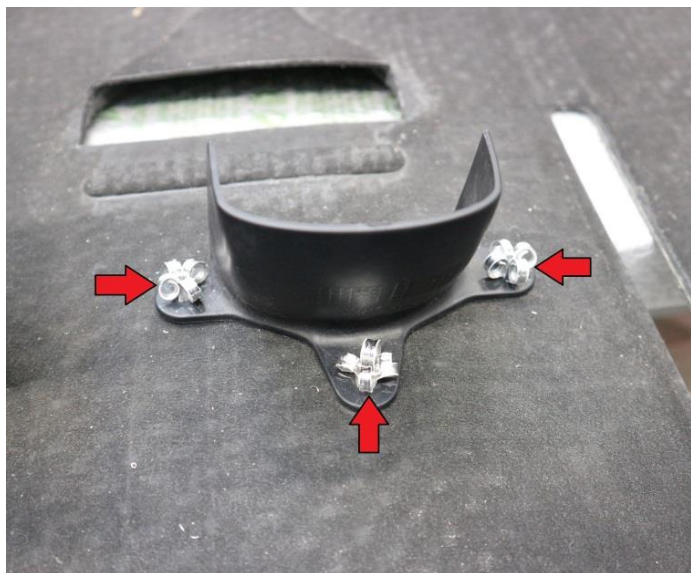
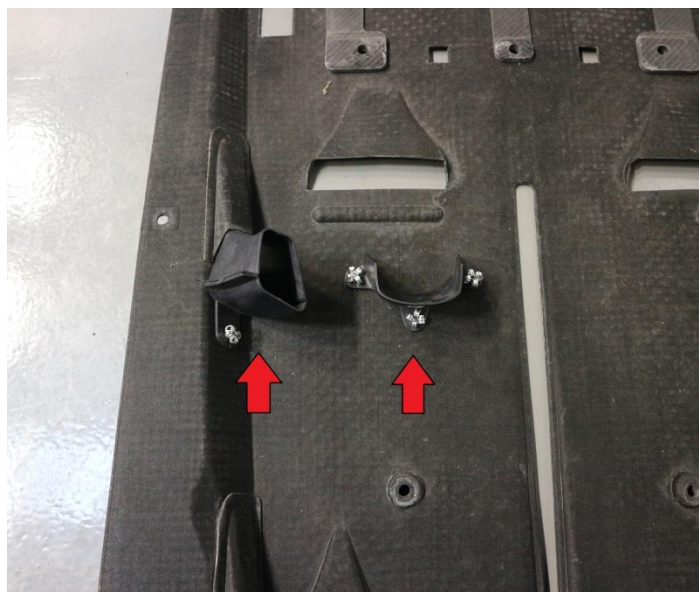
5. Position the 3 rivets and secure them with the riveter.
6. Installation completed:
