Manual Slide Door Center Hinge Corrosion

YEAR(S)	MODEL(S)	ADDITIONAL INFORMATION
2011 - 2018	Sienna

Introduction

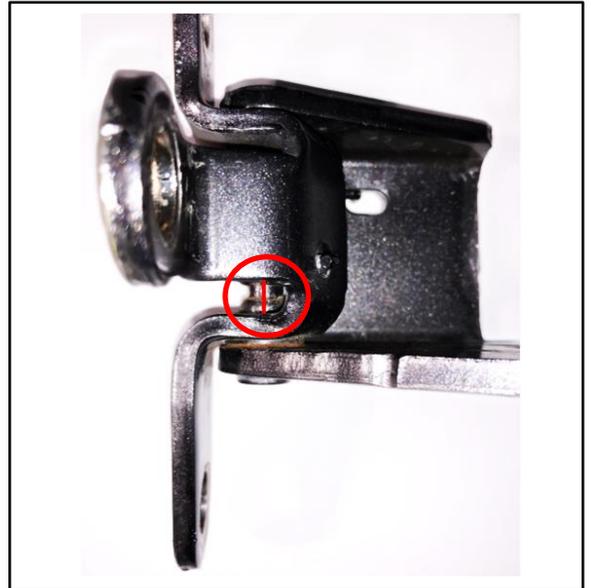
Figure 1.

2. Scribe a line on the center hinge, as shown.

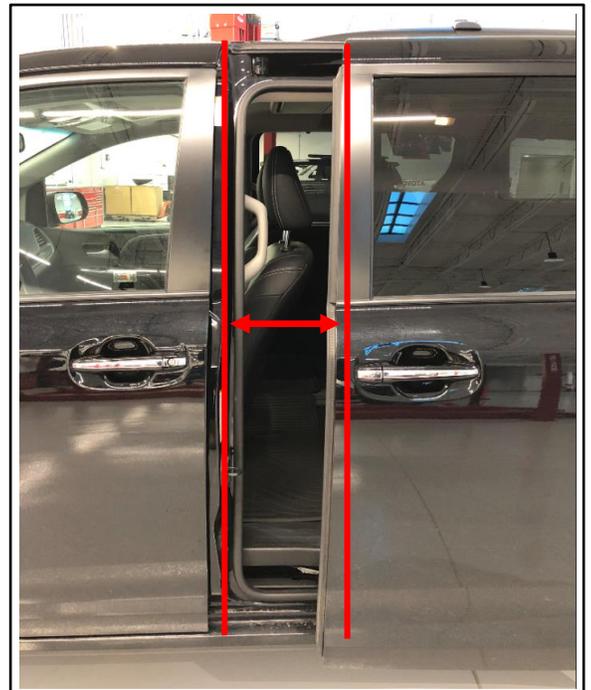
Figure 2.

3. Watch the scribe lines while manually moving the slide door forward and backward until just BEFORE the closed position and when the center hinge pivots.

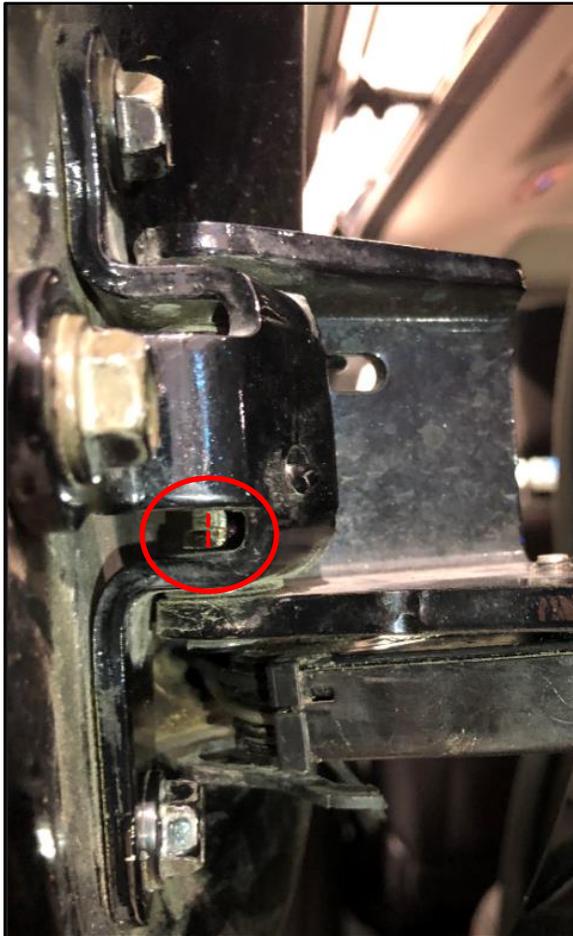
Figure 3. NG Condition

Do the scribe lines rotate together when the hinge pivots, as shown in Figure 3?

- **YES** — If the scribe lines rotate together, then the pin and bushing are seized and the center hinge should be replaced. Continue to the Repair Procedure.
- **NO** — If the scribe lines rotate independently (as shown in Figure 4), then this bulletin does NOT apply. Continue diagnosis using the applicable Repair Manual.

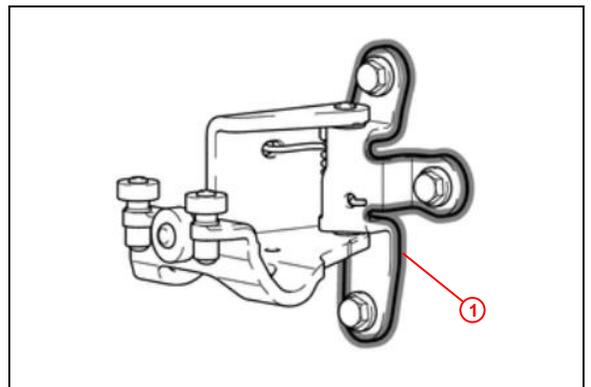
Figure 10.

1	Anti-rust Coating
----------	--------------------------

- C. Using a brush, apply an anti-rust coating to the center hinge, as shown.
