Fuel Lid Door Hinge Broken

Service Category Vehicle Exterior

Section Door/Hatch

YEAR(S)	MODEL(S)	ADDITIONAL INFORMATION
2011 - 2018	Sienna

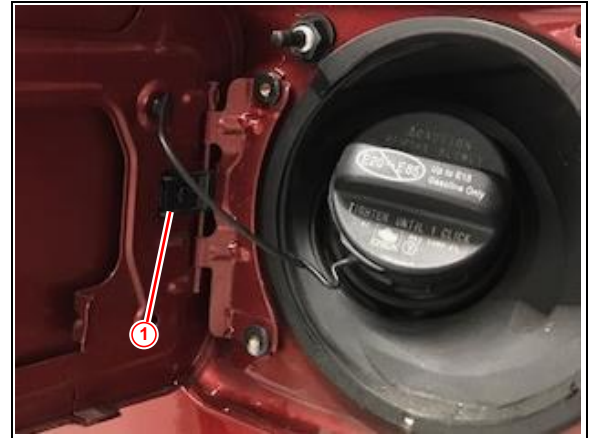
Figure 3.

2. Confirm if the fuel lid door stopper is present.
Is the fuel lid door stopper present?
 - **YES** — Continue to step 3.
 - **NO** — Order the fuel lid door stopper P/N 77358-30060 and continue to step 3.

1	Fuel Lid Door Stopper
----------	------------------------------
