TRD Pro Bumper/Fender Interference

Service Category Suspension

Section Tire/Wheel

Some 2015 – 2020 model year TRD Pro Edition 4Runner vehicles may exhibit an abnormal noise when in Reverse with the wheels at or near full lock due to interference between the tire and bumper and/or fender liner. Follow the Repair Procedure in this bulletin to address this condition.

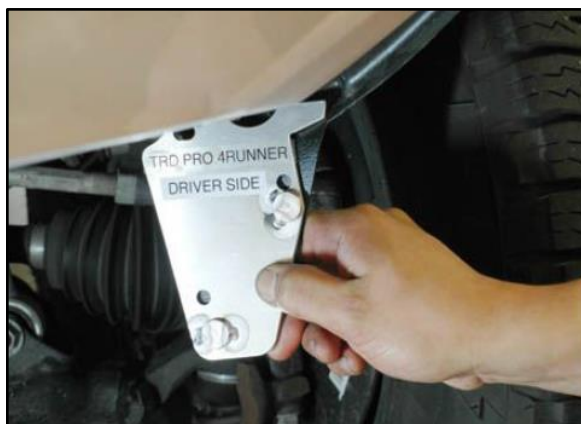
Figure 3.

5. Install the driver side metal fender liner template (from the TRD Pro trim kit) on the front side of the fender liner.

Make sure to place the alignment pins into the two existing holes.

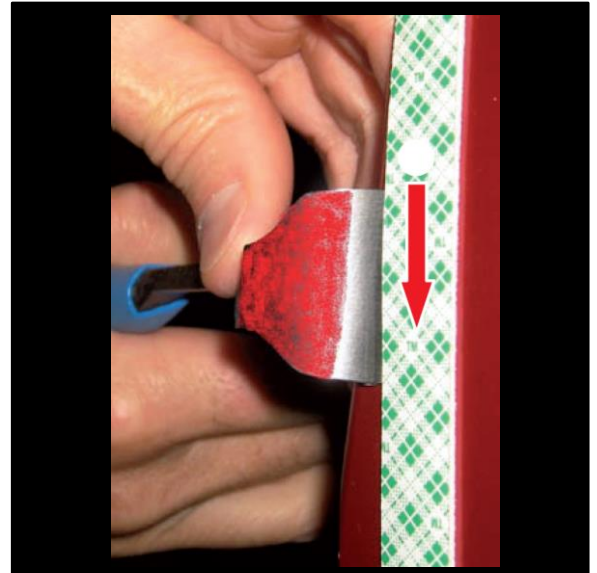
Figure 11. Top to Bottom

- Do NOT make full cuts across the face of the bumper cover.
- ONLY MAKE HALF CUTS BEFORE MOVING TO MAKE THE NEXT CUT.

Failure to make ONLY half cuts may result in uneven cuts, a wavy appearance, or bumper replacement.

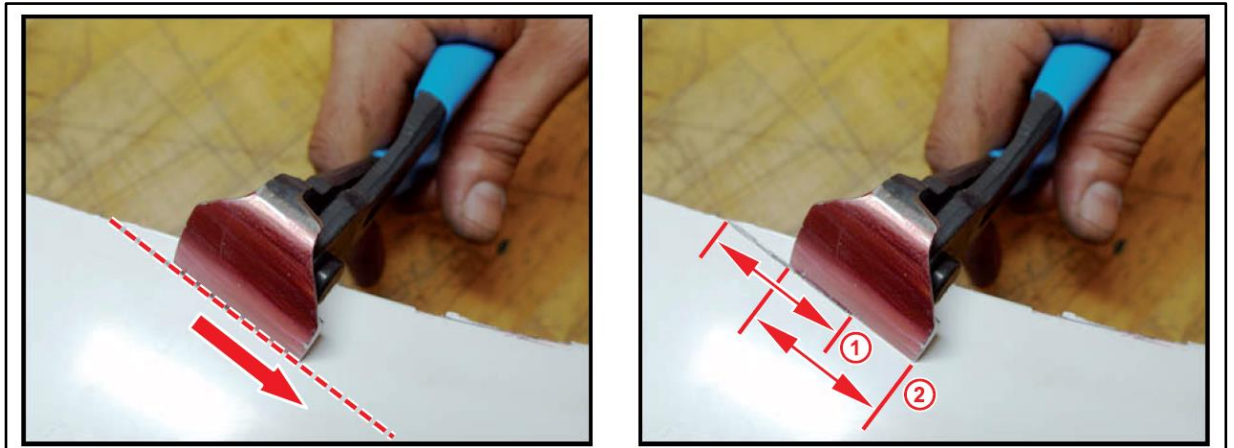
Figure 12. Half Cuts Along Same Line

1	Cut 1
----------	-------

2	Cut 2
----------	-------

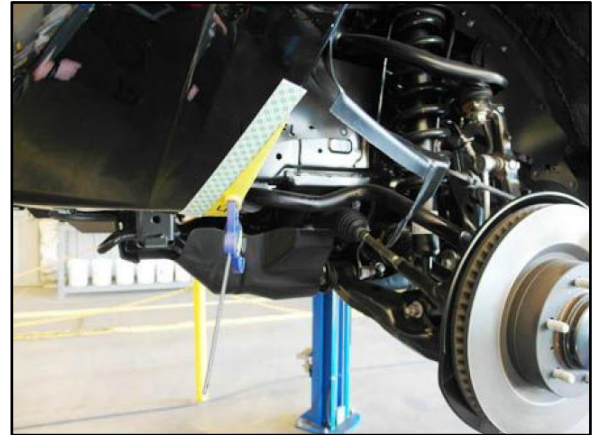
Figure 20.

4. Cut an 8-in. (203 mm) strip of double-sided foam tape and apply it to the edge of the marking template. Ensure the tape is straight and flush against the template.

- Do NOT remove the backing from the tape.
- A NEW piece of tape MUST be used when repeating this step for the opposite side.

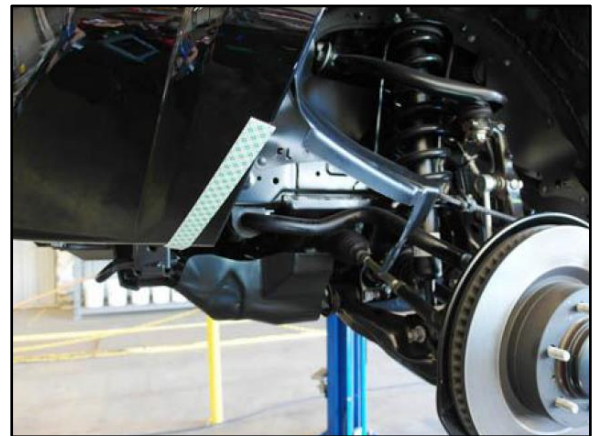
Figure 21.

5. Remove the marking template and clamp.

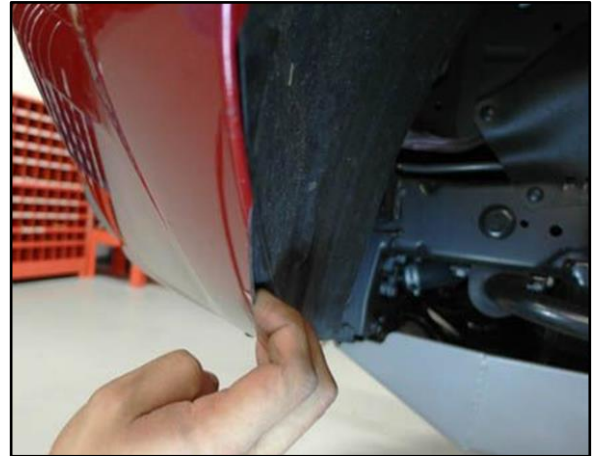
Figure 26.

13. Using your hands, verify the fender liner and bumper are flush.
