Installation of Service Kit

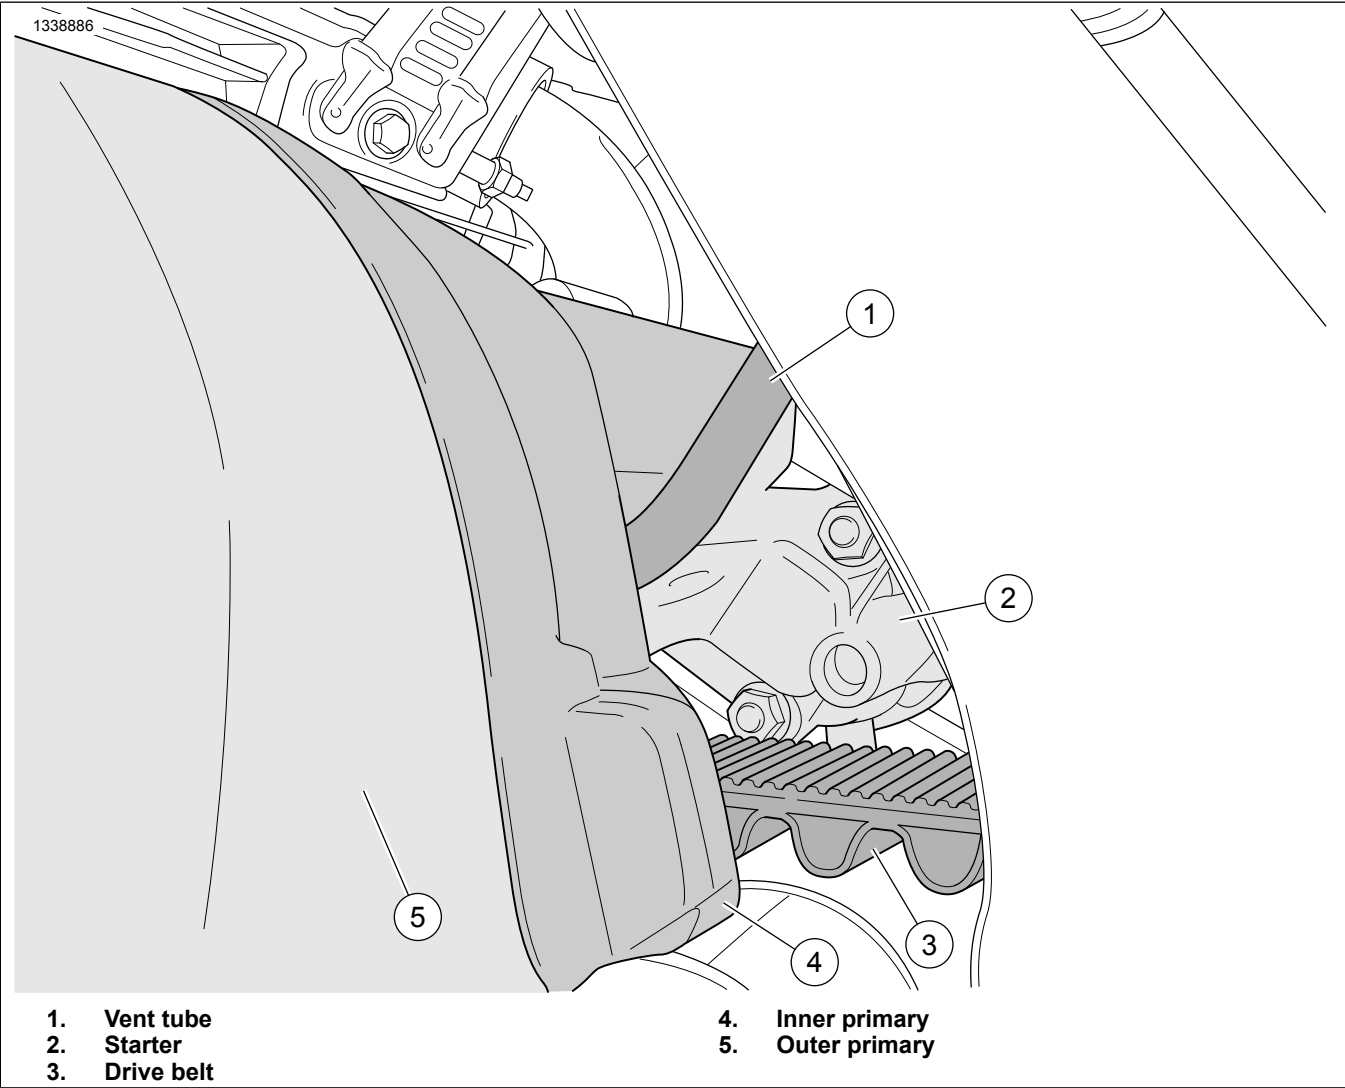
Figure 1. Inner Primary Vent Tube

- 1. See Figure 1. Check for vent tube (1).
  - a. If vent tube is present **STOP**, this service procedure has already been performed.
  - b. If vent tube is not present, go to 2.
- 2. Install Inner Primary Vent Service Kit (Part No. 26500027) per the instructions included in the kit.
- 3. Remove transmission inner side cover. See the service manual.
- 4. Inspect for mainshaft transmission oil deflector (Part No. 36300026).
  - a. If the oil deflector is present, remove and discard. Go to 5.
  - b. If the oil deflector is not present, go to 5.
- 5. Install transmission side covers. See service manual.
