BULLETIN NUMBER:  
**IB17-J-001B**

## UNDERSTANDING DRIVE BELT NOISE

- 2003-2009, 2012-2019MY Isuzu NPR/NPRHD
- 2003-2009MY GMC/Chevrolet W-Series Medium Duty Vehicles  
**Equipped with 6.0L Gasoline Engine**

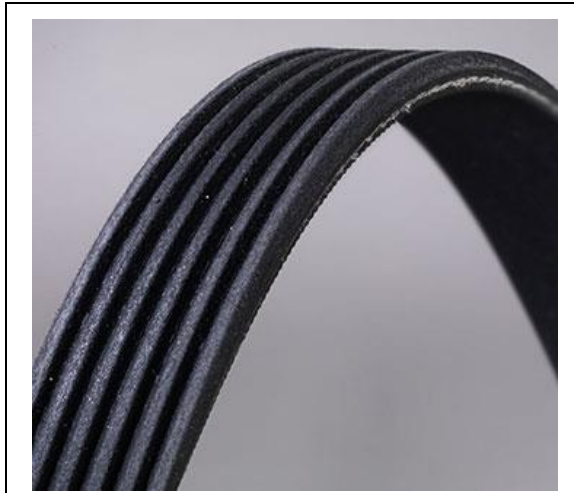
Figure 1

4. A squealing drive belt can also be caused by fluid contamination, such as oil or coolant. When a drive belt has a wet or shiny overall appearance, it is an indication of fluid contamination (see Figure 1). Diagnosing the source of the

contamination is critical; simply replacing the belt will provide only temporary relief. Once the leaking fluid contaminates the new belt it will start making noise again.

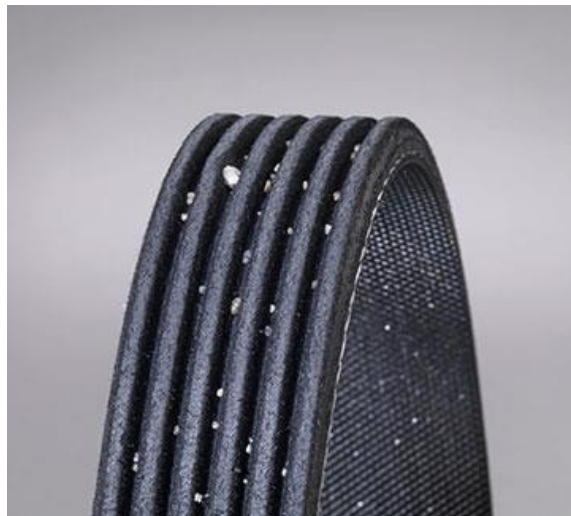
Figure 2

5. A pebble or a foreign object imbedded in the belt (see Figure 2) can cause a tapping, ticking or grinding noise. In this case it is important both to clear the objects and to identify the source of the objects. Check to see that all shields are in place to reduce road debris from entering the engine compartment. Check that the fan shroud is not broken. Make sure to diagnose the source of debris affecting the drive belt.
