**July 20, 2019**

## Warranty Extension: NH-788P White Orchid Pearl or Bellanova White Paint

This warranty extension only applies to 2015-18 Fit and 2016-18 HR-V vehicles that are painted **NH-788P**. AHM referred to the white pearl paint as both **White Orchid Pearl** and **Bellanova White**.

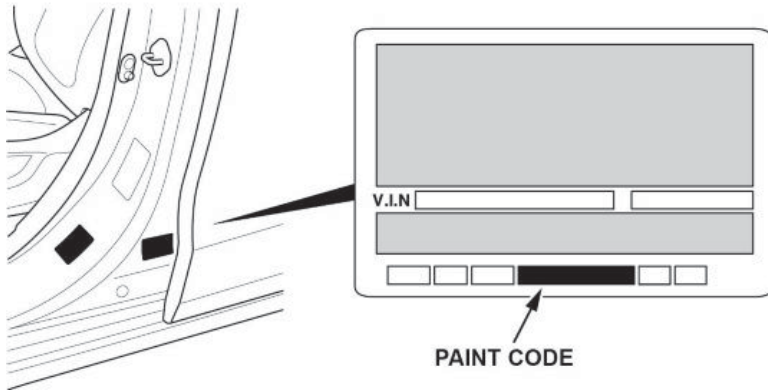
1. Check the paint code on the driver's door jamb to confirm the model year and paint code.

Model Year	Paint Code and Color
2015-18 Fit	NH-788P White Orchid Pearl or Bellanova White
2016-18 HR-V	NH-788P White Orchid Pearl or Bellanova White

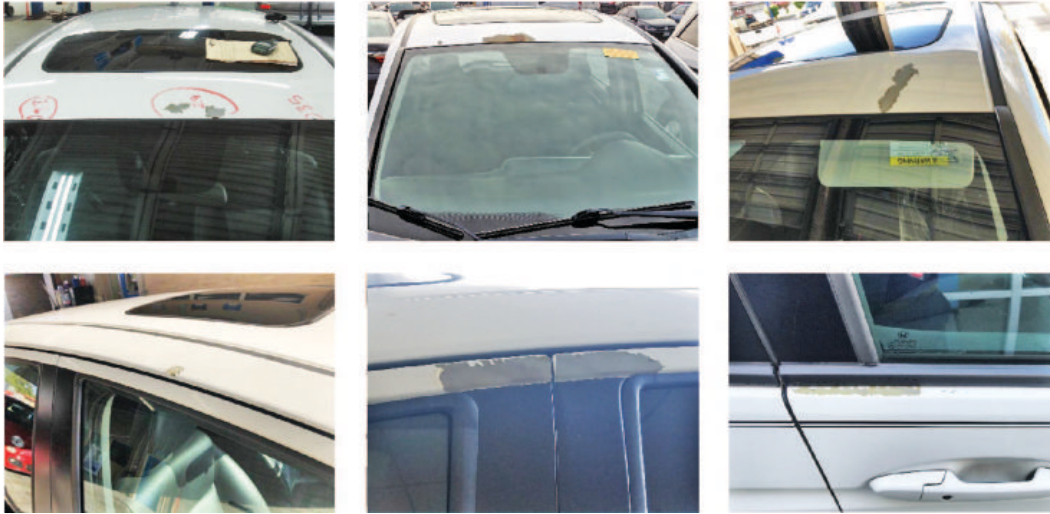
**Fit:**

The exterior paint on the vehicle may peel off. American Honda is extending the warranty on the paint of the affected vehicles to 7 years from the original date of purchase with no mileage limit. This warranty extension does not apply to other paint issues like rock chips, scratches, bird droppings, sap, etc.

3. Inspect the roof, tailgate, hood, doors, and body panel areas for damage.
- If the paint on the vehicle appears similar to the images below, go to REPAIR PROCEDURE.
  - If the paint looks different from the images below, the damage is not covered because it may be caused by sap, bird droppings, stone chips, etc. This bulletin does not apply.

Inspect the vehicle and, if necessary, have a ProFirst Certified Body Shop repaint the entire affected panel(s) with a tri-coat paint (base color coat, mid [mica/pearl] coat, and clear coat) after obtaining DPSM approval.
