Service Alert

Subject: 2019 MAZDA3 (MEXICO BUILT) TRUNK DISABLED / HIDDEN KEY AND FOB RETRIEVAL	Service Alert No.: SA-017/19
	Last Issued: 07/08/2019

2019 Mazda3 (Mexico built)

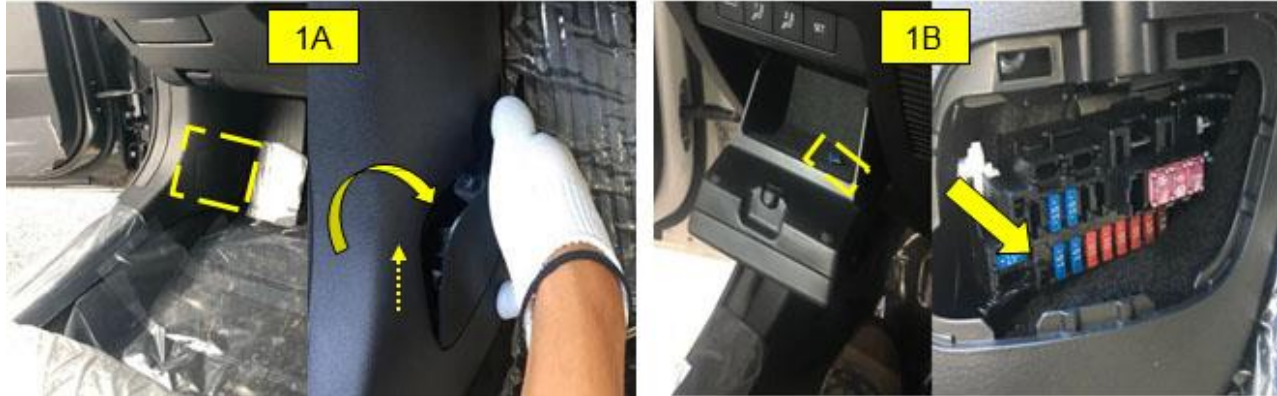
- a. Open the driver's door.
 - b. Locate the fuse box, which is along the bottom left side (1A).
 - c. Open the fuse box by holding the fuse box lid with the right hand and pressing on the clip with the thumb to release the cover.
 - d. Remove the clip on the sides and carefully pull the lid out.
 - e. Locate the 15 amp blue colored fuse hidden in the lower panel compartment on the left side of the steering wheel (1B).
 - f. Avoid touching the metal tabs of the fuse and carefully install the fuse into empty space F15 (1B). Space F15 can be verified by referencing the inside of the fuse box lid.
- NOTE:** Make sure the fuse is installed fully into position and flush with all of the other fuses.
- g. Reinstall the fuse box lid in the reverse order of removal.
4. Retrieve the key/fob hidden in the cargo area.

1. Verify that the key/fob is missing from the main cabin.
2. Verify that the Mazda3 is manufactured in México as the Mazda3 sedan is manufactured in both Mexico and Japan. This can easily be identified by the first three (3) digits of the VIN: 3MZ = Mexico Plant.
 - If manufactured in Mexico, go to the next step to enable the trunk and retrieve the hidden key/fob.
 - If not manufactured in Mexico, this SA does not apply.
3. Enable the trunk lid opener by installing the back door lock fuse into the fuse box located in the driver's footwell.

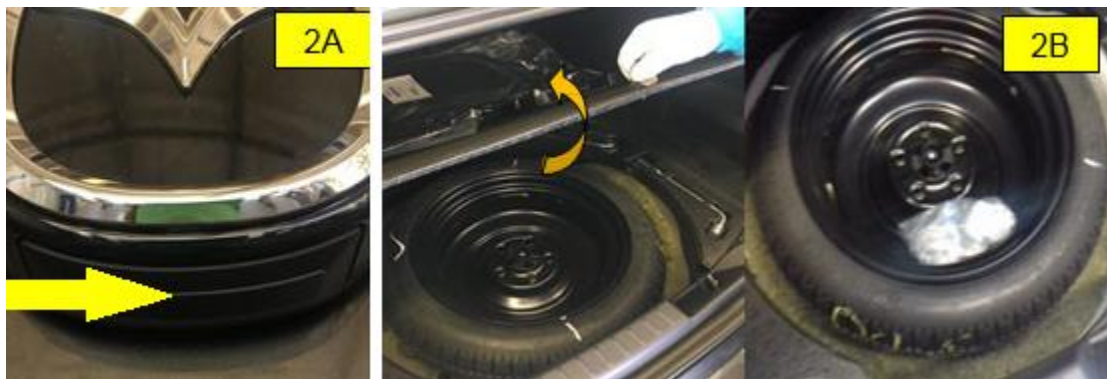
- a. Release the trunk lid using the exterior trunk lid opener (2A).
- b. Lift the trunk mat and locate the hidden bag from the spare tire (2B).
- c. Open the accessory bag and take out the second key/fob.
- d. Fold the bag up and place it back in the center hole of the spare tire.
- e. Reinstall the trunk mat in the proper location and close the trunk lid.
- f. Ensure that the trunk lid is securely closed.
