# Recall Campaign

June 2019  
FL797A  
NHTSA #18V-698

## Subject: TBB Minotour Emergency Doors

**Models Affected: Specific Thomas Built Buses Minotour model buses manufactured March 14, 2014, through June 28, 2018.**

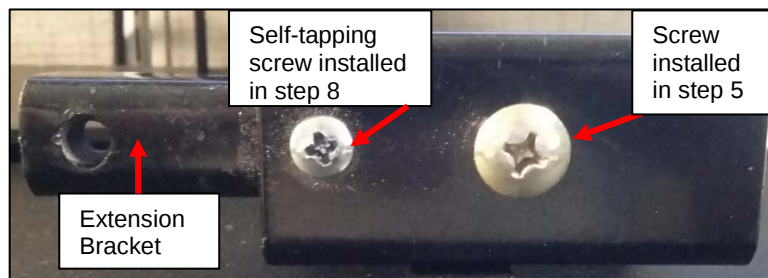
**Figure 5: View of Installed Extension**

7. Ensure the extension bracket is straight and drill a 5/32 inch hole in the original bracket through the extension bracket.
8. Install a self-tapping screw (TBB 69003091) in the hole just drilled and tighten.
9. Tighten the screw installed in step 5 (TBB 69002073). See **Figure 5**.

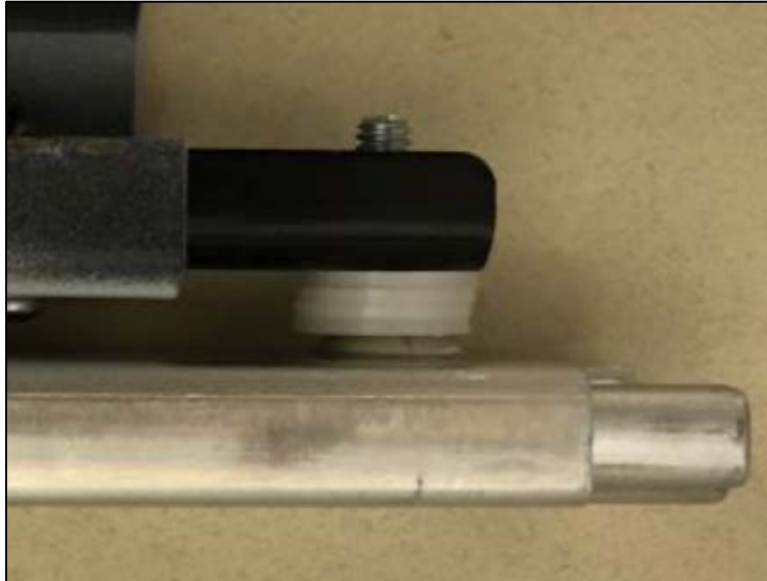
**Figure 6: Installed Extension Bracket Connection to the Prop-Rod**

11. Install a 7/16 inch bolt (TBB 203847) through the prop-rod. Place washers on the bolt between the prop-rod and the extension to prevent interference. (Not all washers may be needed.) See **Figure 6**.

12. Hand tighten the screw to the extension.
13. Install the other end of the prop-rod to the door using the bolt, nut, and washer (if a washer as installed) retained earlier. Tighten with a 7/16 inch socket and wrench.
14. Tighten the extension screw (TB 203847) on the extension, if pads were removed, reinstall.
15. Operate the door to ensure correct installation.
16. Remove the chocks from the tires.
