# Recall Campaign

Daimler Trucks  
North America LLC

June 2019  
FL761A-C  
NHTSA #18V-157 (School Buses)  
#18V-158 (Non-School Buses)  
Transport Canada #18-119 (School Buses)  
#18-120 (Non-School Buses)

## Subject: TBB Minotour Wheelchair Lift Interlock

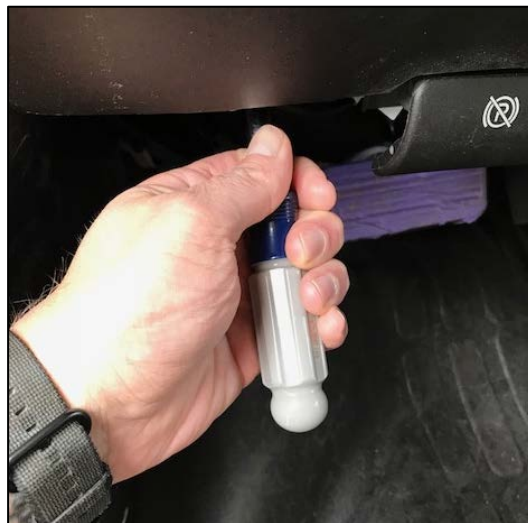
**Figure 1: Location of Screws Beneath the Steering Column Panel**

1. If necessary, park the vehicle, shut down the engine, place in park, set the parking brake, and chock the tires.
2. Remove the panel just below steering column. Using a 10 mm socket, remove the two screws underneath the panel. See **Figure 1**.

1. If necessary, park the vehicle, shut down the engine, place in park, set the parking brake, and chock the tires.
2. Remove the panel just below steering column. Using a 10 mm socket, remove the two screws underneath the panel. See **Figure 1**.
3. Compare the connections to **Figure 2**.

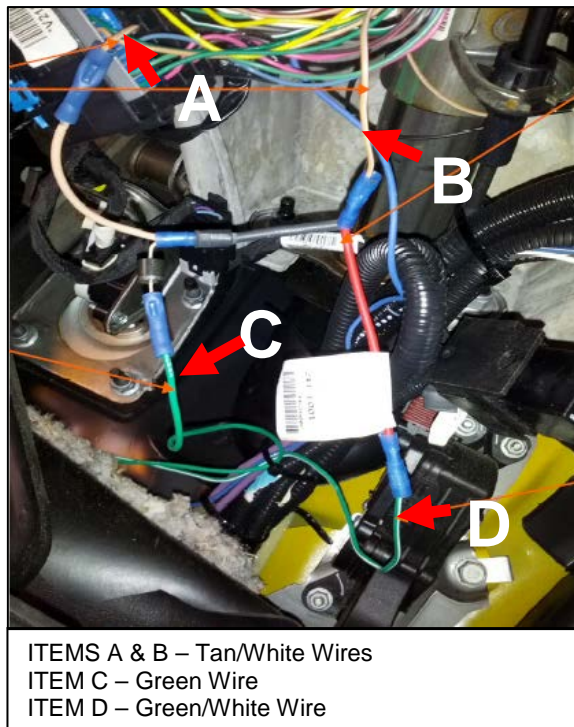
**Figure 2: Current Harness Installation**

3. Cut the two brown wires between the connectors shown in **Figure 2 Items A and B** as close to the butt splice as possible (to allow connection to the new harness).

4. Install new harness TBB 175974 as shown in **Figures 2 and 3**.
  - 4.1 Connect the new harness to Positions A and B, where the brown wires were cut.
  - 4.2 Connect the existing green wire to Position C on the new harness.
  - 4.3 Connect the existing green/white wire to Position D on the new harness.

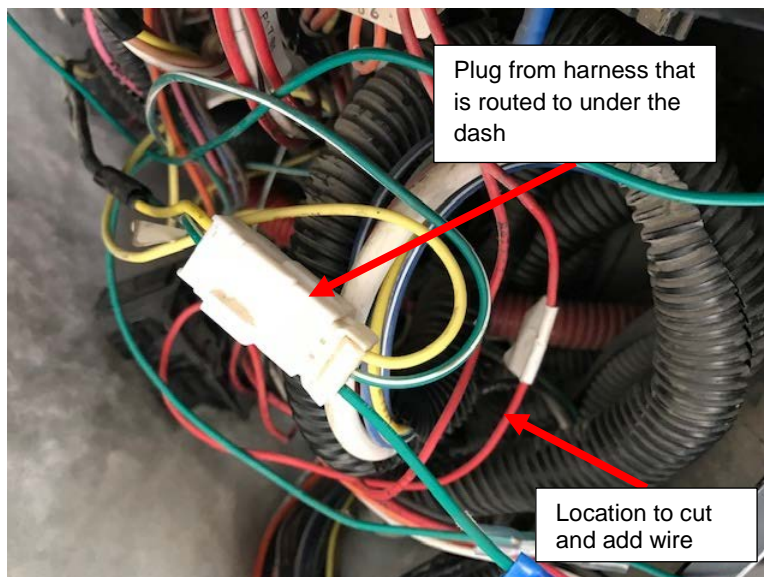
Figure 4: Plugs Behind the PC Boards

1. Behind the PC board, cut wire WC564 about 3-4 inches back from plug (plug with 3 wires) and cap off the side going to plug. See **Figure 4**.
2. From the end cut from the plug, add approximately 12 inches of green wire. See **Figure 4**.

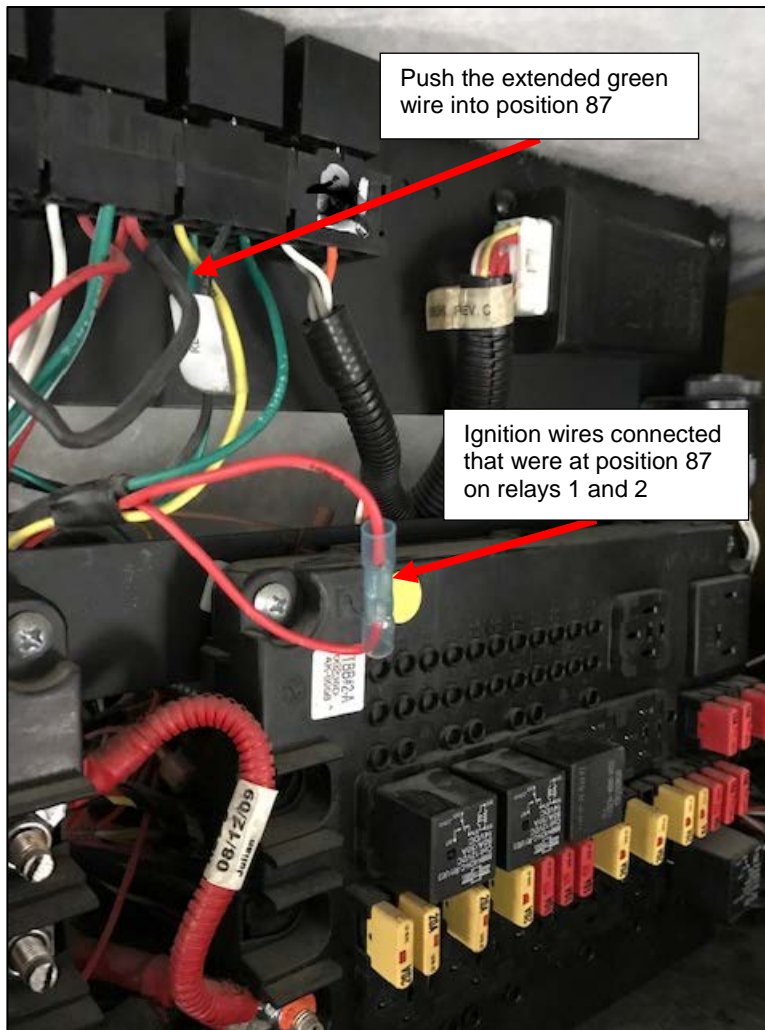
Figure 5: Connections at Relay

3. On relay 1 on the lift harness (on the metal mounting plate of the PC board), remove the ignition wire from position 5, which is 87 on the relay. See **Figure 5** for position and conversion of the relay block.
4. Put a spade terminal on the green wire that was added and plug it into position 5.

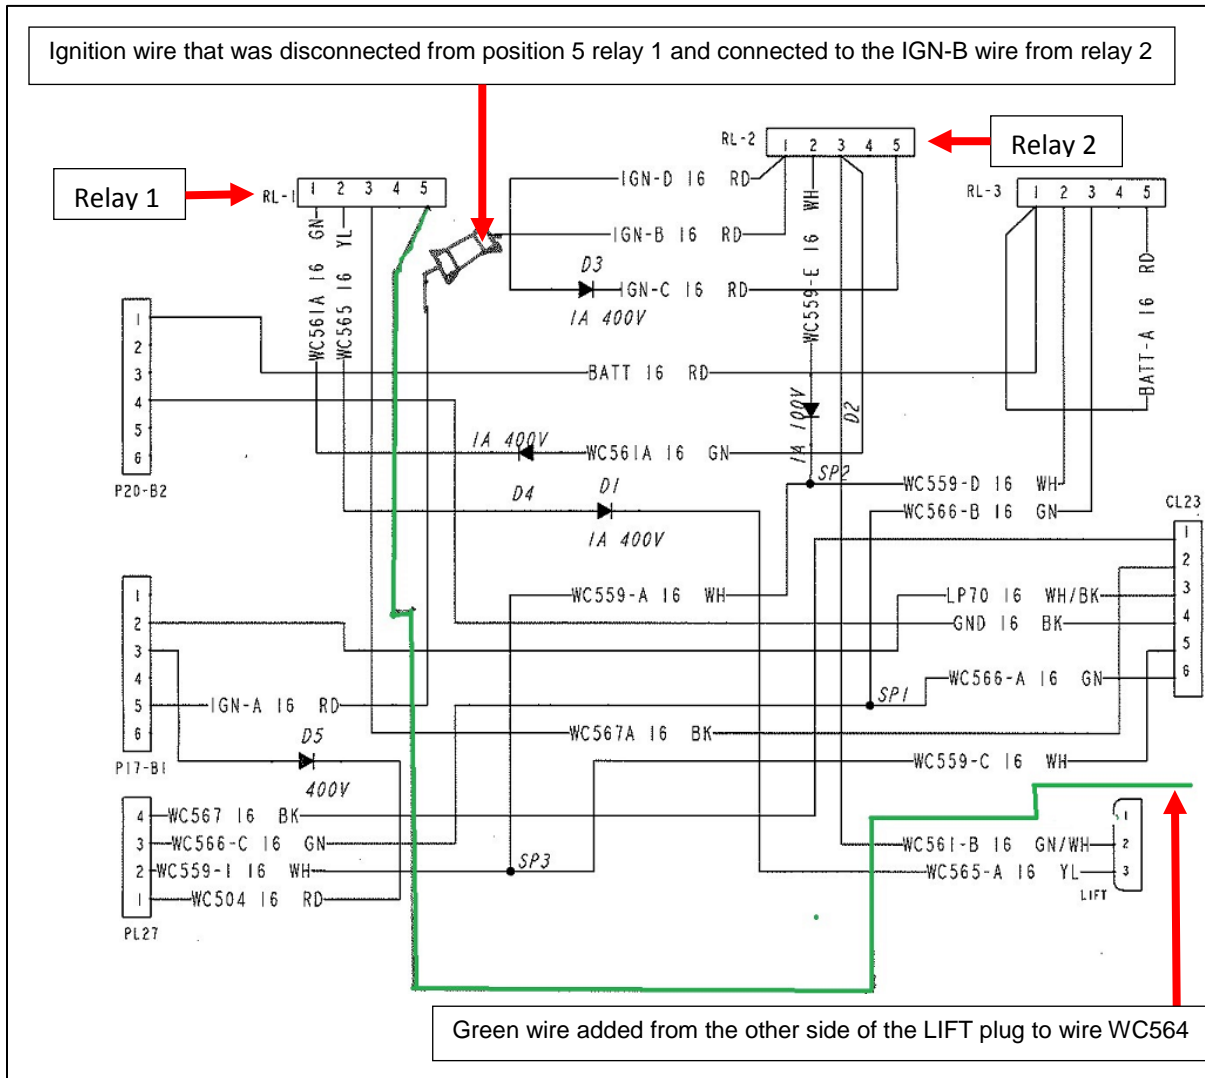
Figure 6: Schematic of Harness and Relays

5. Connect the ignition wire that was in position 5 to the wire that was also in the same position 5 on the relay with a butt connector. See **Figure 6** and **Figure 7** for a schematics/diagrams showing the connections.

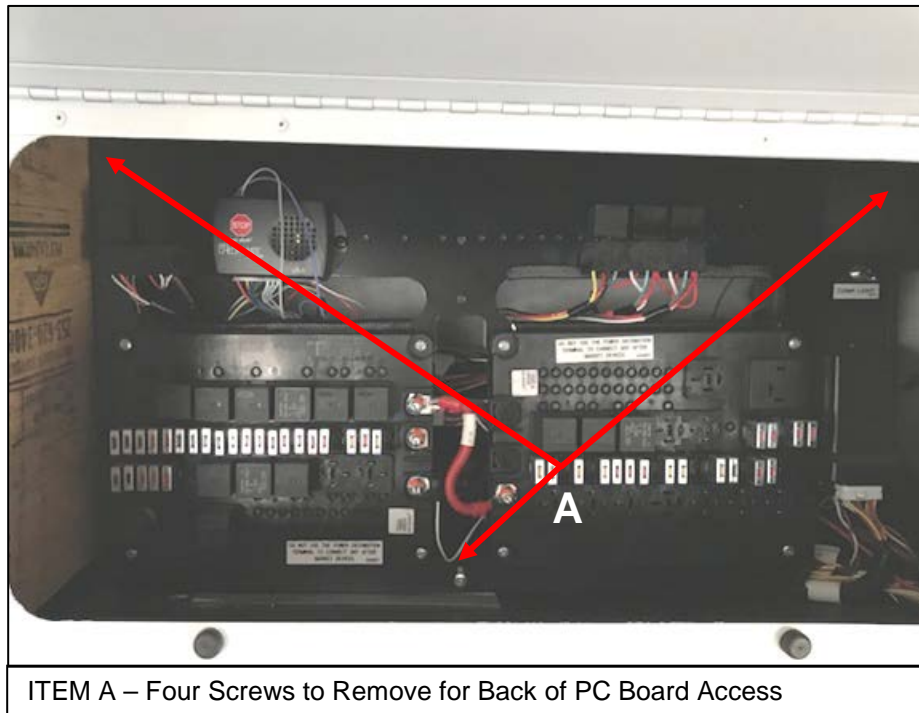
Figure 8: View of PC Boards

4. Open the PC circuit board cabinet (above the driver's seat) and prop the door open. See **Figure 8**.
5. Remove the three screws indicated in **Figure 8** and lay the PC board down.

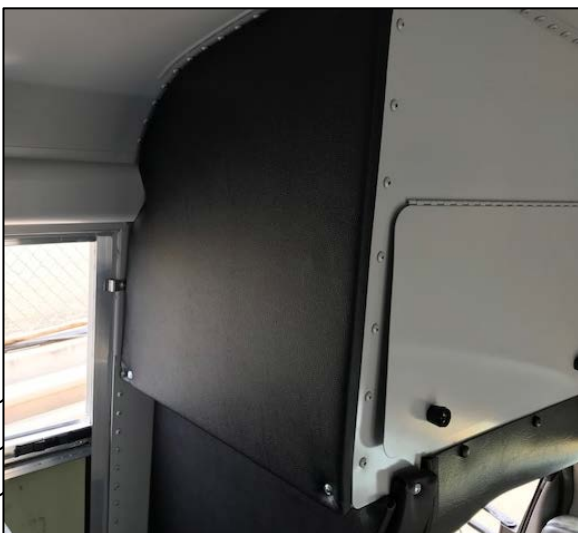
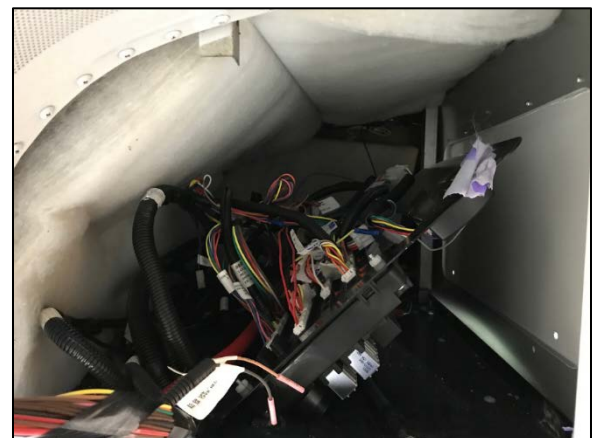
6. Remove the side cushion, retain it and screws. See **Figures 9 and 10**.
7. Remove the existing harness and install the new harness TBB 217778. The old and new harnesses have the same connection points on the back of the boards and connecting harnesses. **Figure 11** shows the locations on the back of the PC board. The remaining plugs on the harness will be connected to harnesses that are not plugged into the PC boards.
