# Emissions Recall

## Code: 37M3

**Subject** Undisclosed Transmission Control Module (TCM) Software

**Release Date** July 19, 2019

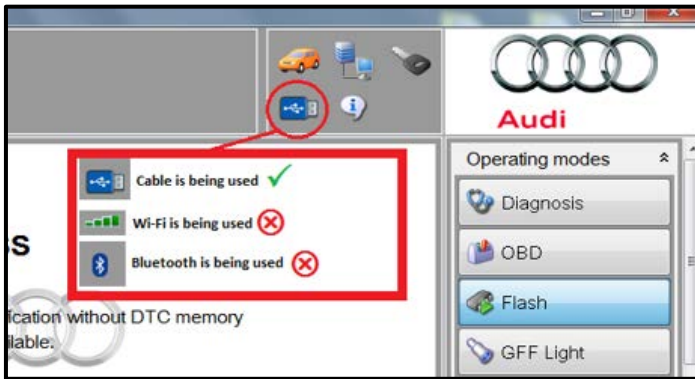
- Confirm that scan tool is communicating with the diagnostic head by USB cable.
  - If the Bluetooth or WiFi symbol is shown, then disconnect the diagnostic head from the vehicle and reconnect the USB cable to the diagnostic head and then reattach to the vehicle.
