SERVICE BULLETIN

APPLICABILITY: 2019MY Ascent
SUBJECT: A/C System Inoperative

NUMBER: 10-92-19
DATE: 07/15/19

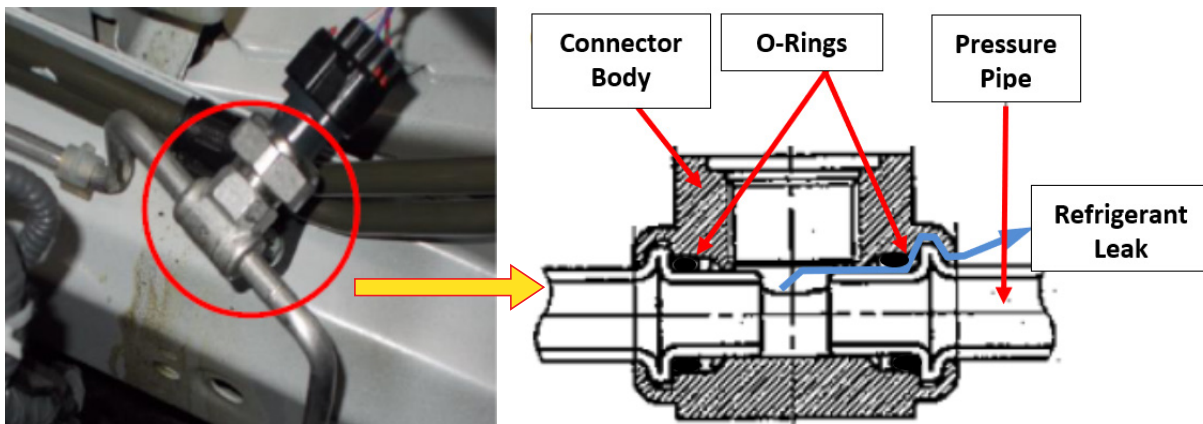
This bulletin announces a change made to optimize the sealing of the pressure switch connector used on a metal high-side refrigerant pipe. The sealing capability of the connector may have been compromised during manufacture and result in a refrigerant leak.

The new A/C pipe was incorporated into production starting with VIN **K3463823**.

Description	Part Number	Application
PIPE-EVAPORATOR COOLING	73431XC00A	Ascent
