# SS 1034438 New Cascadia Cab to Chassis Redundant Ground Strap

Steering wheel switches inoperative, AM/FM radio reception corrupted, failure of the steering wheel clockspring.

Under certain conditions if the vehicle cab loses it's dedicated ground location various ground sneak paths may be created that can damage portions of the cab wiring.

Installing a simple redundant ground strap from the Main Ground Junction Block (MGJB) to the frame will protect the vehicle from an unexpected loss of cab grounding. See attached.

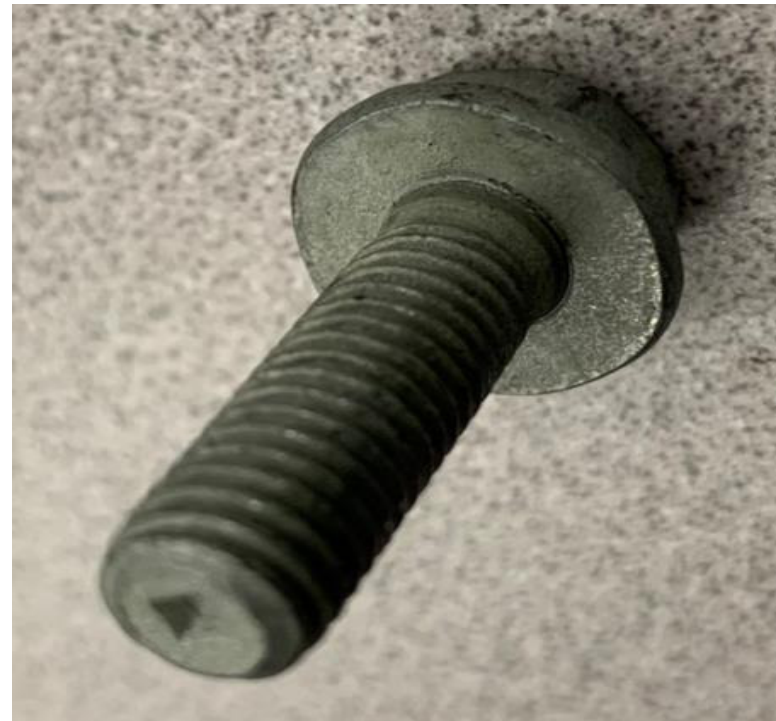
Locate the MGJB left side of enginewall. Use a 13mm socket to remove the lower leftside 8mm capscrew.

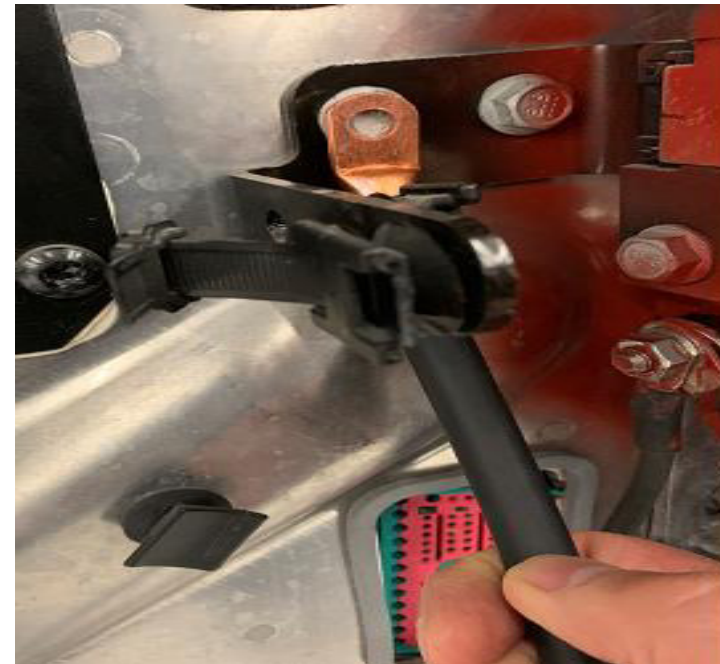
Grind a small amount of paint off of the bracket, sufficient enough for the face of the capscrew to have direct metal to metal contact. The goal is to ensure that the grounding strap and the MGJB have direct continuity with the frontwall when the nut is reinstalled.

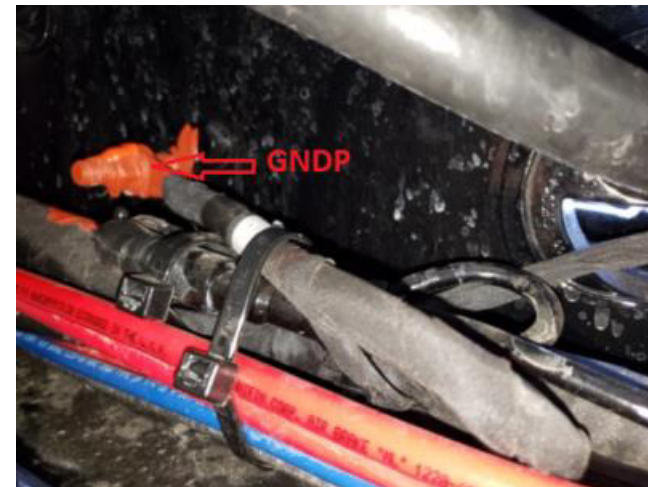
Both sleeper cabs and day cabs with in cab battery box mounting have the same frame mounted stud for GNDP.

See 288 content print D66-06133 for the routing of GNDP to the frame.

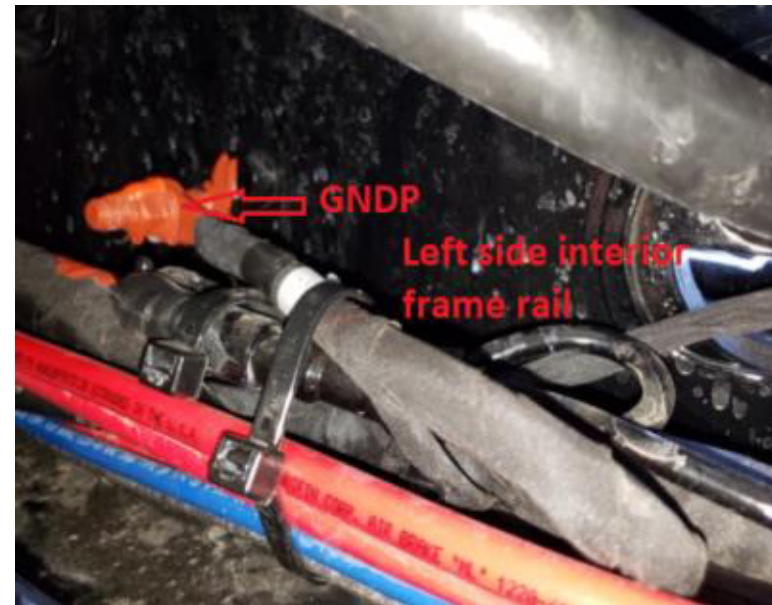
Check for availability of the ground stud on the left side outer frame rail. There will be a difference between applications with frame rail battery box mounting and in-cab battery box mounting depending upon the respective 282 datacode of the build. Vehicles with in cab battery box mounting will not have the ground mounting stud as per the visual noted below on the left. In such cases, the next location is the GNDP stud as mentioned earlier, located in the inner left side frame rail, as noted below on the right:
