## INSTRUCTION TO SERVICE

| <b>ITS: 58708</b> | |
| <b>SUBJECT:</b> | Inspect and Reorient DEF Tank Strap, if needed. |

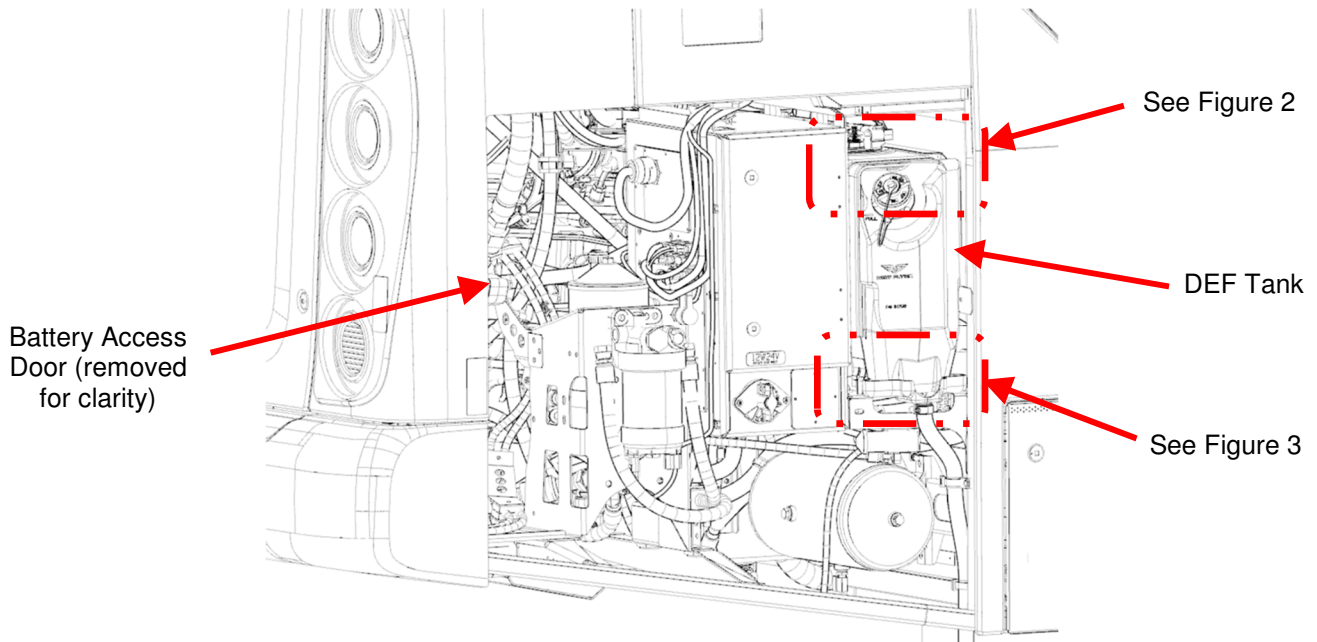
1. Turn the main battery disconnect switch to the “OFF” position.
2. Open the Battery Access Door and locate the DEF tank support strap as shown in Figure 1.

**Figure 1: DEF Tank Location, Battery Access Door (removed for clarity)**

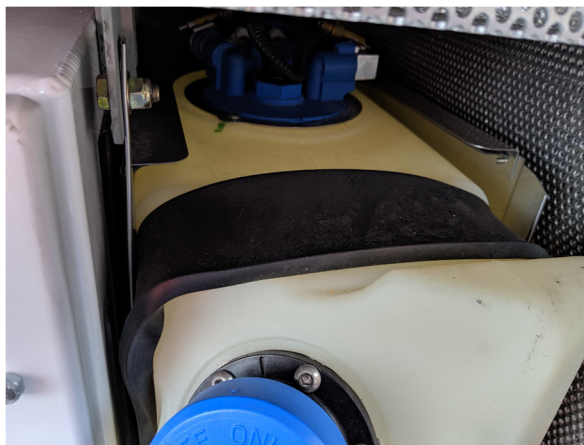
3. Inspect the existing DEF tank strap and compare the installation to the examples shown in Figure 2, if the strap is installed correctly with the rubber flanges on the outside then go to Step 7. If the strap is installed incorrectly with the rubber flanges resting against the tank, then it will need to be corrected.

**Incorrect Strap Orientation**

**Figure 2: Incorrect/Correct DEF Tank Strap Orientation**

4. Remove and save the existing washer (x2), spring and nut from both ends of the strap and remove the strap.
5. Remove the rubber channel installed on the strap and reverse the orientation so the short flanges are located away from the tank when re-installed. Only the rubber channel is to be removed, the orientation on the strap is to remain as removed, see Figure 2 for reference.
6. Using the existing hardware removed in Step 4 reinstall the strap on the DEF tank in the same location and orientation as was removed. Tighten the nuts until the springs compress to 1.4", do not over tighten the strap. See Figure 3 for strap hardware orientation.

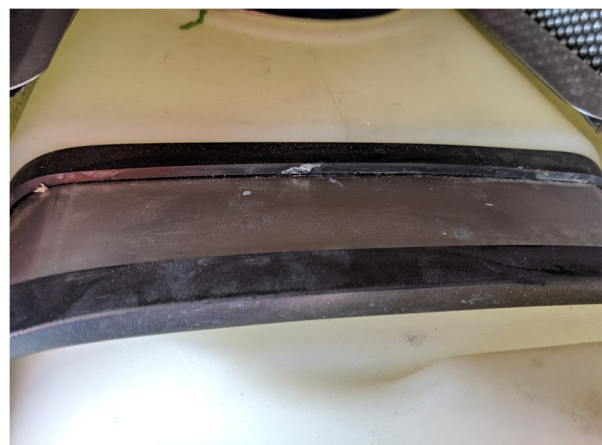
**Correct Strap Orientation**

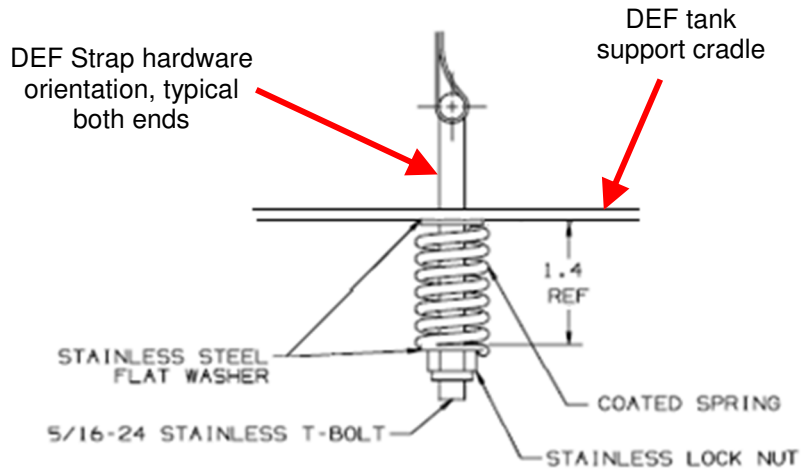
**Figure 3: Correct DEF Strap Hardware Orientation/Installation, typical both ends**
