Rear Brake Squeal/Squeak Noise

Market USA

| YEAR(S) | MODEL(S) | ADDITIONAL INFORMATION |
|---|---|---|
| 2016 | iA | VDS(s): DLBYV, DLBZV |

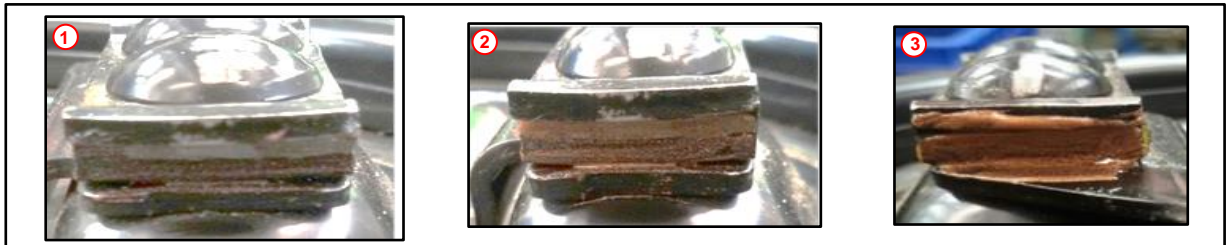
Figure 2. Anchor Part

| 1 | Lack of Grease (Not OK) |
| 2 | Proper Amount of Grease (OK) |

| 3 | Excess of Grease (Not OK) |

Is the correct amount of grease present on the rear brake components?

- YES** — This bulletin does NOT apply. Continue diagnosis using the applicable Repair Manual.
- NO** — Continue to step 4.
