August 10, 2019

Version 3

Whistling from Center Dash Area

Supersedes 19-014, dated July 10, 2019, to revise the information highlighted in **yellow**

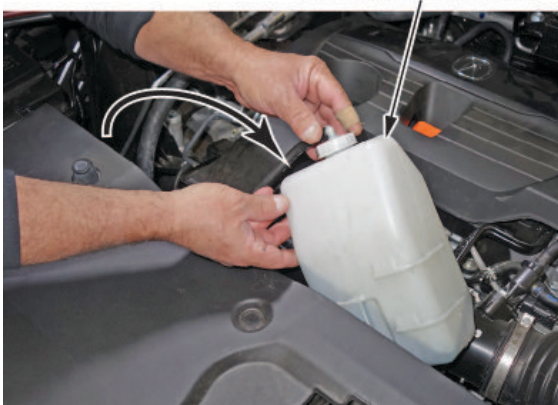
COOLANT RESERVOIR

2. Relocate the coolant reservoir, and remove the engine cover.

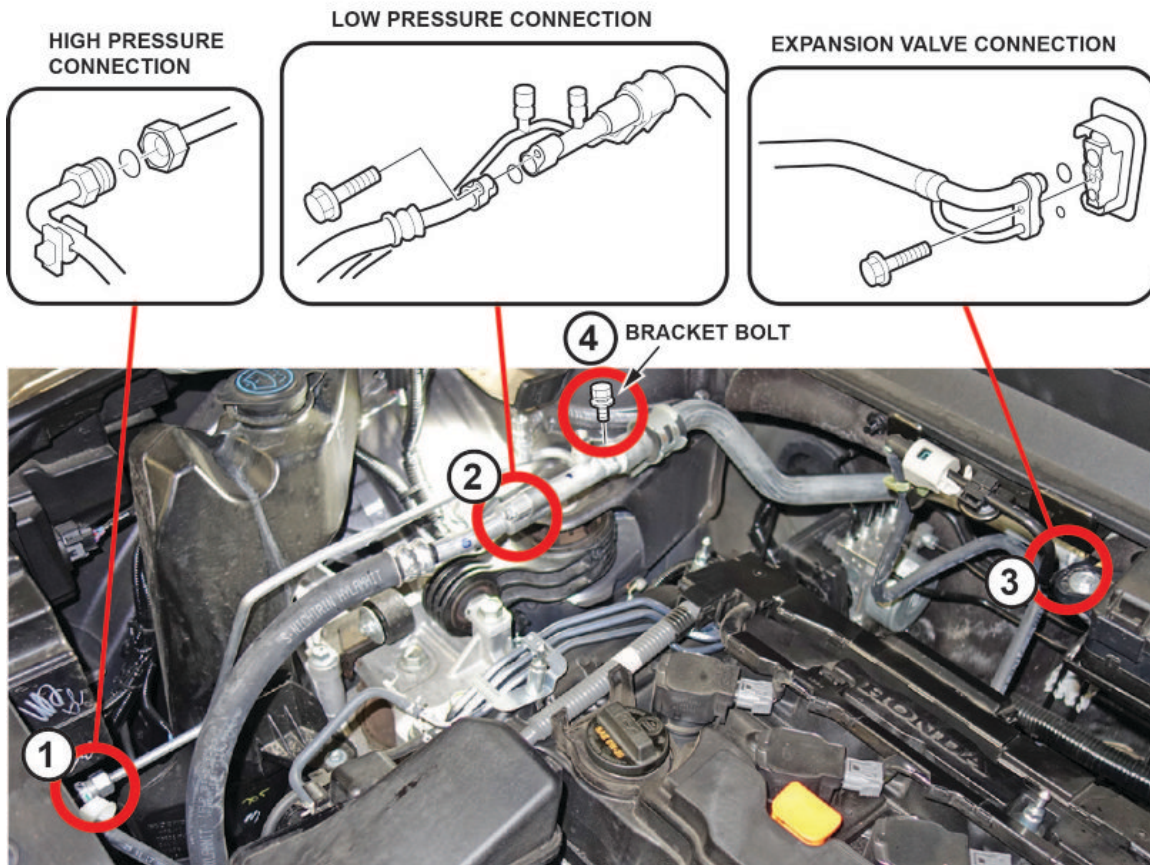
3. To prevent damage to the A/C line, carefully disconnect the lines as shown below and remove the bracket bolt.

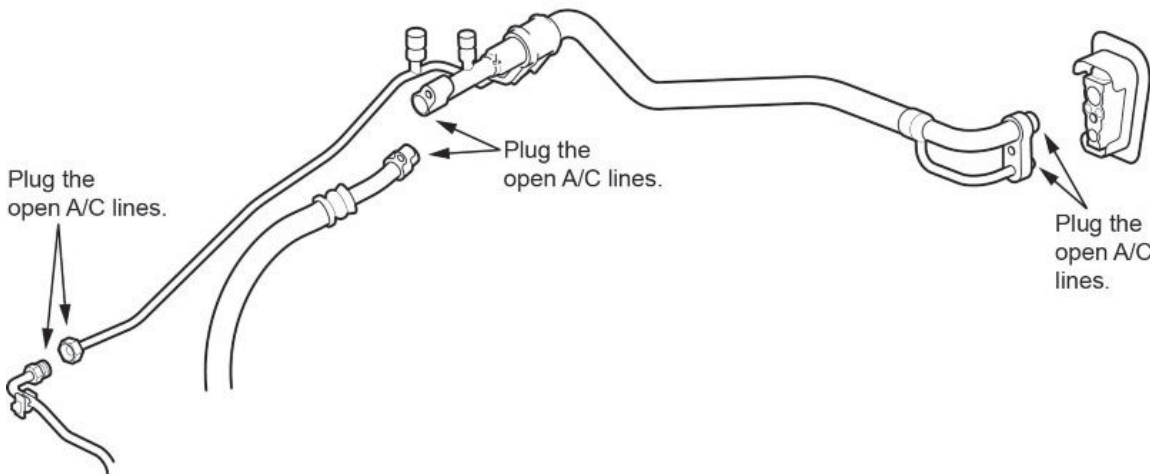
4. Plug all open A/C lines immediately after removal to prevent dust and moisture from entering the system.

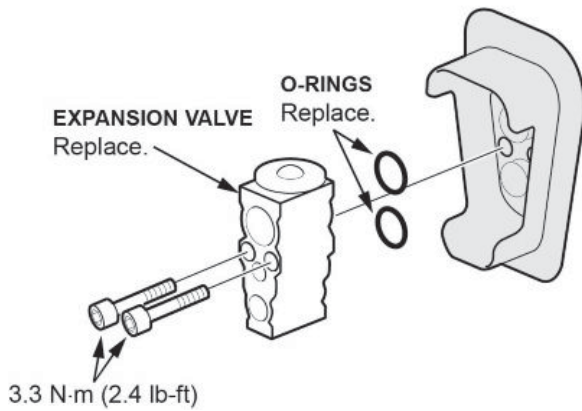
5. Remove the two bolts, then remove the expansion valve.

6. Install the new expansion valve. Make sure you replace the O-rings with new ones, and torque the bolts to **3.3 N·m (2.4 lb-ft)**.

To avoid damage, apply a thin coat of refrigerant oil to the new O-rings before installing them.

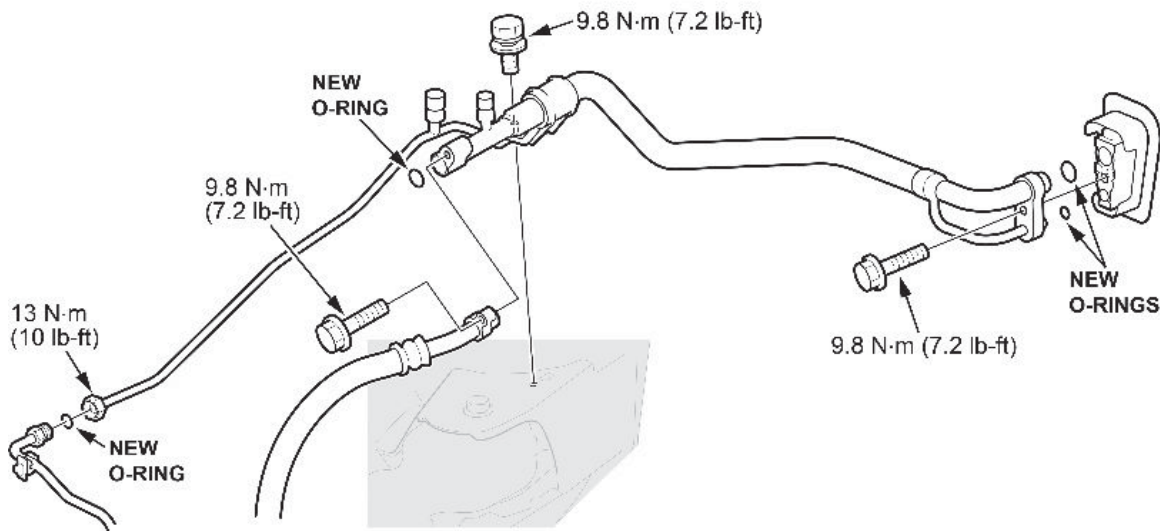
7. Install the A/C lines. Make sure you replace all of the O-rings with new ones, and torque all of the bolts as shown below.

To avoid damage, apply a thin coat of refrigerant oil to the new O-rings before installing them.
