Technical Service Bulletin

60 Panoramic sunroof noises

60 19 34 2054203/2 August 9, 2019. Supersedes Technical Service Bulletin Group 60 number 19-24 dated March 7, 2019 for reasons listed below.

Model(s)	Year	VIN Range	Vehicle-Specific Equipment
Q7	2017	All	Not Applicable
Q7	2018	000001 - 044739	Not Applicable

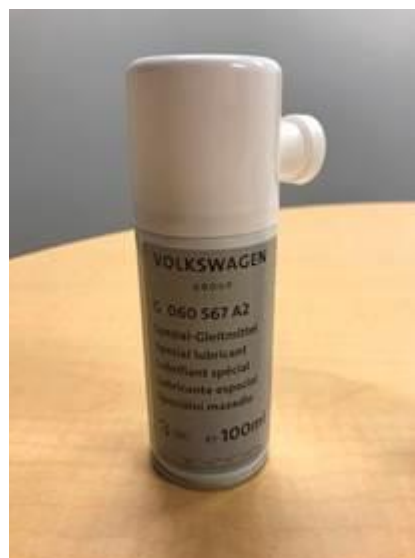
Figure 2. Special lubricant: **G 060 567 A2.**

The only maintenance materials approved for use on the sunroof frame are the cleaner and lubricant specified above. Alternative cleaners and lubricants used on this sunroof mechanism may cause permanent mechanical damage and worsen the level of noise from the sunroof mechanism.

If the sunroof mechanism has been lubricated with an unapproved lubricant it must be thoroughly cleaned off of the mechanism components using the cleaner G 065 567 A2 and lubricated with the approved lubricant G 060 567 A2.

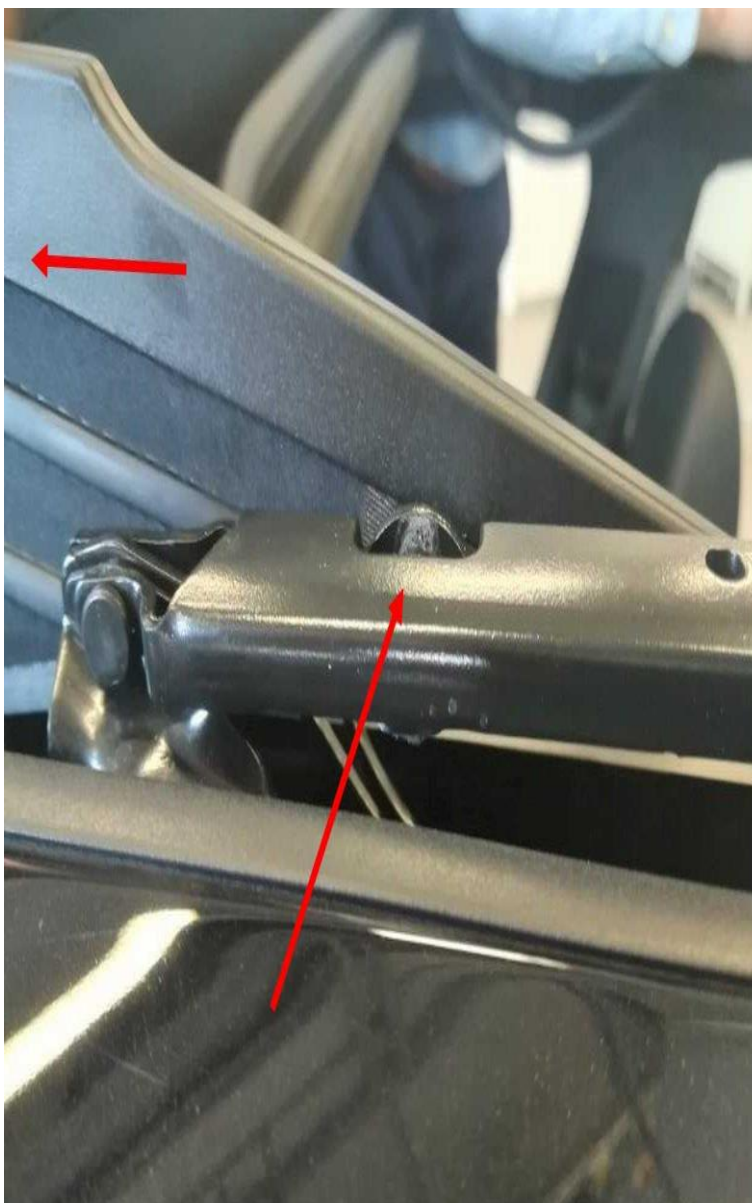
2. Figure 3 shows the left slide and tilt mechanism. The upper left arrow points to front of the vehicle. The lower arrow points to the first mounting point of the glass panel.

Figure 3. Left side of slide and tilt mechanism.

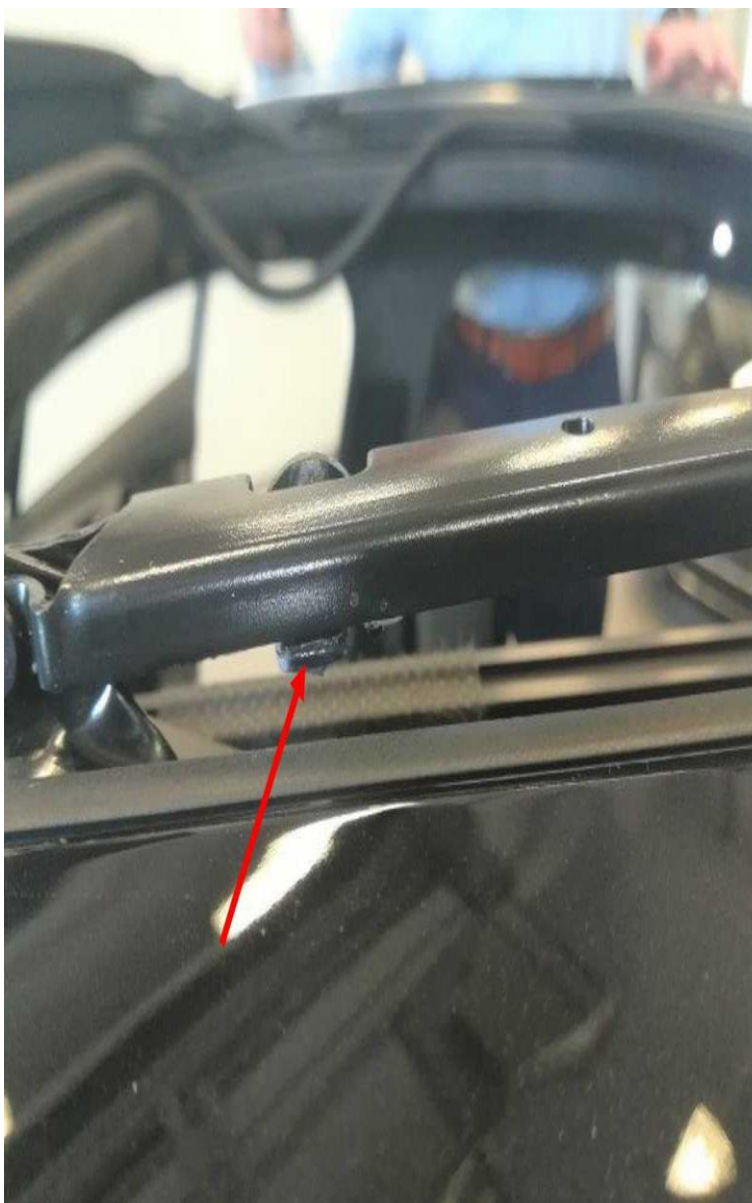
3. There is a lug under the first mounting point (Figure 4, red arrow). This point has to be lubricated with G 060 567 A2 lubricant.

Figure 4. Lug to be lubricated on slide and tilt mechanism.

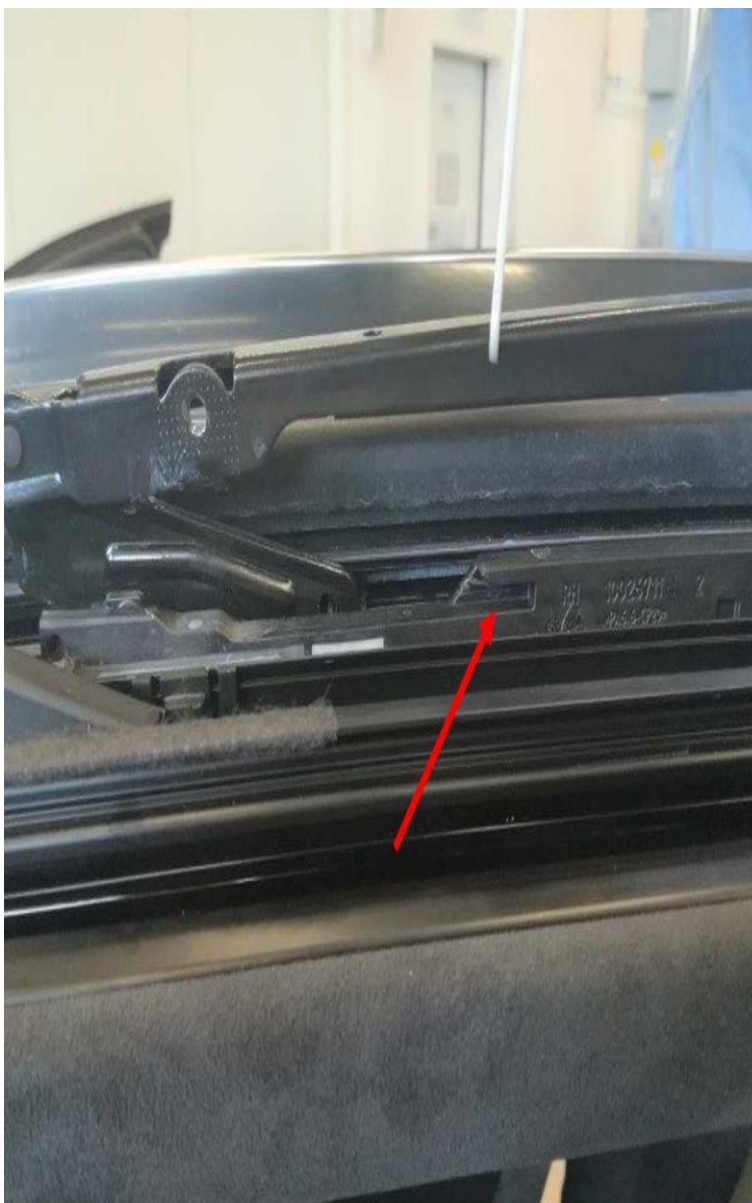
4. Figure 5 and 6 shows the right slide and tilt mechanism from the inside. The groove indicated by the red arrow should be lubricated with G 060 567 A2 lubricant.

Figure 5. Groove in the slide and tilt mechanism.

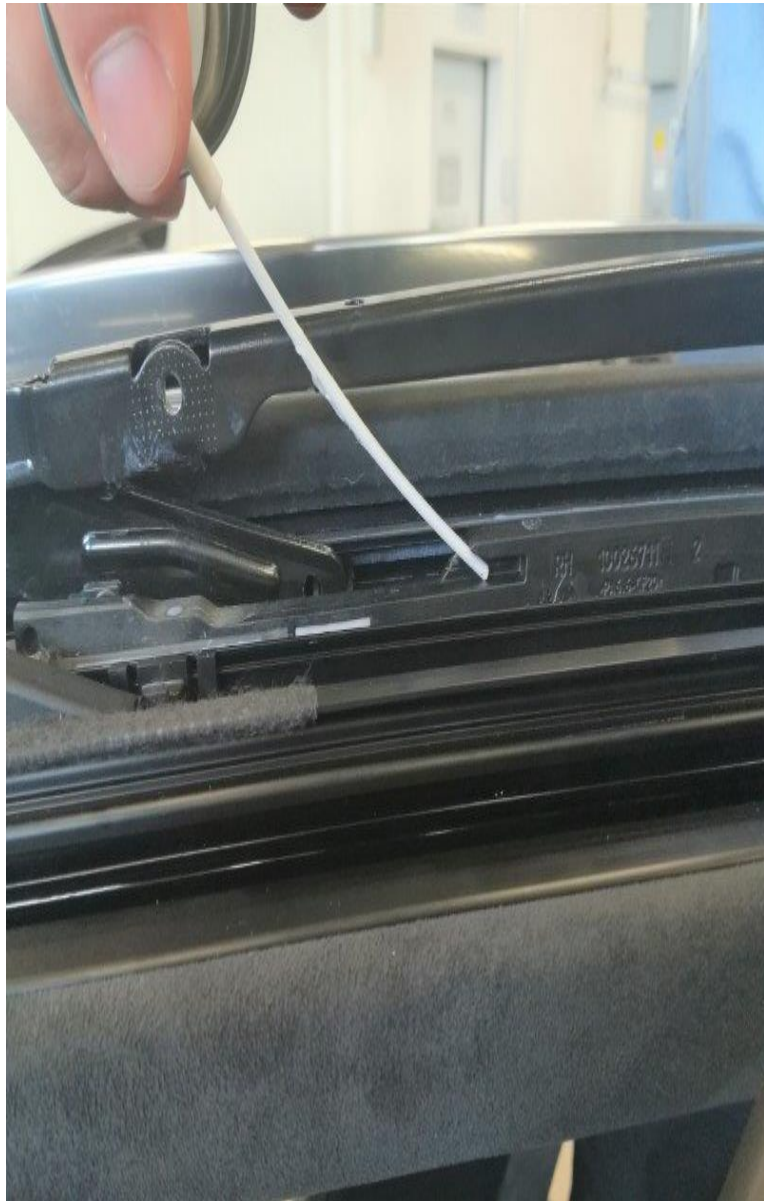
Figure 6. *Lubricating the groove in the slide and tilt mechanism.*

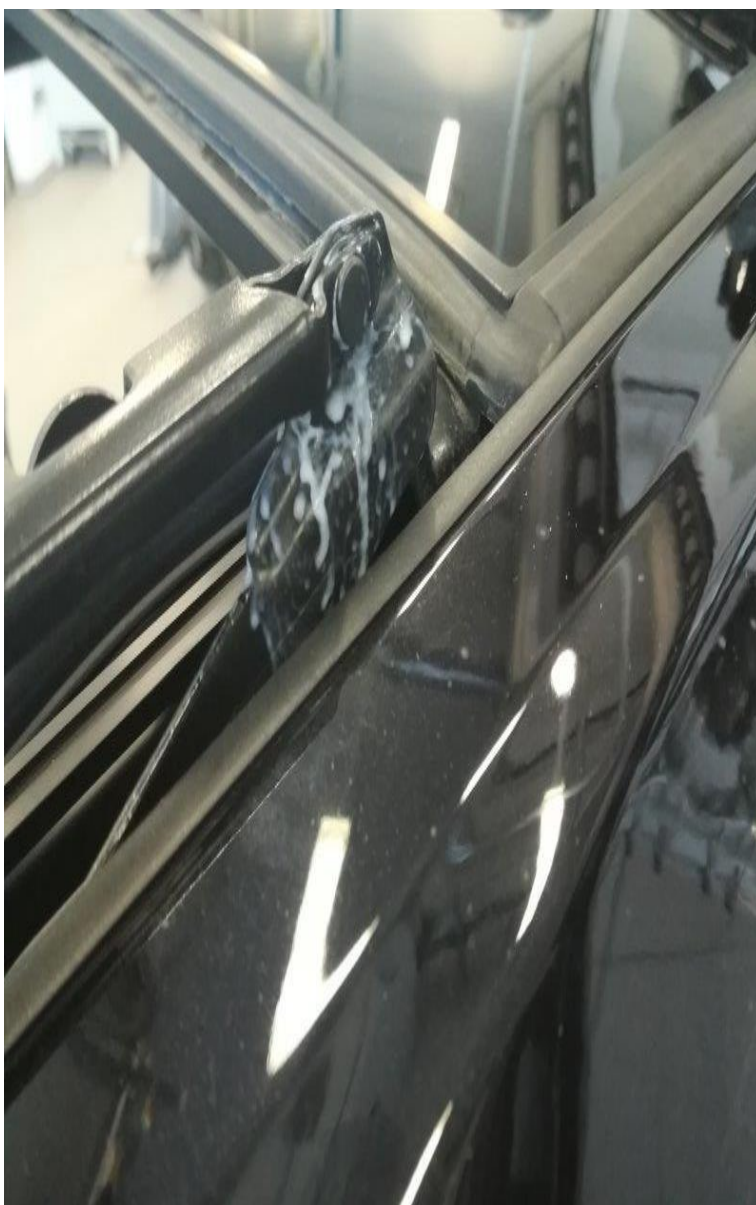
Figure 8. Bracket after lubrication.

5. Figure 7 and 8 shows the rear section of the left slide and tilt mechanism that must be lubricated with G 060 567 A2 lubricant. The outer area of this bracket will be lubricated (see red arrow).

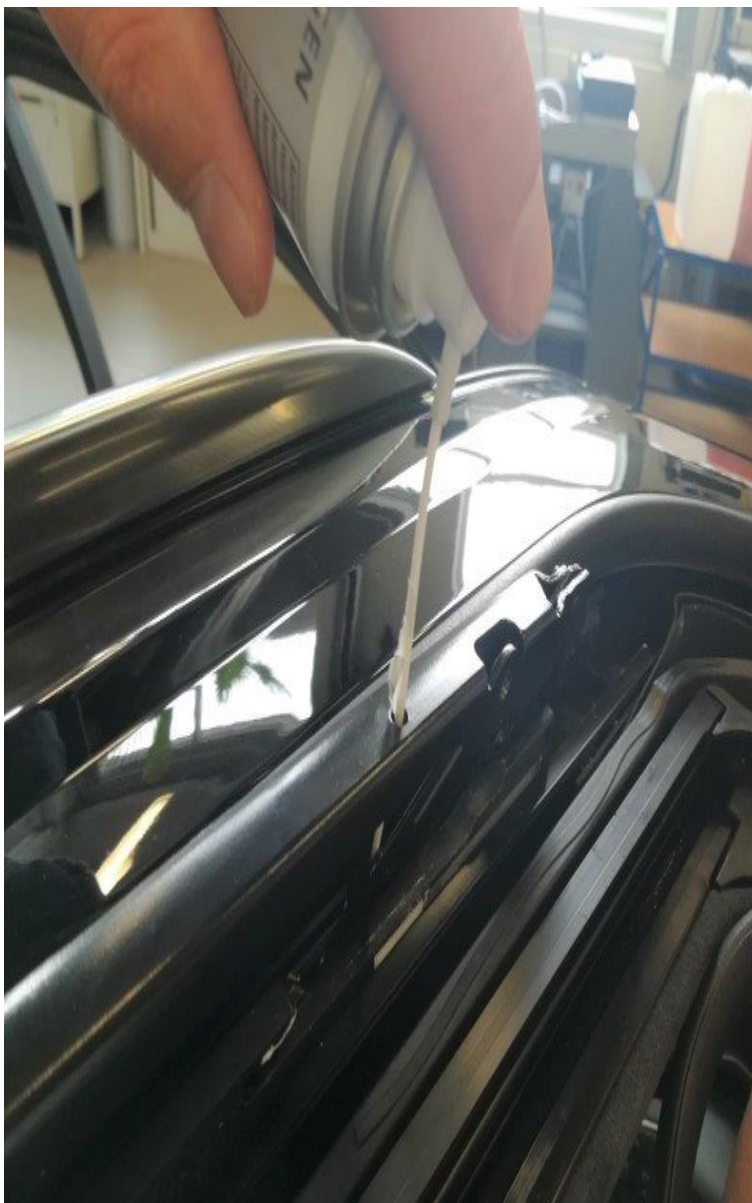
6. Figure 9 and 10 shows the left front slide and tilt mechanism. The channel that must be lubricated can be accessed with the spray tube through the first hole in the arm as shown.

Figure 9. Accessing the channel through the arm of the slide and tilt mechanism.

Perform this procedure to both sides of the sunroof slide and tilt mechanism.

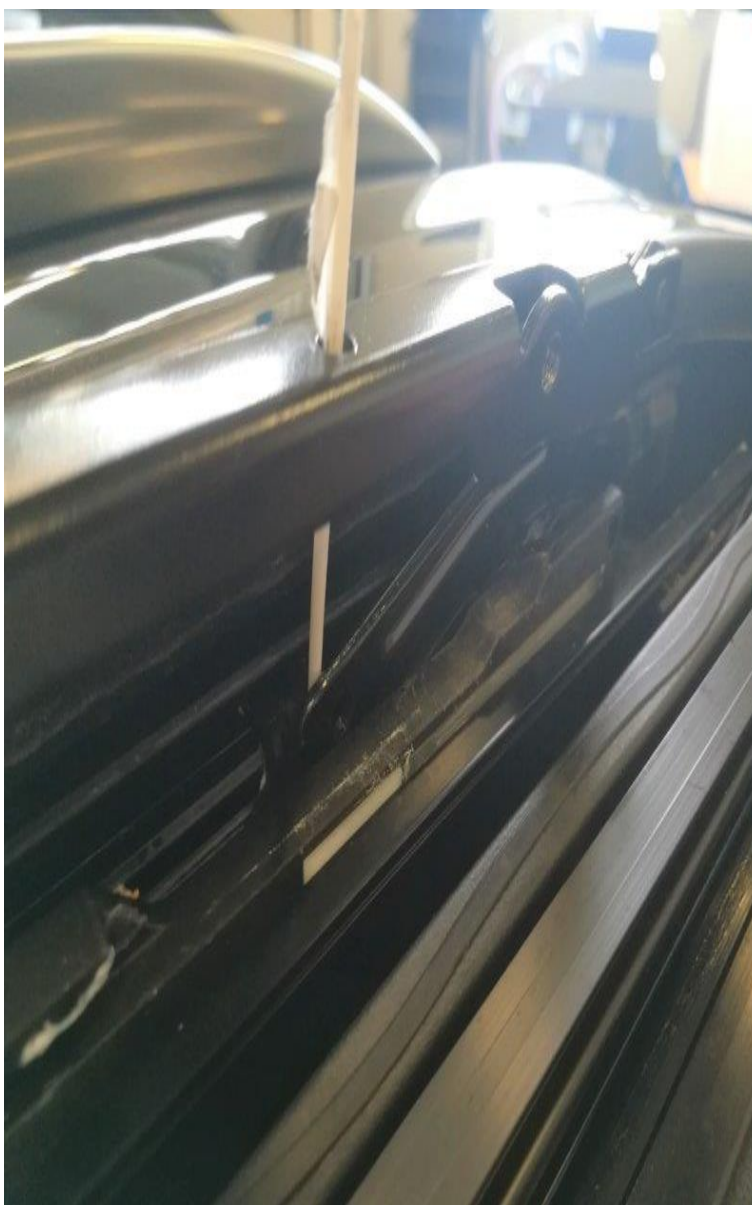
Figure 10. Close up view of the lubrication of the channel under the arm of the slide and tilt mechanism.
