**Campaign Code:**  
L636-A.14.19

**Campaign Description:**  
Stone-guard grill installation on the front radiator

**Model:**  
Urus

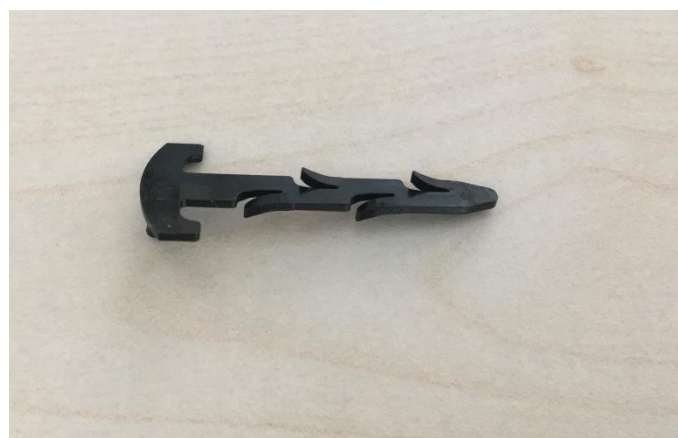
4. Install 9 small fixing pins in their slots in the protective grill.
