# Service Information Bulletin

B51 31 17

## Tailgate latch is squeaking

Engineering Designation	Model Description
F48	X1 Sports Activity Vehicle

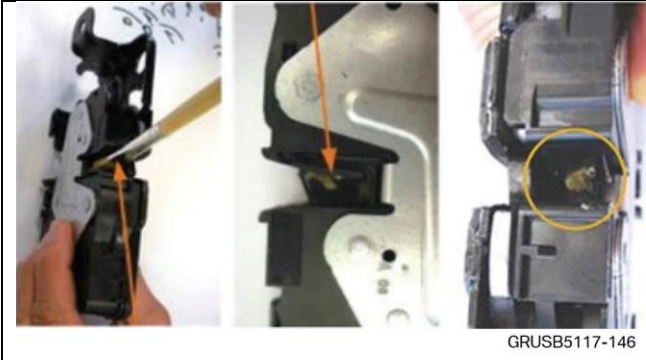
<p>GRUSB5117-146</p>	<ol style="list-style-type: none"><li>1. Remove the contamination from the tailgate lock with a dry cloth and if necessary, compressed air.</li></ol> <p>

The tailgate latch is squeaking when opening or closing the tailgate.

The latch has become contaminated with dirt.

Note: Do not remove the tailgate latch from the vehicle. It is shown removed for clarity.</p> <ol style="list-style-type: none"><li>2. Clean the striker with a dry cloth.</li></ol>
--	---

3. Grease the rotary striker on the latch with BMW Sunroof Lubricant (p/n 83 19 2 157 321) in the areas shown.

NOTE: Use screwdriver to close latch to avoid a pinch hazard.

- Grease in the open and closed positions, but do not apply excessively.

4. Open and close the tailgate three times to spread the grease across the mechanism.
