# Service Information Bulletin

Drivers Assistance, Remote Control Systems

B66 25 19

## **SERVICE ACTION: Check KAFAS (Camera-Based Driver Assistance System) Camera installation**

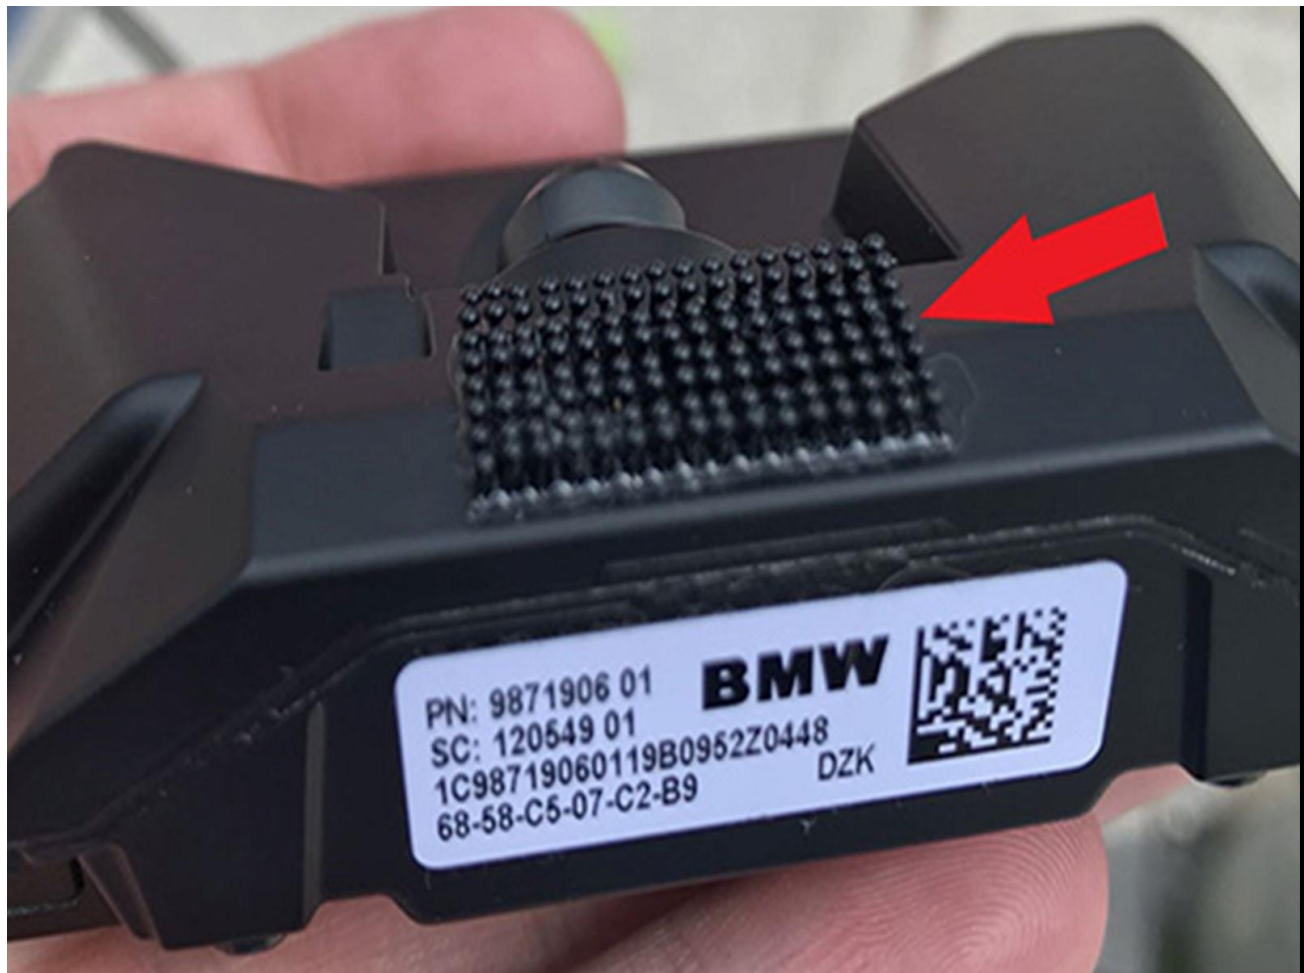
The KAFAS camera is not seated firmly in its mounting bracket on the windscreen, allowing it to vibrate. This may result in:

- Mounting surface must be free of dust, dirt and grease in the area shown (arrow)
- Affix tape, pressing firmly over entire area for maximum contact
- Reinstall the KAFAS camera according to repair instructions REP 66 51 060
- KAFAS camera must be calibrated after re-installation
- Path to calibration is as follows: Vehicle management > Service functions > Driver Assistance > KAFAS: Reset calibration
- Vehicle must then be driven with clear lane markings, clear skies (no rain or dark clouds or shadows; or in tunnel)

Apply adhesive tape to the KAFAS camera to act as a buffer, thereby preventing movement within its mounting bracket.

- Remove and install KAFAS camera according to repair instructions REP 66 51 060 (Mid variant)
