# Service Bulletin

Bulletin No.: 19-NA-137

**Subject: Squeak Noise From the Vehicle Underbody**

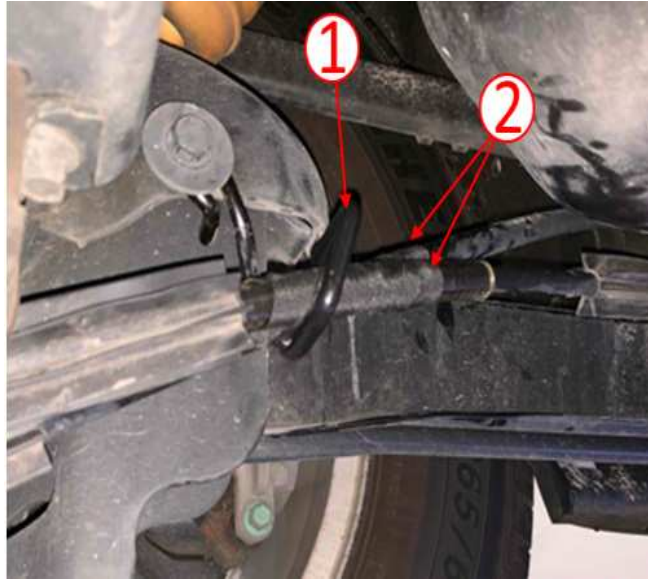
5360283

<b>Involved Region or Country</b>	North America, Russia, Europe, Middle East, Israel, South America, Japan, South Korea and Thailand.
<b>Condition</b>	Some customers may comment that a squeak noise can be heard from under the vehicle while driving at slow speeds.
<b>Cause</b>	This condition may be caused by the parking brake cables rubbing against each other or alongside the body.

Using Woven Polyester Electrical Tape (PET), locate both of the brake cables near the parking brake cable bracket (1) and apply tape (2) to the cables ensuring that the tape is applied in a double layer extending along the cable as shown above.

**Note:** Ensure that the tape extends at least 25 mm (1 in) above and below the rubbing point at the parking cable bracket or the body.

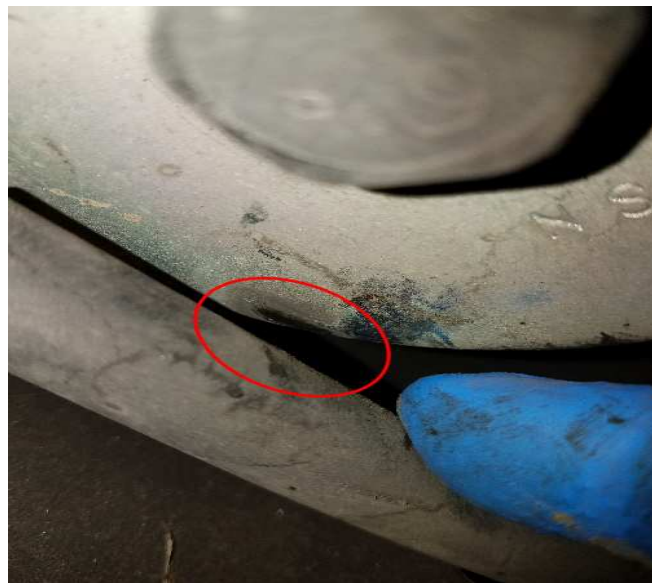
5377922

Follow the brake cables along-side the body and examine for contact to the body.

⇒ If contact to body has been found, apply the Woven Polyester Electrical Tape (PET) to the cable ensuring that the tape is applied in a double layer extending along the cable.
