Technical Service Bulletin

60 Rattle noise near central roof area

60 19 35 2054270/4 August 19, 2019. Supersedes Technical Service Bulletin Group 60 number 19-31 dated June 12, 2019 for reasons listed below.

Model(s)	Year	VIN Range	Vehicle-Specific Equipment
A6	2019 - 2020	All	Not Applicable

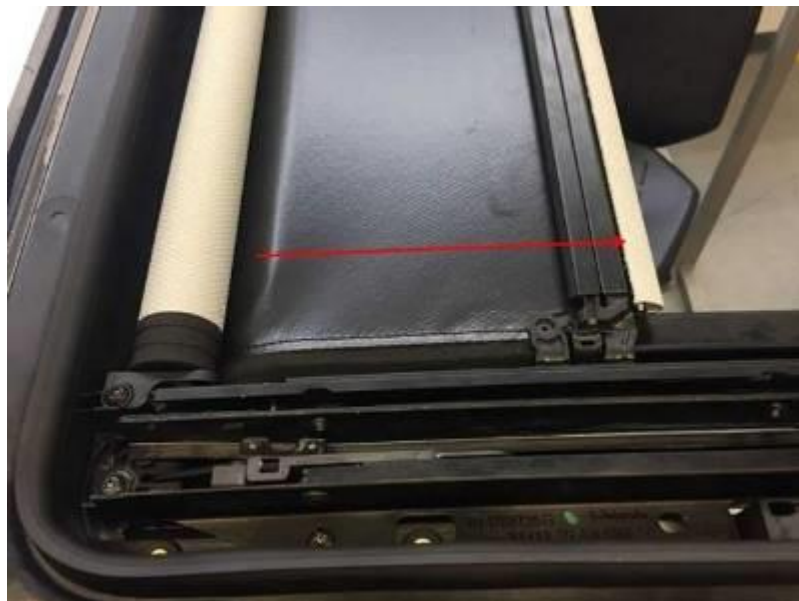
Figure 1. Closing the roller shade.

1. Remove the glass sunroof panel using the repair manual instructions.
2. Close the roller shade by about 20cm (Figure 1).

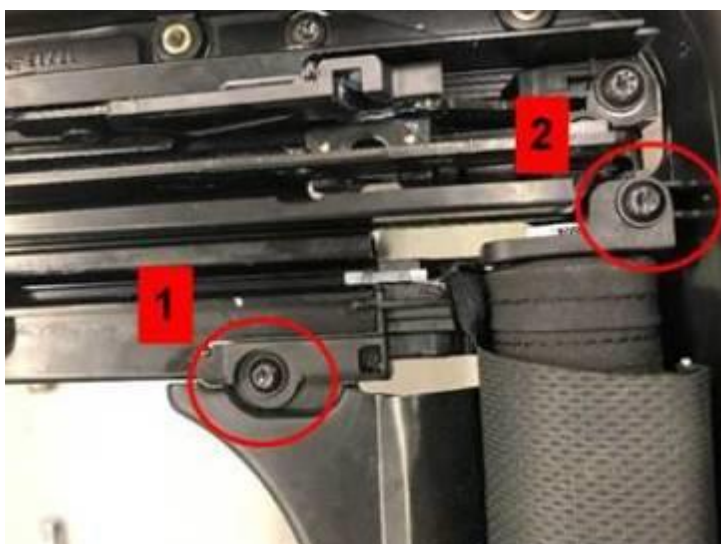
Figure 5. Remove the bolts.

3. Loosen the roller shade from the drive cable and push the material back until the bolts are exposed, then remove the bolts completely (Figures 2 -5).

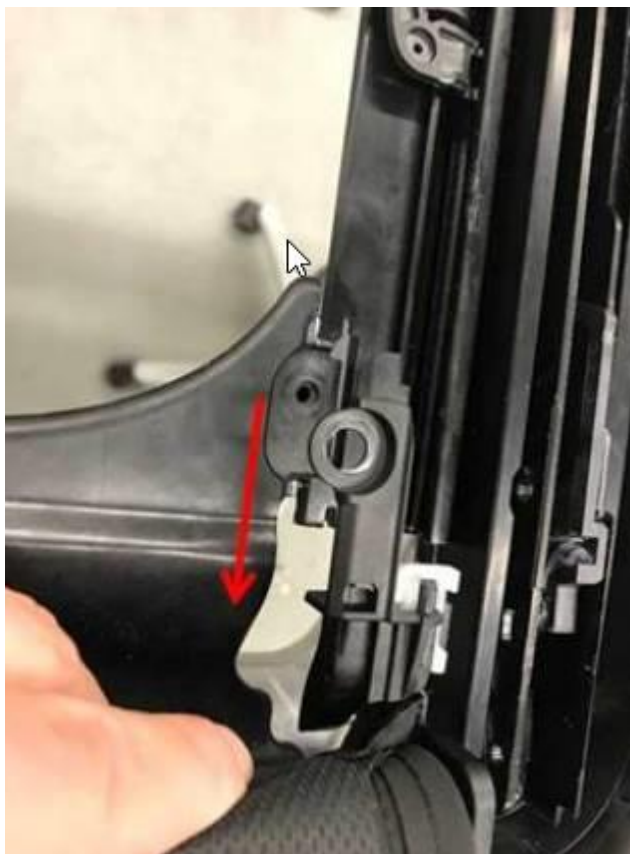
Figure 6. Slide roller shade backward.

4. Remove the roller shade by sliding it backward and clean the mounting points as shown in Figure 6 and 7. Use the cleaning solution D 009 401 04 or equivalent surface preparation solvent (e.g. isopropyl alcohol or adhesion promoter) to prepare the surfaces for adhesive backed felt strip material.

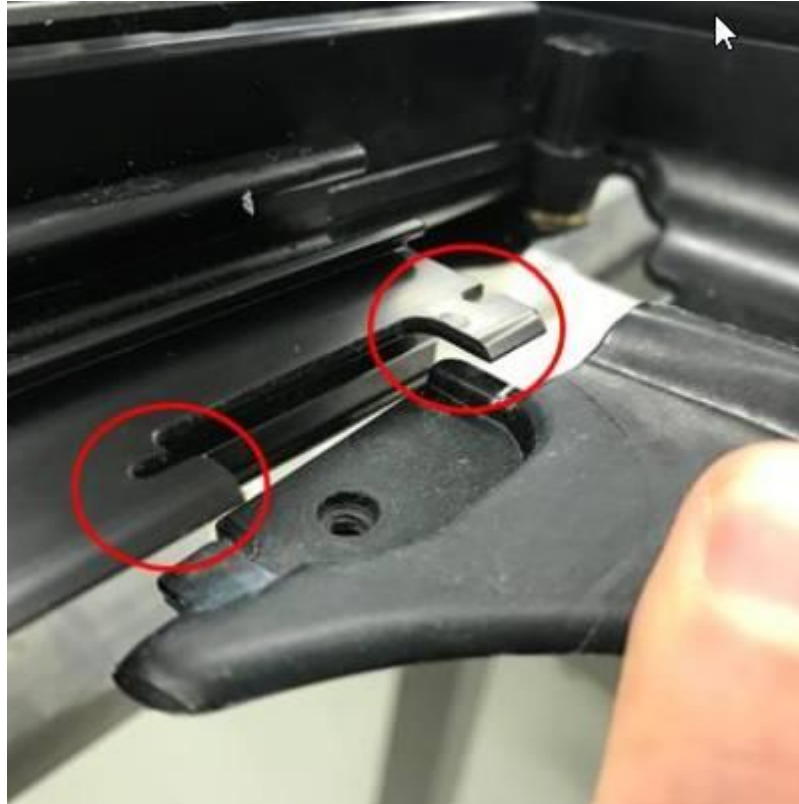
Figure 7. Areas to clean using cleaning solution D 009 401 04.

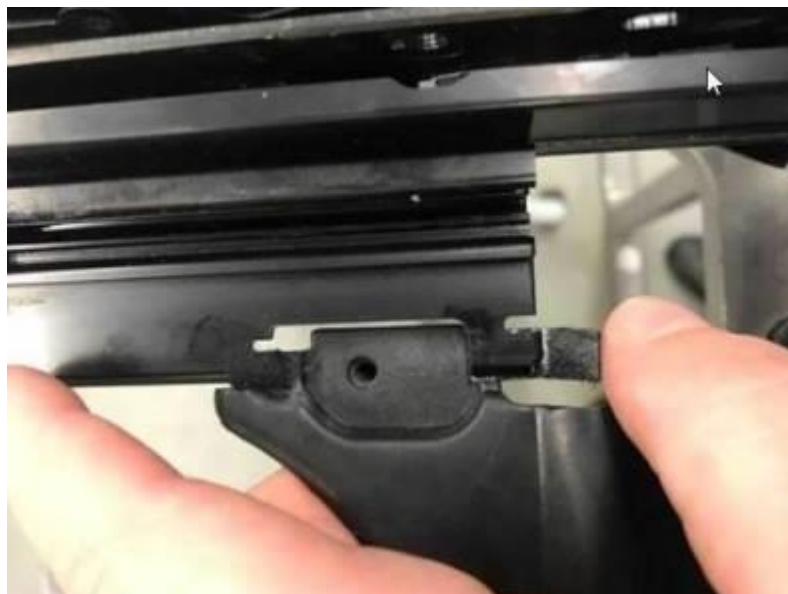
Figure 8. Applying felt tape.

5. Push down on the roller shade pan and starting from the bottom of the guide rail, wrap the areas shown in figure 8 with sections of felt tape 000 979 950 and fold them forward and over to the top of the guide rail such that both the top and bottom of the tabs are isolated (Figure 8 and 9).

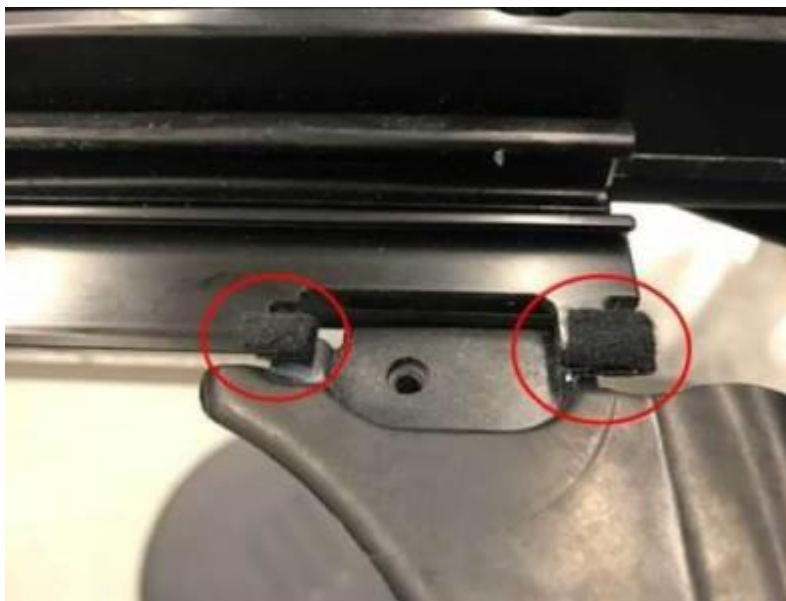
Figure 9. Apply felt tape on points shown. The tops and bottoms of the tabs must be isolated.

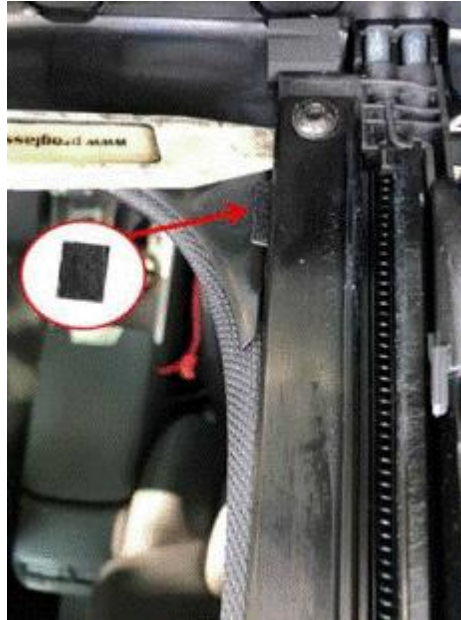
Figure 13. Isolation of guide rail and frame by the installation of a section of felt strip material.

- Lift the guide rail slightly using a plastic wedge. Place a 20mm x 20mm section of felt strip material 533 867 910 A between the guide rail and the frame as shown in figure 13. The backing for the adhesive side must be removed and the felt tape section adhered before the screw is tightened. Reinstall the screw and tighten to 5Nm. (Figure 8).

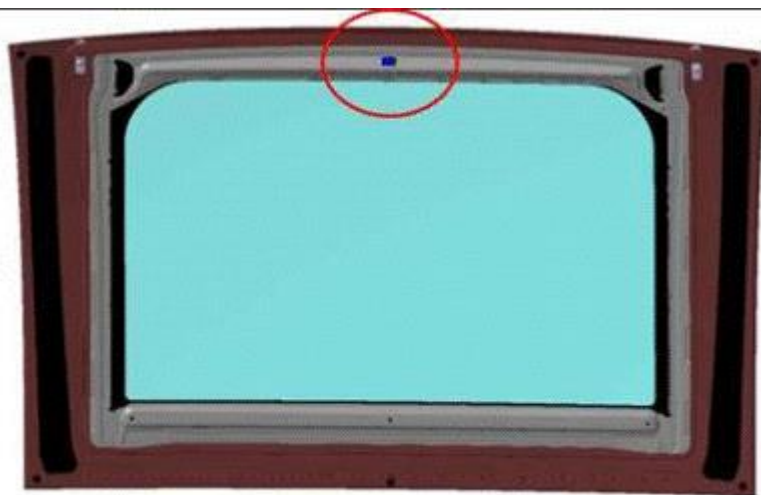
Figure 15. Area of sunroof glass panel structure to be prepared.

9. Measure and mark the center of the glass sunroof panel structure shown in figure 15. Clean this area with cleaning solution D 009 401 04 or equivalent surface preparation solvent (e.g. isopropyl alcohol or adhesion promoter) to prepare the surfaces for adhesive backed felt strip material. Apply a 20mm x 20mm section of adhesive felt strip material 533 863 288 A to this central area of the glass sunroof panel structure as shown in figure 16 and 17.

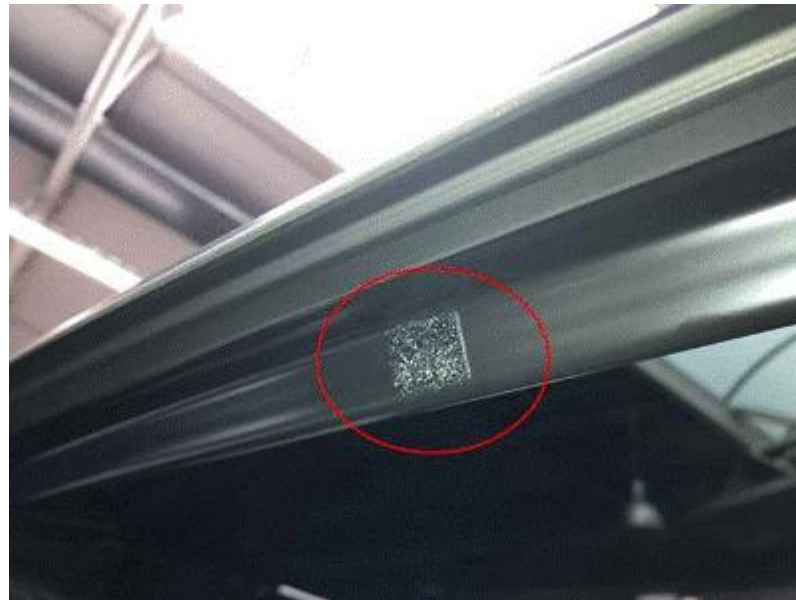
Figure 17. Adhesive felt strip material affixed to the center area of sunroof glass panel structure.
