# WORK DESCRIPTION FOR FIELD MEASURE

Code: 1808P61C42

## Correct seam seals on underbody

Model 205.2, 205.3, 238.3 and 253

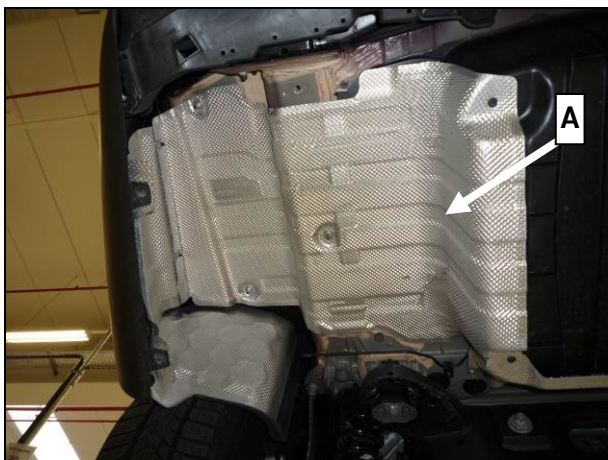
Basic data AR49.10-P-4952RF – model 253.
6. Remove heat shield (A, Figure 1 and 2) of the rear muffler.

Figure 1 shown on model 238!

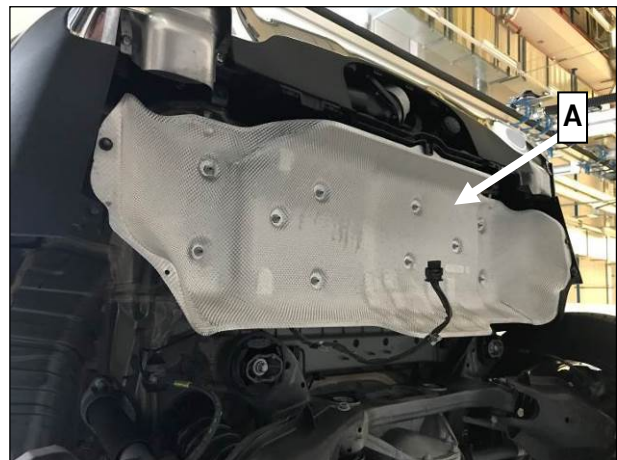
Figure 2 shown on model 253!

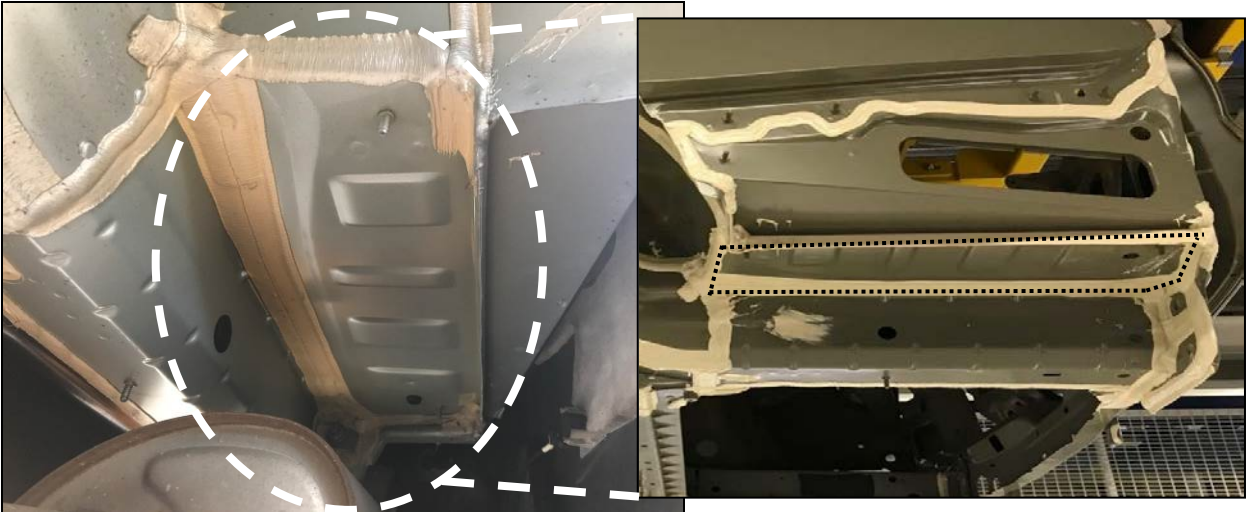
Figure 17

**i** Seam seal on left rear longitudinal member!

For the affected seam seals on model 205, see page 5 – 8 (Figure 10 – 19)!

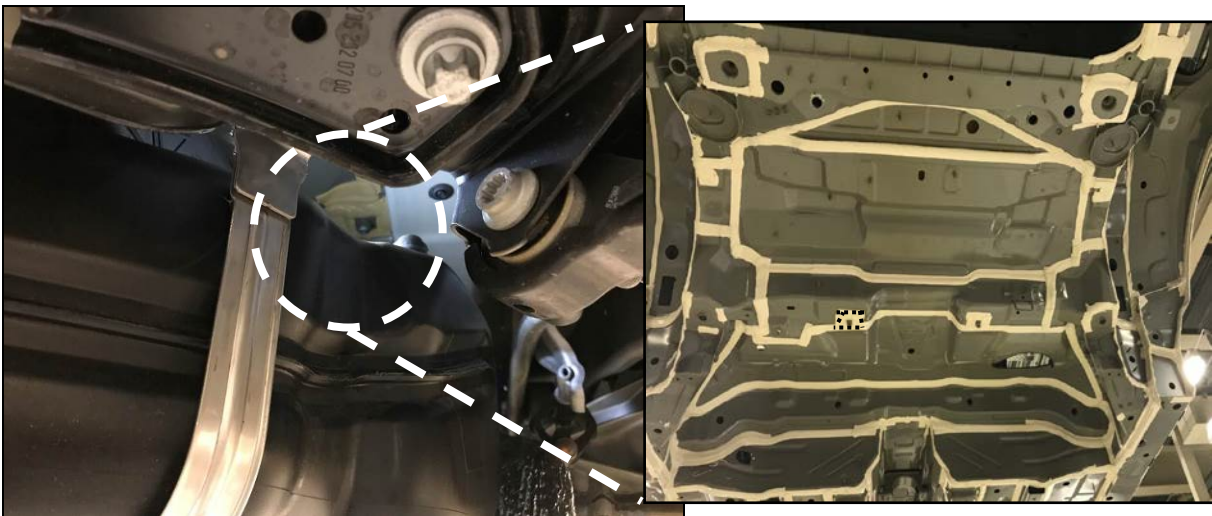
Figure 21

**i** Seam seal of fuel tank!!

For the affected seam seals on model 238, see page 9 – 13 (Figure 20 – 31)!

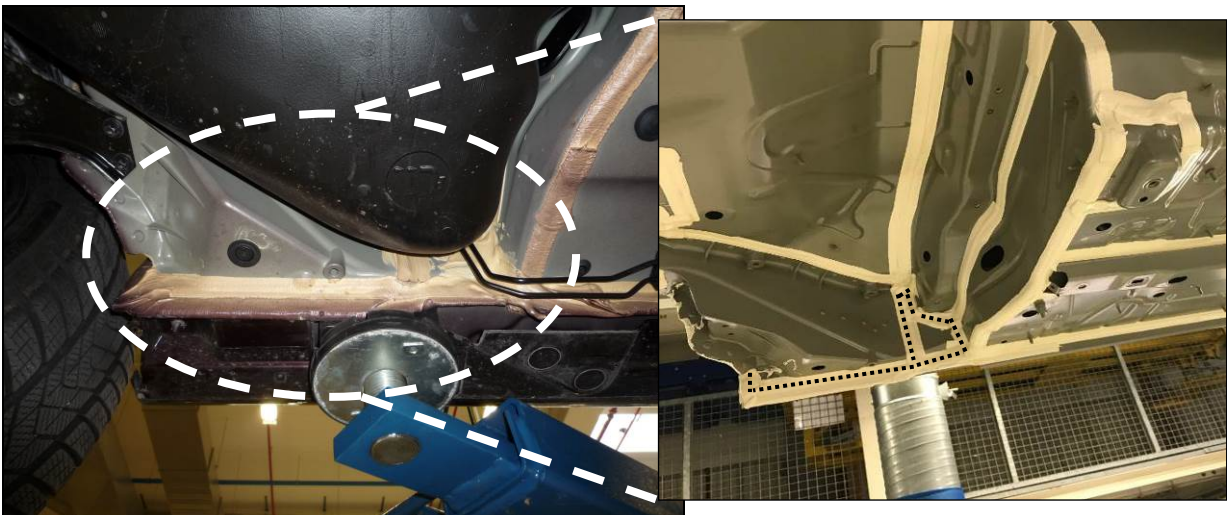
Figure 23

**i** Seam seal on left inner rear longitudinal member!

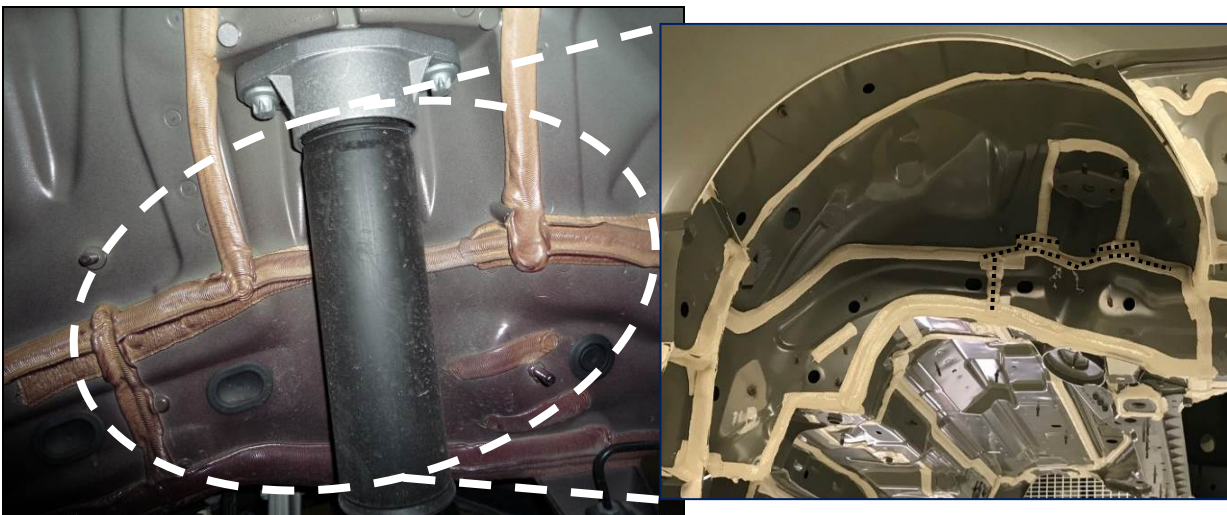
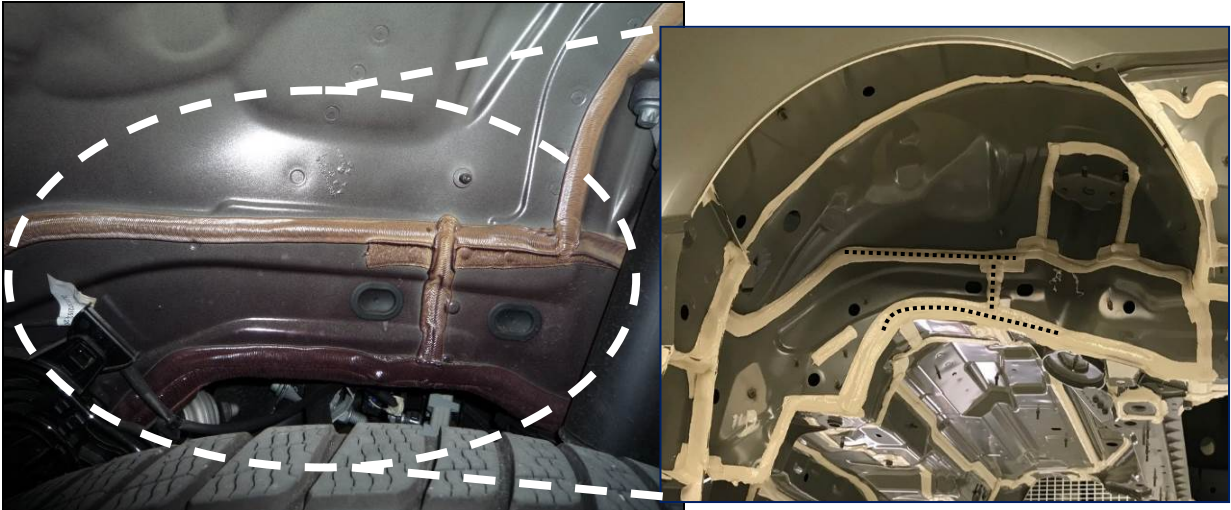
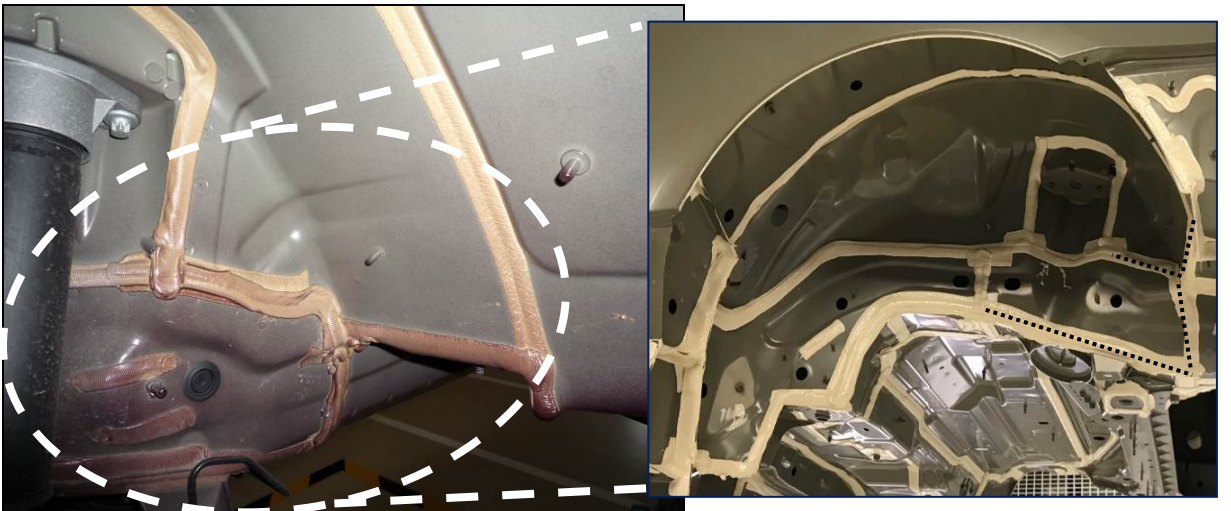
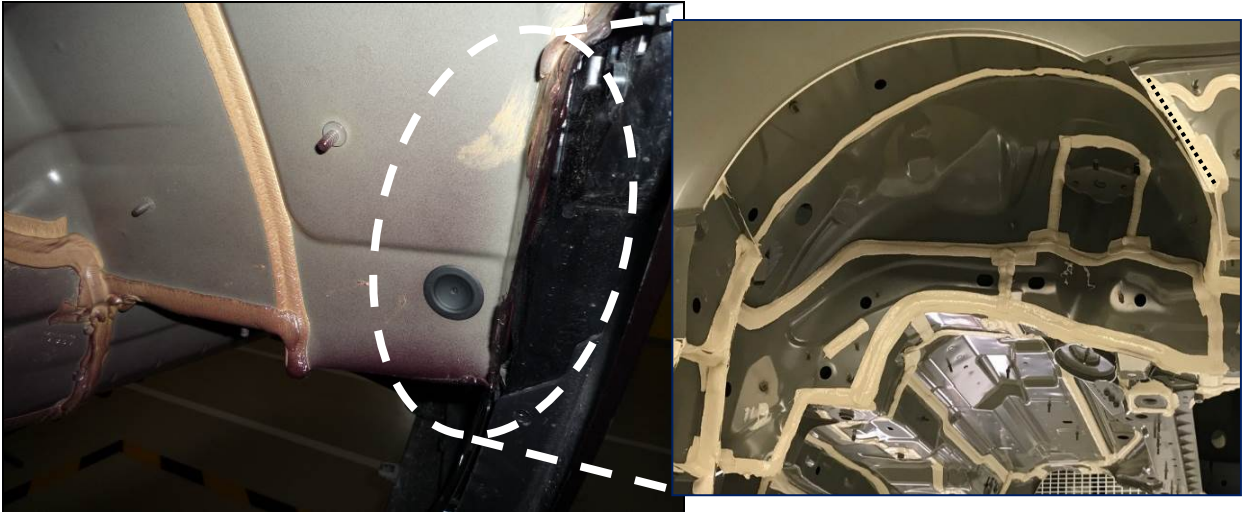
Figure 24

**i** Seam seal on left rear wheel arch!

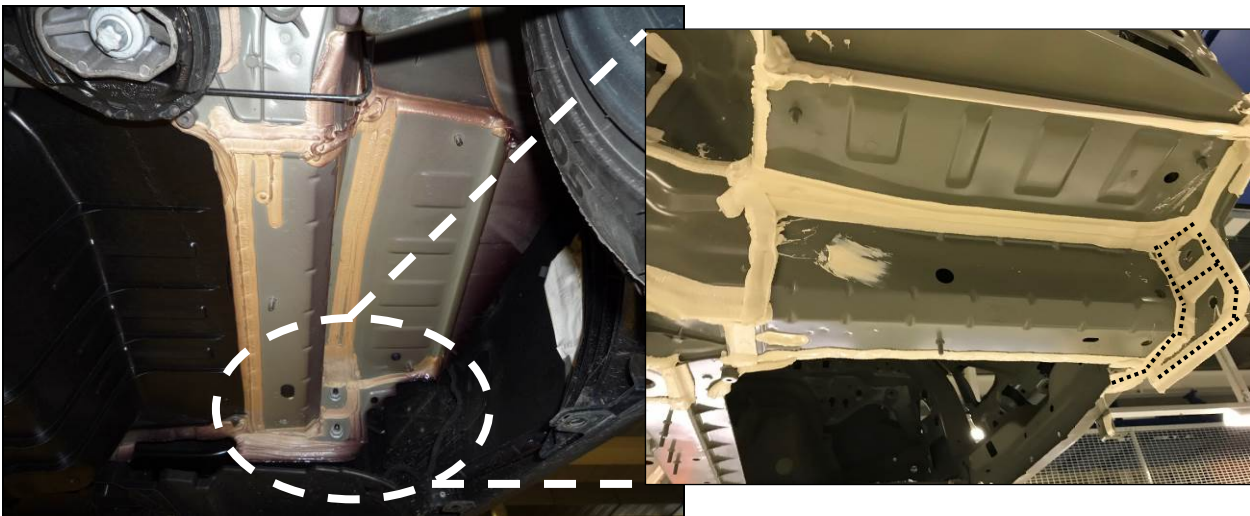
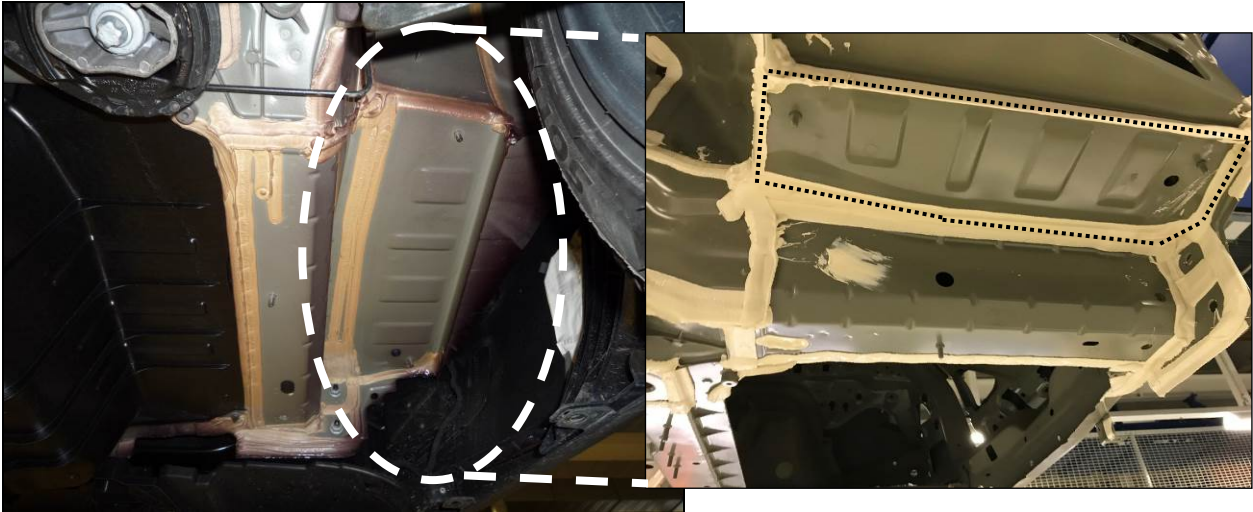
Figure 29

**i** Seam seal on left rear longitudinal member!

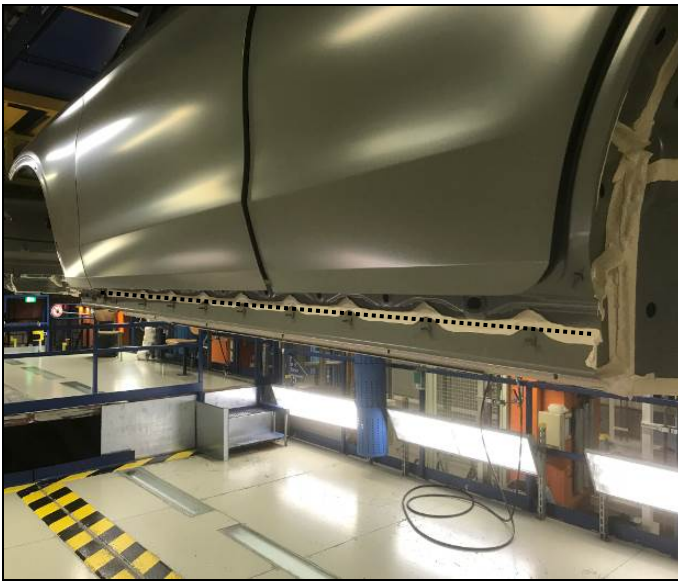
Figure 40

**i** Seam seal on left outer longitudinal member!

For the affected seam seals on model 253, see page 14 – 19 (Figure 32 – 40)!
