# Door Mirror Foot Light Projects Distorted Logo

YEAR(S)	MODEL(S)	ADDITIONAL INFORMATION
2018 - 2019	C-HR

Some 2018 – 2019 model year C-HR vehicles may exhibit a condition where the door mirror foot light projects a distorted image of the C-HR logo onto the ground. Follow the Repair Procedure in this bulletin to address this condition.

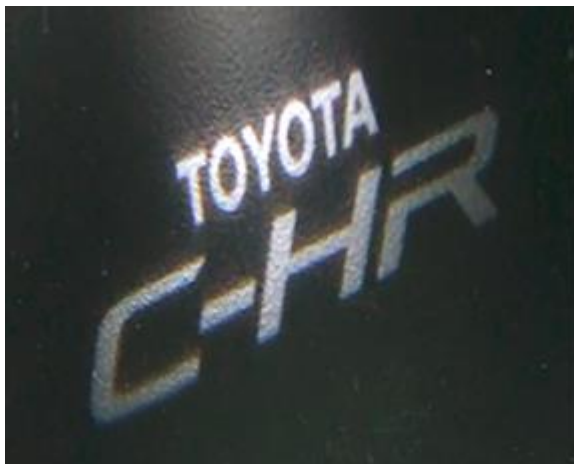
**Figure 1. OK Condition**

1. Confirm the “Toyota C-HR Distorted Image” condition exists.

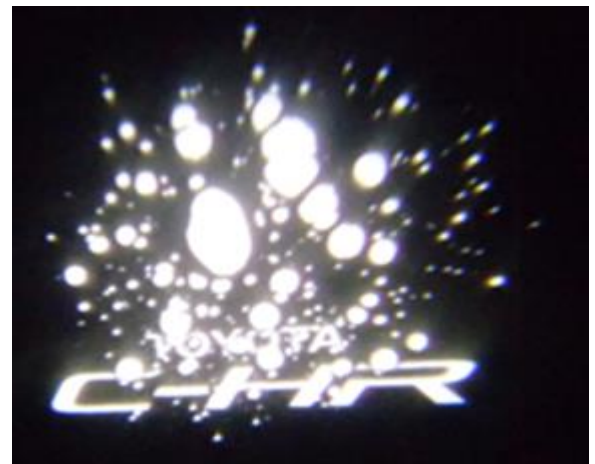
**Figure 2. Not Good Condition**

ANY type of distortion in the image of the Toyota C-HR logo is NOT acceptable.

Does the door mirror foot light project a distorted image of the Toyota C-HR logo onto the ground?

2. Remove the outer mirror lamp assembly.

3. Install the NEW outer mirror lamp assembly.

4. Confirm the C-HR logo projects correctly.
