MIL ON DTC P0A45

YEAR(S)	MODEL(S)	ADDITIONAL INFORMATION
2016 - 2018	RAV4 HV

Some 2016 – 2018 model year RAV4 Hybrid vehicles may exhibit a hybrid system warning message/MIL ON condition with Diagnostic Trouble Code (DTC) P0A45 (Drive Motor “B” Position Sensor Circuit) present. Follow the Repair Procedure in this bulletin to address this condition.

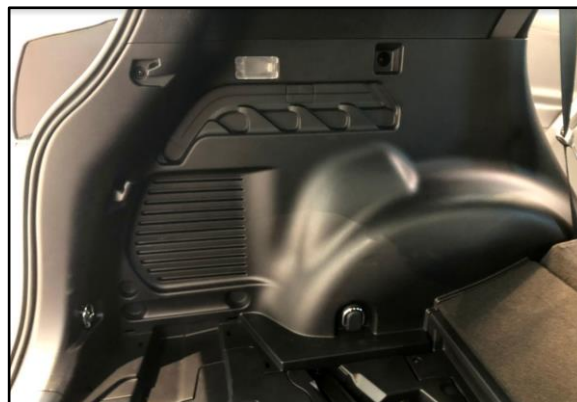
Figure 7.

8. Remove the deck trim side panel assembly left-hand side.

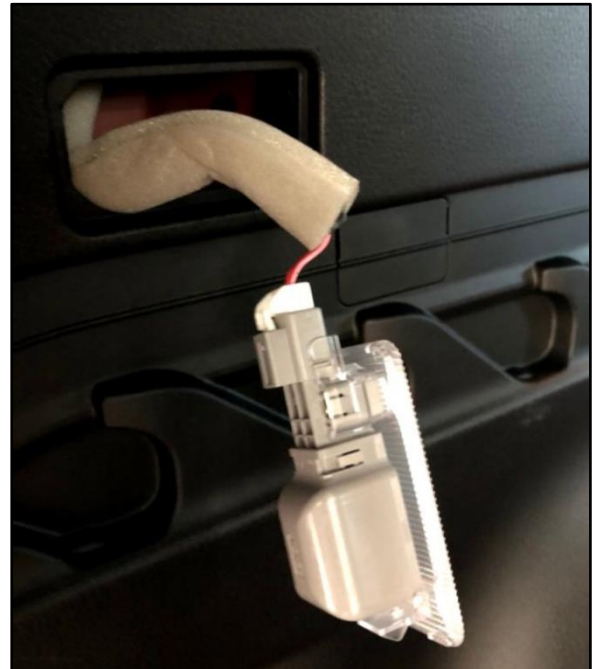
Figure 9.

- B. Remove the light assembly.
 - (1) Detach the light assembly from the trim panel.
 - (2) Remove the connector.

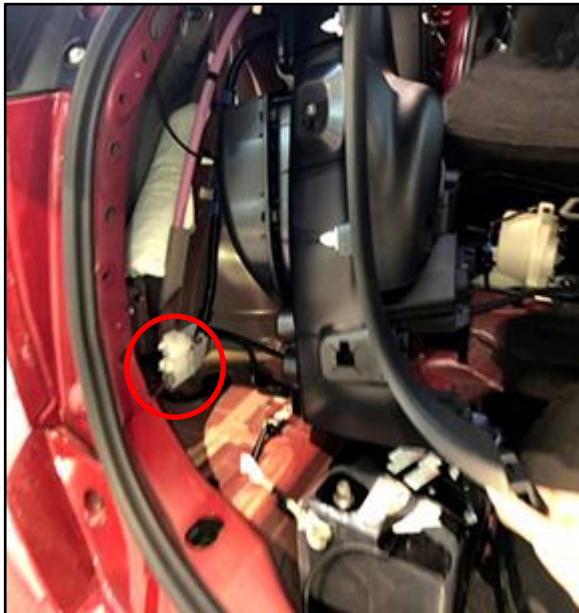
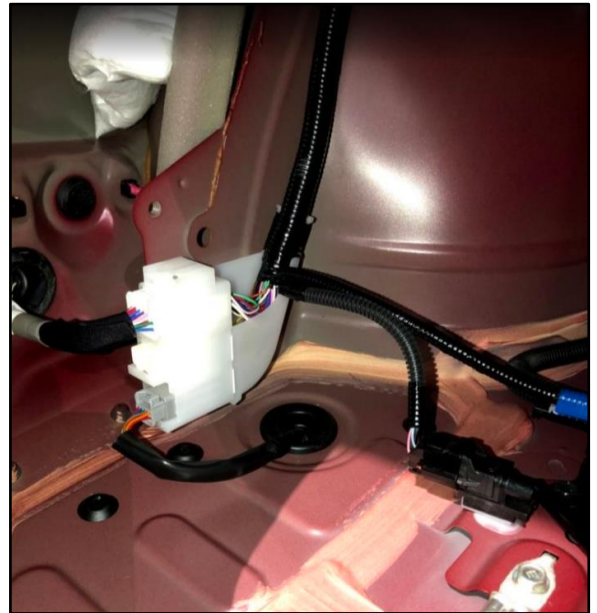
Figure 11.

9. Pull back the panel and locate the frame wire harness connector.

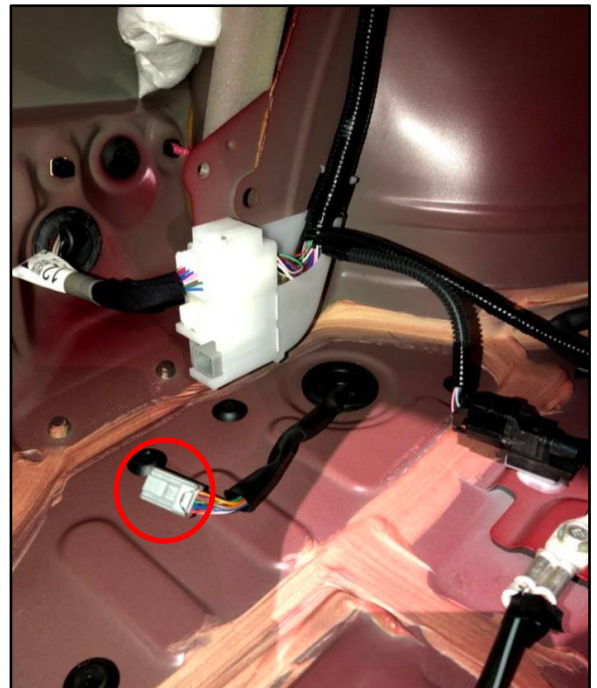
Figure 13.

10. Remove the frame wire harness connector.

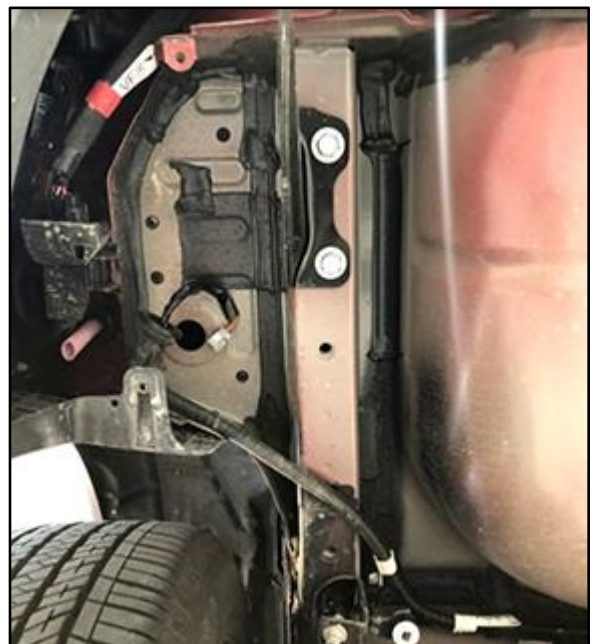
Figure 15.

12. Remove the plastic nut and two clips to remove the underbody rear left-hand cover.

1	Clip
2	Plastic Nut

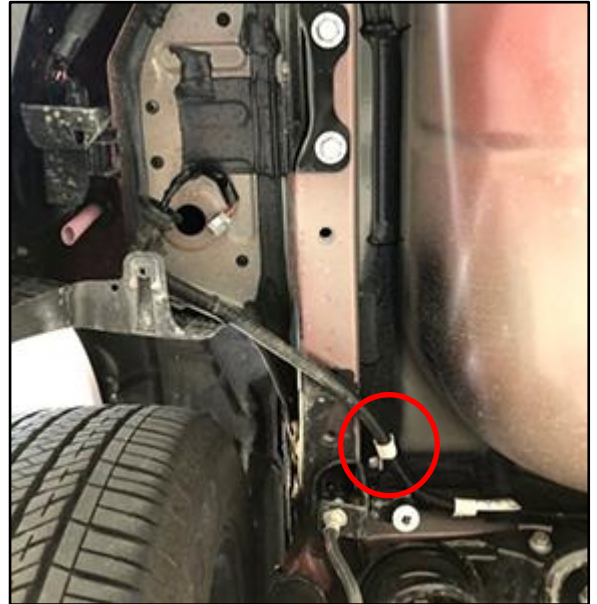
Figure 23.

3. Engage the white clip.

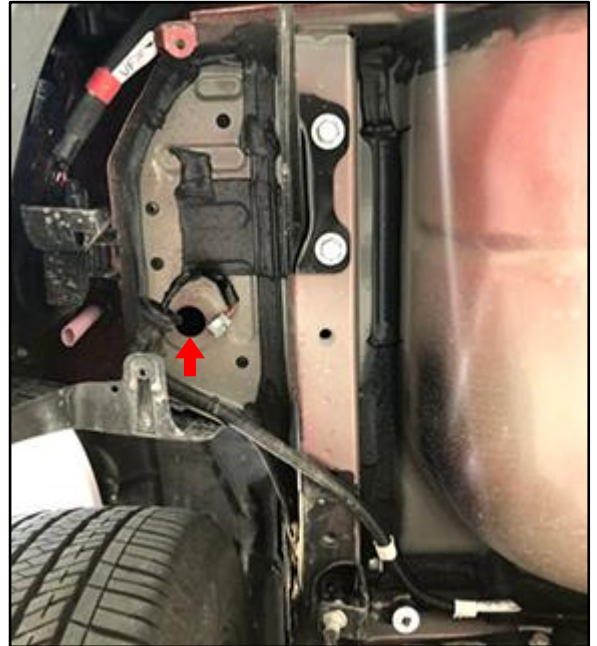
Figure 25.

5. Push the harness connector and grommet through the body hole.

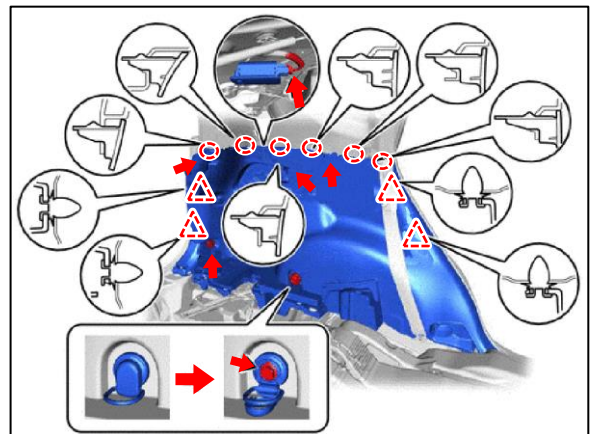
Figure 28.

8. Install the deck trim side panel assembly left-hand side.
 - A. Engage the six claws and four clips.
 - B. Install the bolt and luggage hold belt striker assembly.
 - C. Install the bolt and tether anchor set bracket.
 - D. Install the screw and two bolts.
 - E. Close the tether anchor set bracket cover.

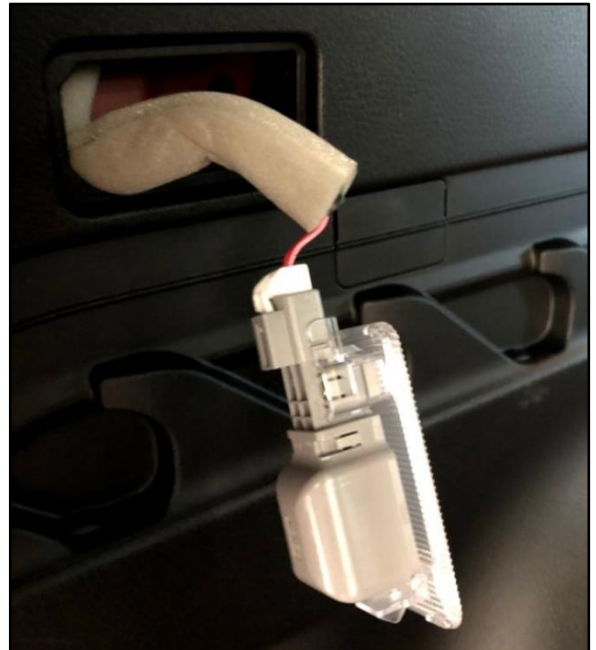
Figure 29.

F. Connect and install the light assembly.

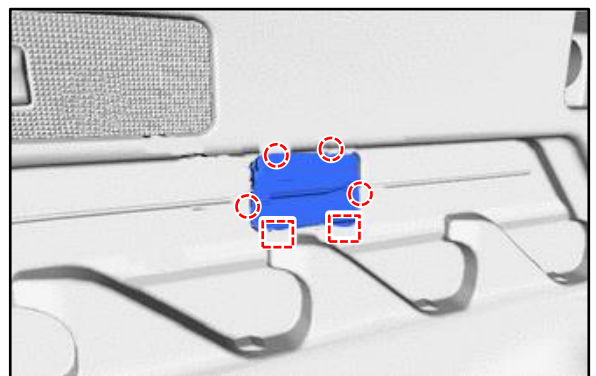
Figure 30.

G. Install the deck trim service hole cover by attaching the four claws and two guides.
