HVAC Evaporator Drain Hose Clogged Due to Insect Intrusion

Service Category Vehicle Interior
Section Heating/Air Conditioning

SUPERSESION NOTICE

The information contained in this bulletin supersedes Service Bulletin No. T-SB-0033-14.

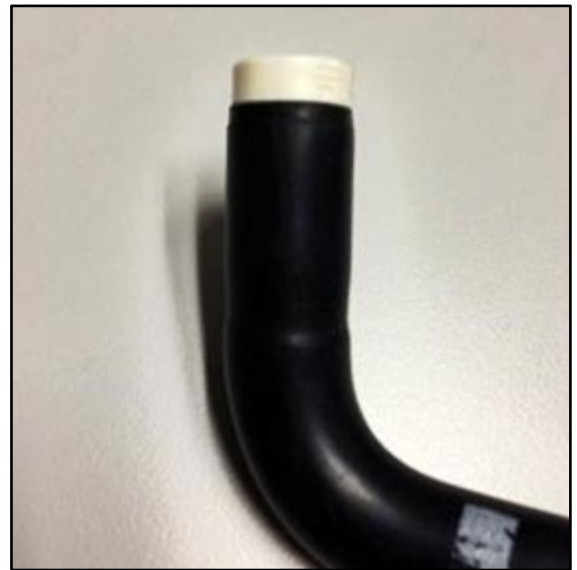
1. Follow the instructions provided in the Safety Requirements for Handling the ARINIX® Tip (Water Hose Connector) section of this bulletin.
2. Locate the HVAC evaporator drain hose.
3. Following the vehicle specific Repair Manual, remove the HVAC evaporator drain hose.
4. Put on all necessary PPE and install the ARINIX® Tip (water hose connector) into the NEW HVAC evaporator drain hose listed in the Parts Information section of this bulletin.
5. When installing the ARINIX® Tip, verify it is fully seated in the HVAC evaporator drain hose as shown in Figure 1.

1. Follow the instructions provided in the Safety Requirements for Handling the ARINIX® Tip (Water Hose Connector) section of this bulletin.
2. Locate the HVAC evaporator drain hose.
3. Following the vehicle specific Repair Manual, remove the HVAC evaporator drain hose.
4. Put on all necessary PPE and install the ARINIX® Tip (water hose connector) into the NEW HVAC evaporator drain hose listed in the Parts Information section of this bulletin.
5. When installing the ARINIX® Tip, verify it is fully seated in the HVAC evaporator drain hose as shown in Figure 1.
6. Following the vehicle specific Repair Manual, install the HVAC evaporator drain hose.

5. Put on all necessary PPE and install the ARINIX® Tip into the NEW HVAC evaporator drain hose listed in the Parts Information section of this bulletin.
6. When installing the ARINIX® Tip, verify it is fully seated in the HVAC evaporator drain hose as shown in Figure 1.
7. Following the vehicle specific Repair Manual, install the HVAC evaporator drain hose.

1. Follow the instructions provided in the Safety Requirements for Handling the ARINIX® Tip (Water Hose Connector) section of this bulletin.
2. Locate the HVAC evaporator drain hose.
3. Following the vehicle specific Repair Manual, remove the HVAC evaporator drain hose.
4. Before installing the ARINIX® Tip (water hose connector) into the original HVAC evaporator drain hose, the end of the hose MUST be cut perpendicular as shown in Figure 2.
5. Put on all necessary PPE and install the ARINIX® Tip into the original HVAC evaporator drain hose listed in the Parts Information section of this bulletin.
6. When installing the ARINIX® Tip, verify it is fully seated in the HVAC evaporator drain hose as shown in Figure 1.
7. Following the vehicle specific Repair Manual, install the HVAC evaporator drain hose.

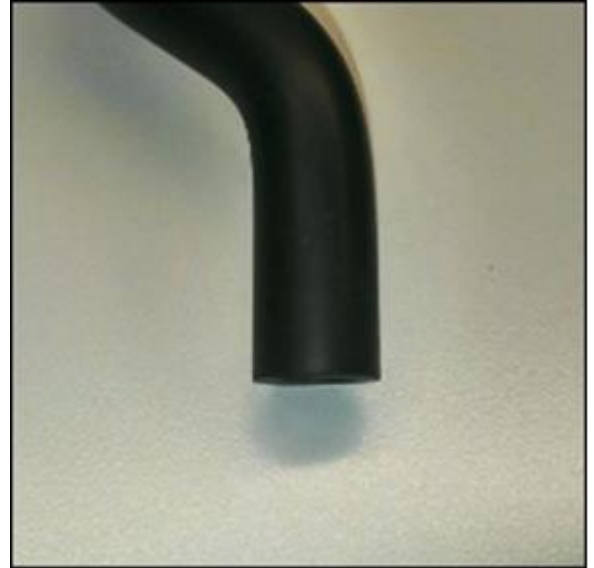
1. Follow the instructions provided in the Safety Requirements for Handling the ARINIX® Tip (Water Hose Connector) section of this bulletin.
2. Locate the HVAC evaporator drain hose.
3. Following the vehicle specific Repair Manual, remove the HVAC evaporator drain hose.
4. Before installing the ARINIX® Tip (water hose connector) into the NEW HVAC evaporator drain hose, the end of the hose MUST be cut perpendicular as shown in Figure 2.
