Carpet Pulling Out From Side Trim

Service Category Vehicle Interior

Section Interior Panels/Trim

YEAR(S)	MODEL(S)	ADDITIONAL INFORMATION
2015 - 2019	Yaris	Body Type(s): 5D, 5Dr. Hatch Back

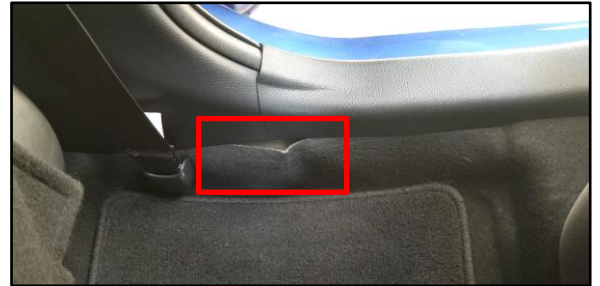
Figure 2. Not Good Condition

Some 2015 – 2019 model year Yaris vehicle passenger front, passenger rear, and/or driver rear doors may exhibit floor carpet that appears deformed or incorrect. When weight is applied on the floor near the door scuff plate, the carpet can be pulled out from behind it. Follow the Repair Procedure in this bulletin to address this condition.

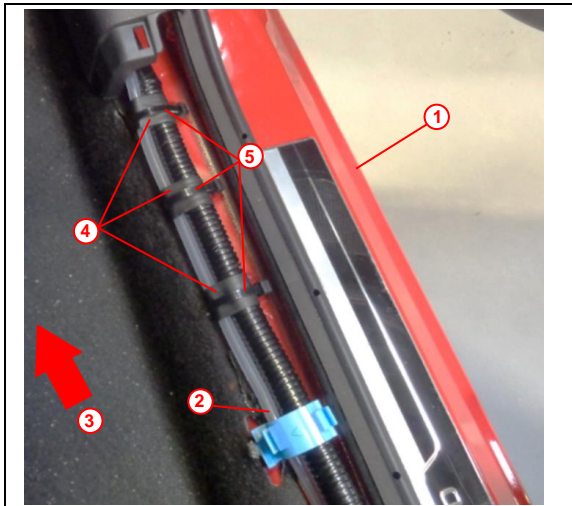
Figure 3. Passenger Front

1	Passenger Front Side
2	Drain Tube
3	Front of Vehicle
4	Insulating Felt
5	Cable Tie

3. Using a knife or hole punch, make a hole in the carpet just large enough to fit a cable tie through. (See Figures 3 and 4.)
 - Passenger front: Three holes and three cable ties
 - Passenger rear (left and right sides): One hole and one cable tie

4. Cut the 30 x 2-in. insulating felt or thick tape into five 6 x 2-in. pieces.

5. At each of the five cable tie locations, wrap the cut felt or tape completely around the conduit and the drain tube.

6. Route the cable tie underneath the conduit and through the punched hole in the carpet.

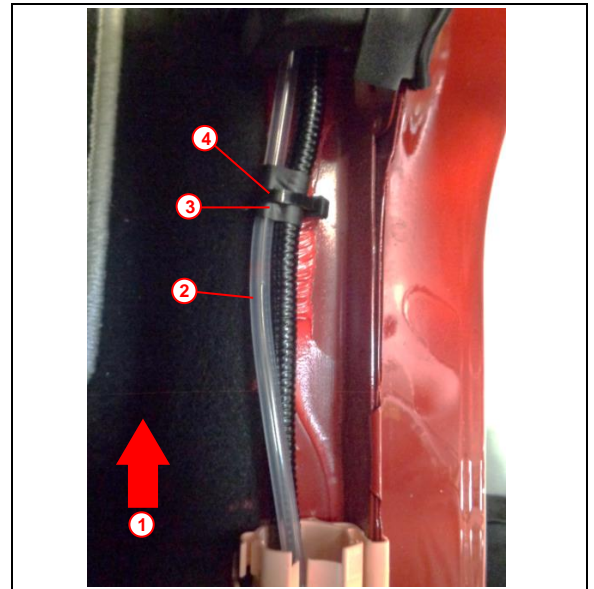
Figure 4. Passenger Rear

1	Front of Vehicle
2	Drain Tube
3	Insulating Felt
4	Cable Tie (One for Each Side)
