MODEL  
2017-2019MY  
Niro (DE HEV)

NUMBER  
041

## TECHNICAL SERVICE BULLETIN

**SUBJECT:** COMBINATION TSB / SERVICE ACTION: AIR  
FILTER KIT & NVLD REPLACEMENT (SA395)

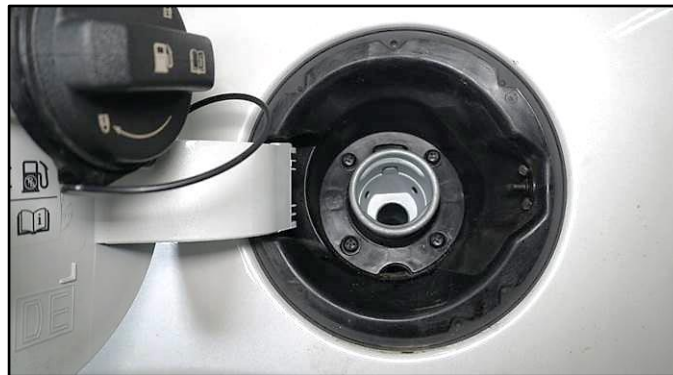
### DTC P0456: Evaporative Emission System-Leak Detected (Very Small Leak)

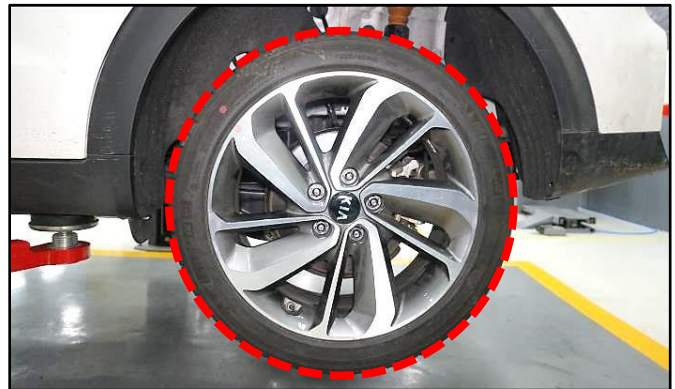
1. Raise the vehicle on a lift and remove the left rear wheel.

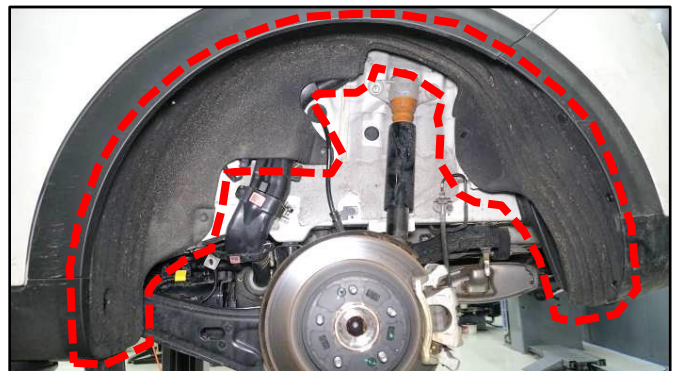
2. Remove the left rear fender liner.

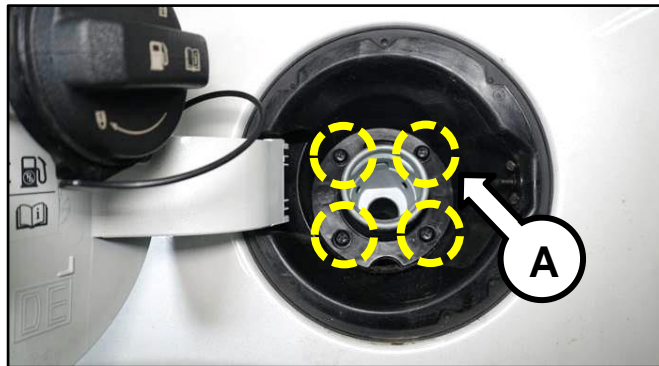
3. Open the fuel filler door and remove the four (4) retaining screws (A) of the filler neck.

**Torque specification for screw (A):**  
**5.75 – 8.70 ft.lb. (7.8 – 11.8 N.m,**  
**0.8 – 1.2 kgf.m).**

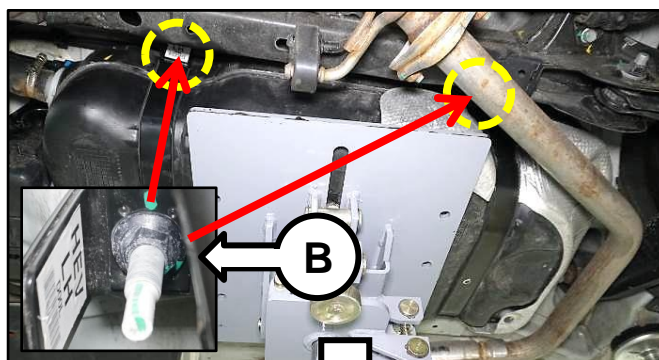
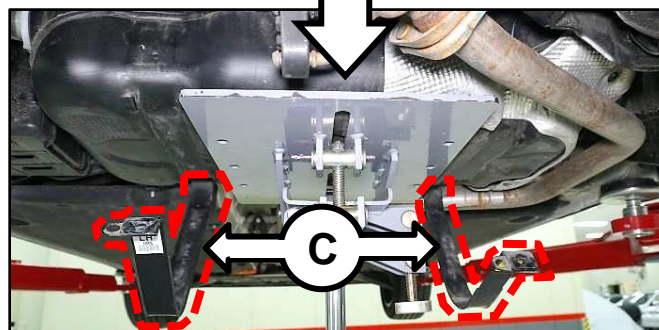
4. **If only the fuel tank air filter is being replaced, skip this step and proceed to step 5. This step is only required for replacement of the NVLD.**

Support the fuel tank with a suitable jack and then partially remove both of the fuel tank bands (C) by removing bolts (B).

**Torque specification for bolt (B):**  
**28.9 – 39.8 ft.lb. (39.2 – 54.0 N.m,**  
**4.0 – 5.5 kgf.m)**

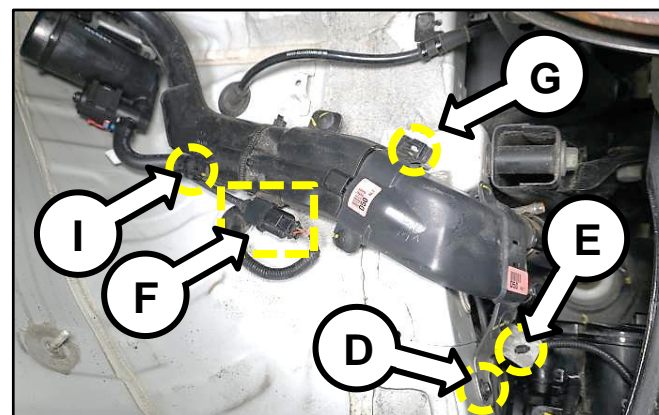
5. Remove the filler neck mounting bolt (D) and clip (E).

**Torque specification for bolt (D):**  
**2.8 – 5.7 ft.lb. (3.9 – 7.8 N.m,**  
**0.4 – 0.8 kgf.m)**

6. Disconnect the filler neck connector (F).

7. Carefully detach the filler neck mounting clip (G) from the body.

8. Carefully cut the zip tie (I).

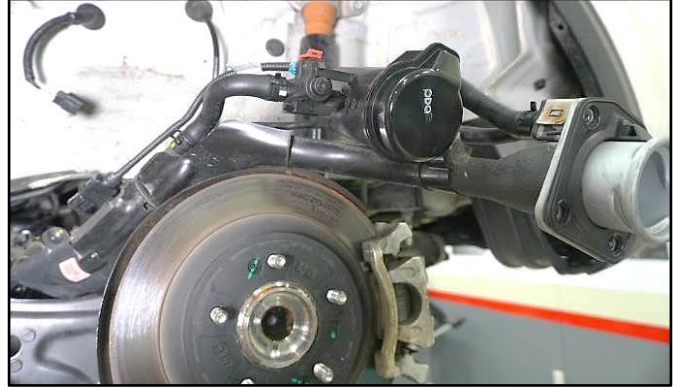
9. Lower the fuel filler neck assembly.

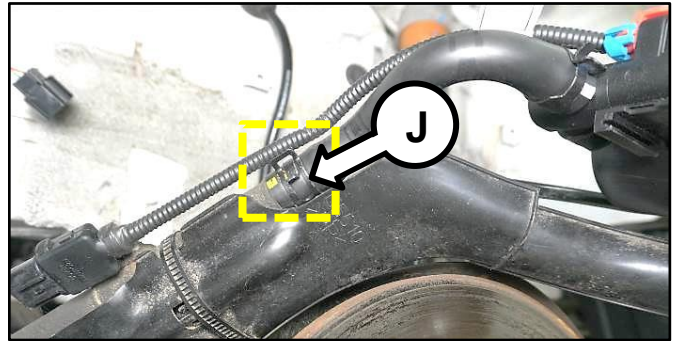
10. Release the mounting clamp (J).

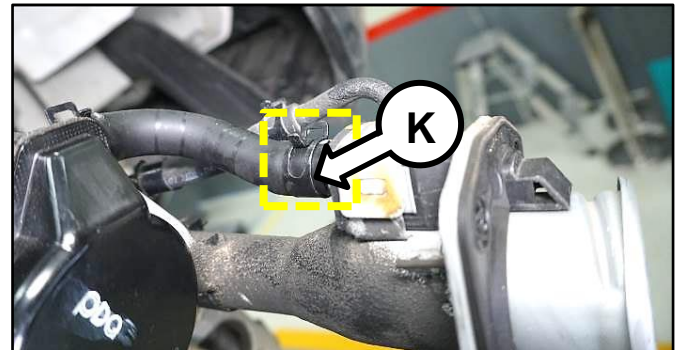
11. Release the mounting clamp (K).

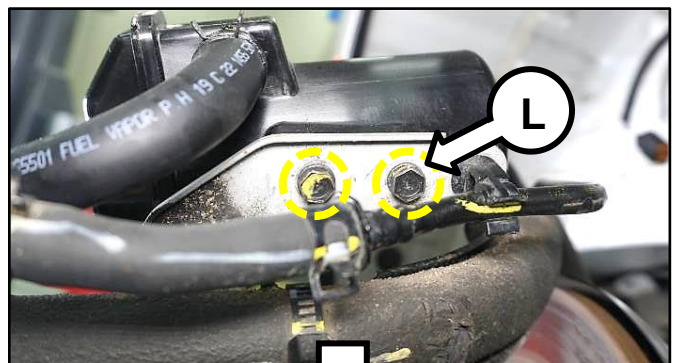
12. Remove the two (2) air filter retaining bolts (L) and remove the air filter assembly.

**Torque specification for bolt (L):**  
2.8 – 5.7 ft.lb. (3.9 – 7.8 N.m,  
0.4 – 0.8 kgf.m)

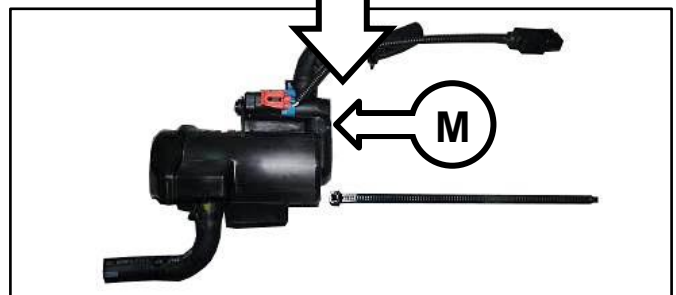
13. Install the new improved air filter assembly (M).

If only the fuel tank air filter required replacement, reinstall all removed components in the reverse order of removal. Ensure proper operation of the vehicle. If the NVLD requires replacement, proceed to the next step.

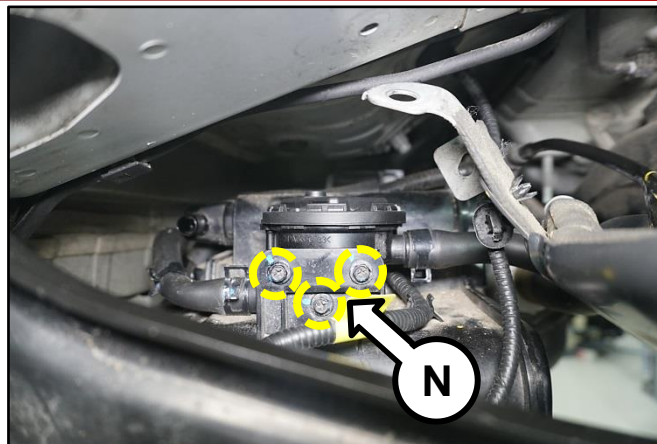
14. Carefully lower the fuel tank approximately eight (8) inches (twenty (20) centimeters) to allow access to the NVLD.

15. Remove the three (3) NVLD bracket mounting bolts (N).

**Torque specification for bolt (N):**  
**2.8 – 5.7 ft.lb. (3.9 – 7.8 N.m,**  
**0.4 – 0.8 kgf.m)**

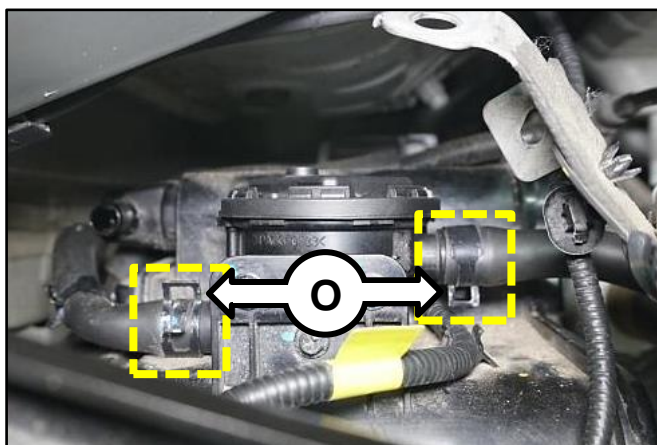
16. Release the upper and lower hose clamps (O) and carefully detach both hoses.

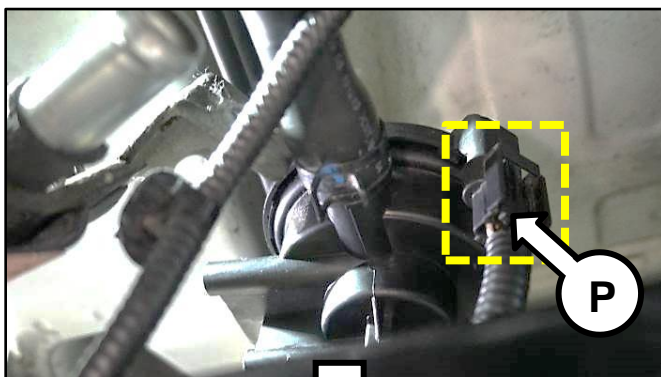
17. Disconnect the NVLD connector (P) and then remove the NVLD.

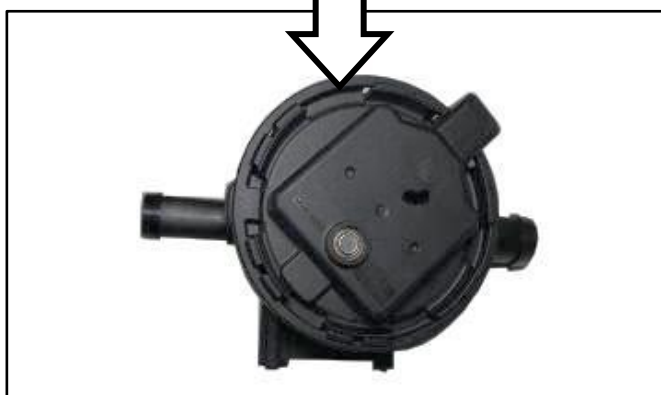
18. Install the new NVLD and reinstall all removed components, including the filler neck with the new air filter, in the reverse order of removal.

19. Verify proper operation of the vehicle.
