## Technical Information Bulletin

### R1801

Steering - 15

RH Stalk and Trailer Hand Brake Retrofit

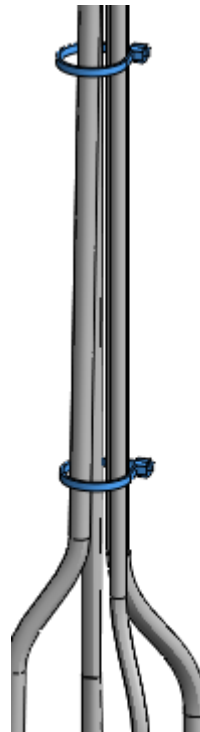
Figure 10

All harnesses are captured in cable tie

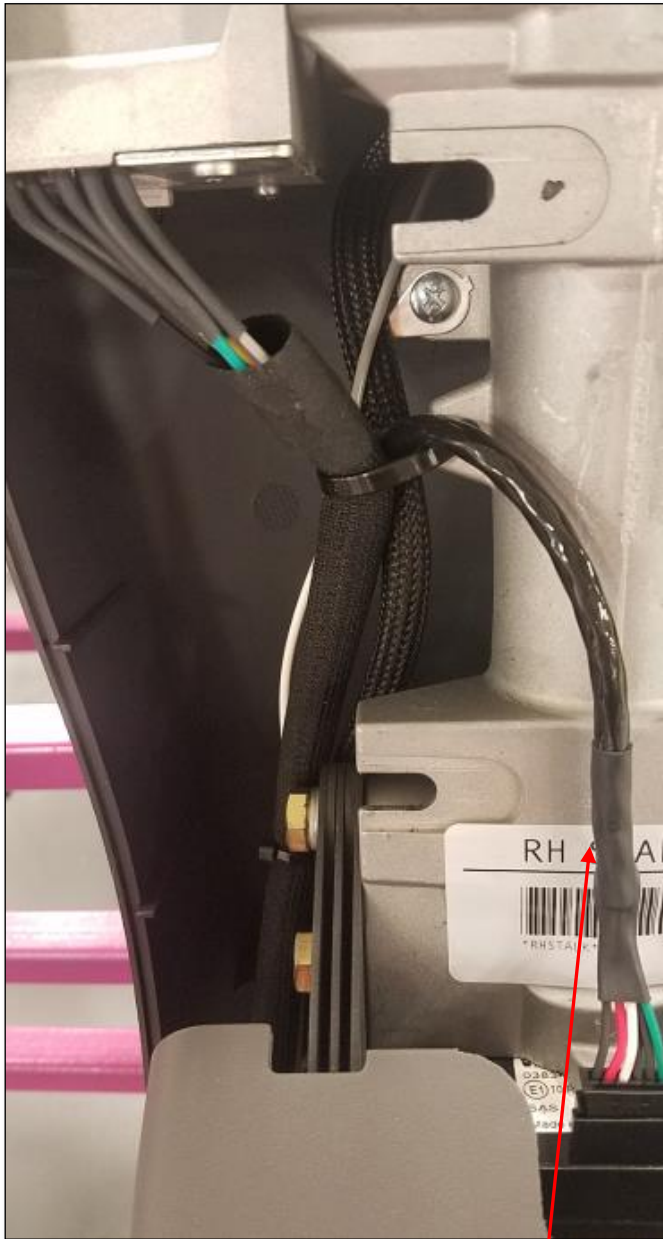
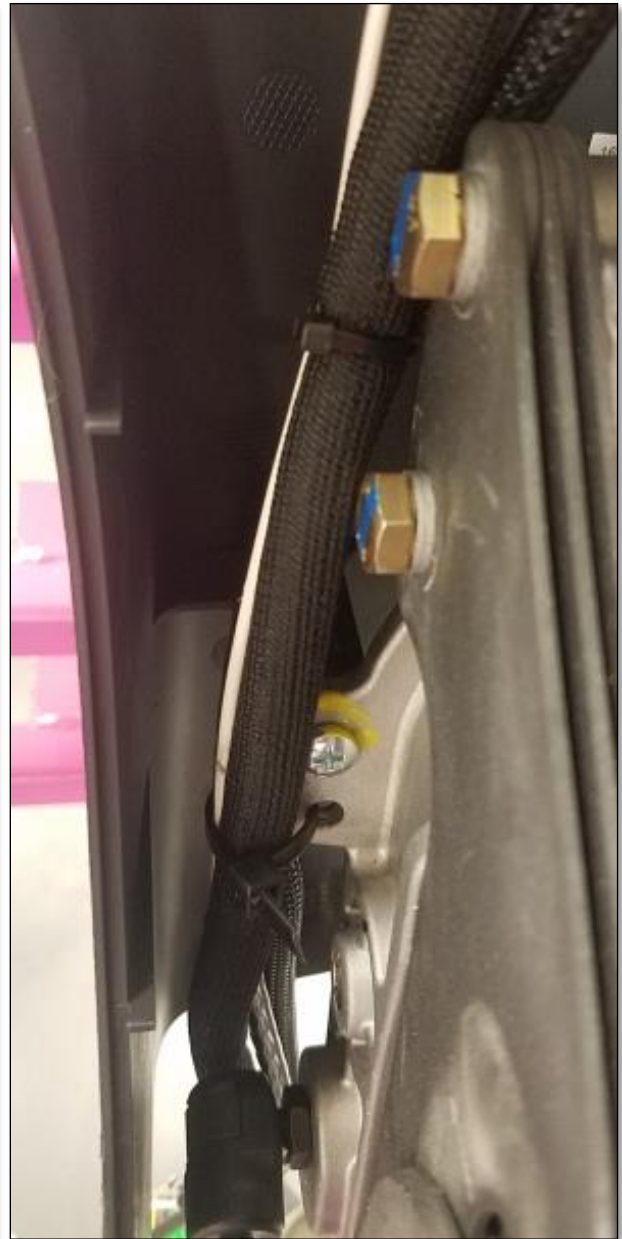
## APPENDIX A – HORN CONTACT

- 7) Install front shroud by pushing firmly into place. Be sure not to catch turn stalk or right-hand stalk rubber closeout in-between shroud halves.
- 8) See **Appendix A** for the finished routing of columns containing horn contact configuration.  
See **Appendix B** for the finished routing of columns containing clock spring configuration.

**\*\*If column does not contain SAS, SAS harness will not be included in column and cable tie\*\***

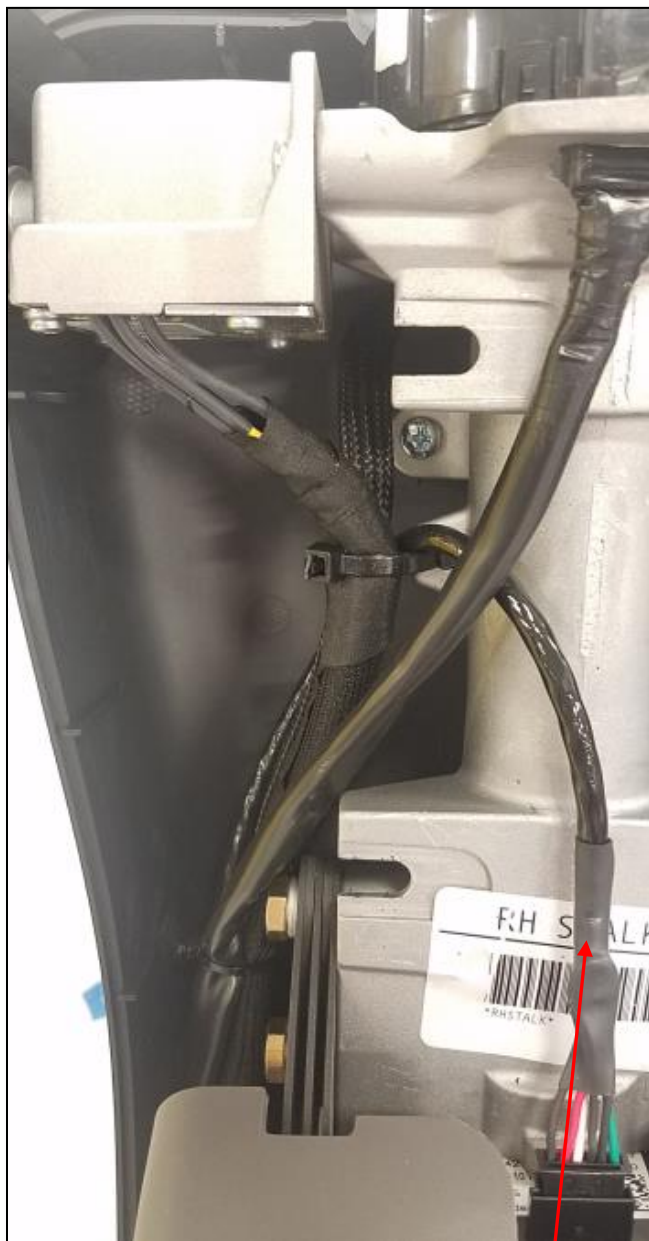
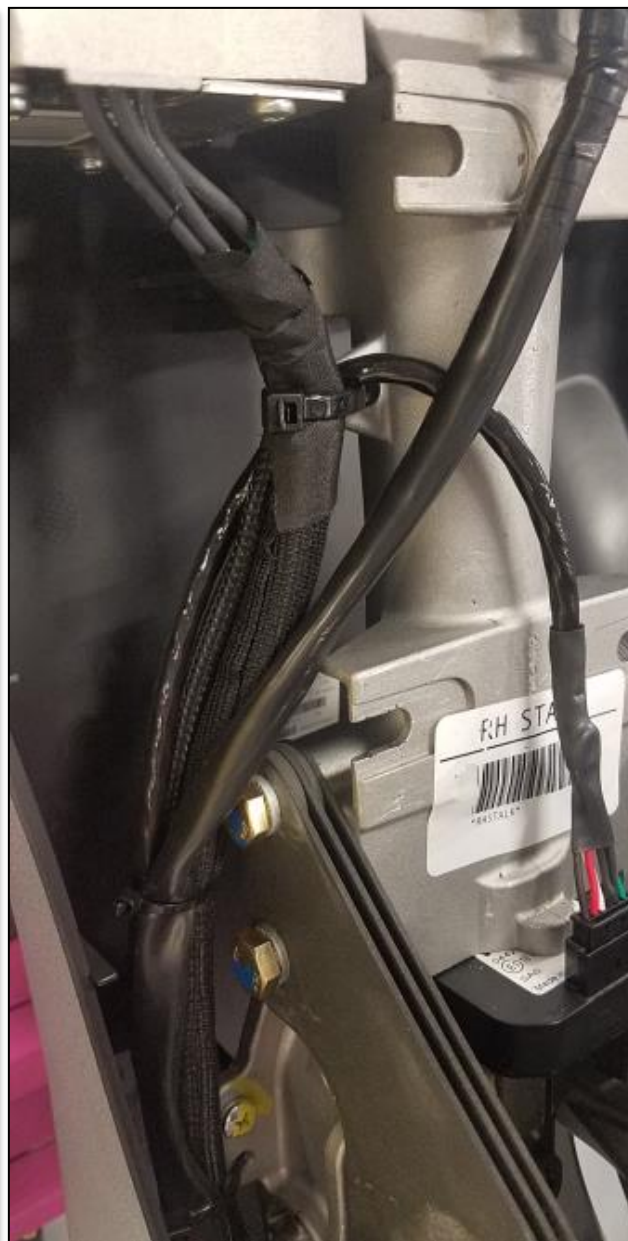
## APPENDIX B – CLOCKSPRING

**\*\*If column does not contain SAS, SAS harness will not be included in column and cable tie\*\***

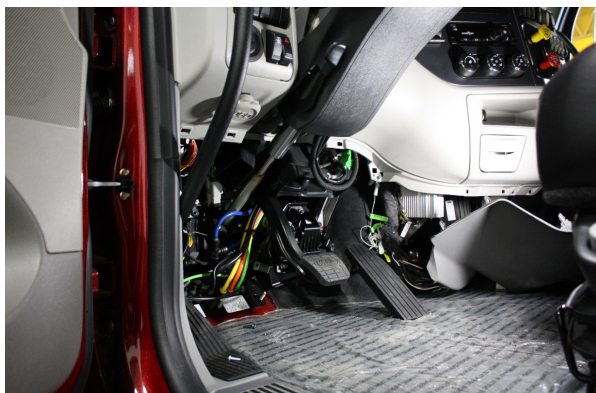
**Figure 1**

1. Remove lower kick panels, as shown in Figure 1.

Peterbilt interior is shown in the picture. The Peterbilt kick panel is installed with 5 screws and the Kenworth kick panel is installed with 2 screws.

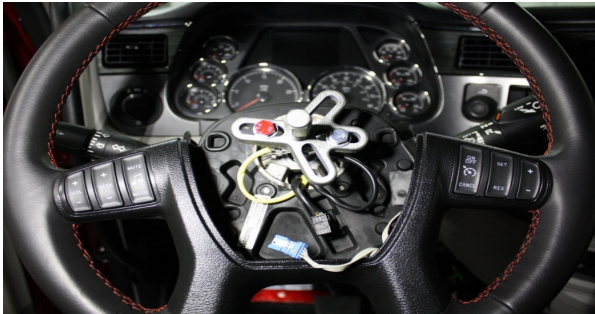
**Figure 3**

6. Remove Retaining clip and steering wheel nut.
  - a. Dispose of removed wheel nut; new production intent wheel flange nut is required for reassembly.
  - b. If the removed retaining clip is damaged, replace with a new production intent clip.
7. Attach steering wheel puller as shown in Figure 3. Remove the wheel while making sure the wheel remains centered and the wire connectors do not get damaged.

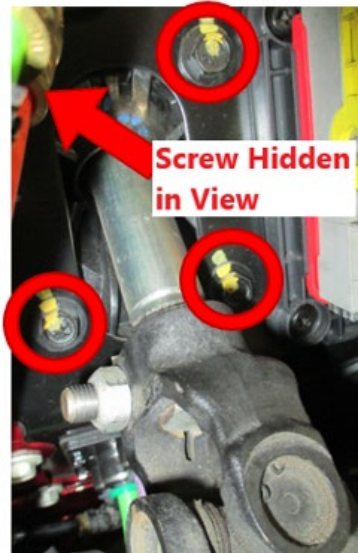
**Figure 5**

9. Remove the four screws that attach the steering column lower shaft bearing block to the front wall, as shown in Figure 5. Dispose of removed mounting screws; new production intent screws are required for reassembly.

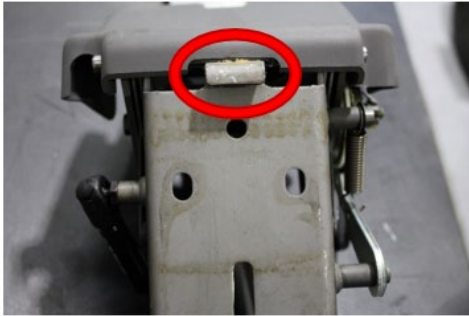
**Figure 8**

17. Hang the replacement steering column on the cross car beam using the “hook-n-go” feature on the column-mounting bracket shown in Figure 8.

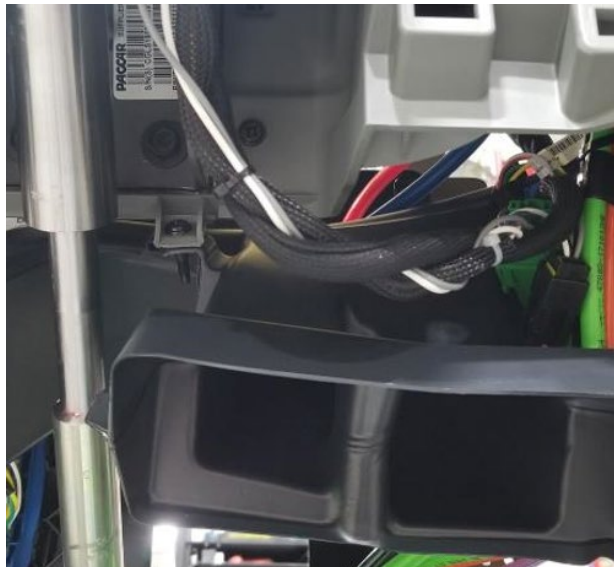
**Figure 13**

- a. If it was noted in **step 12** that the steering column wires were secured with clipping hardware between the bottom of the column shrouds and the IP harness connectors:
  - i. Unlock the steering column for adjustment and position the column in the upmost tilt position at full telescope extend toward the driver. This allows slack for future adjustment by the driver.
  - ii. Route the steering column wires to match the original starting condition, securing the wires at the original clipping point(s) using new production intent clipping hardware.
  - iii. Be sure to include any other items (air lines, other wires, etc.) that were originally included in the steering column routing.
  - iv. Connect the steering column wire connectors to the IP harness connectors.
  - v. Tuck the slack from the steering column wires above the HVAC vent and behind the dash panel as shown in Figure 13.
