Technical BULLETIN

CERTAIN 2006 ~ 2019 FJR13AC/AEC/ASC/PC (CALIFORNIA MODELS) Canister Replacement/ Air Vent Hose Relocation Due to Water Intrusion

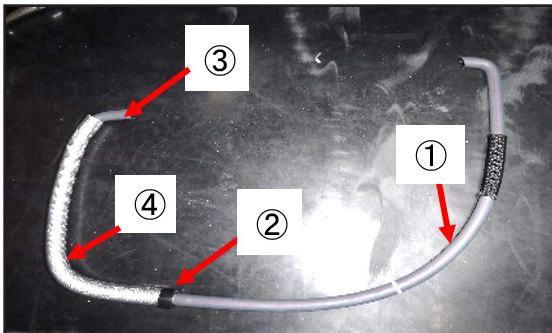
3. Assemble the parts from the kit as shown below by sliding the "PROTECTOR, PIPE" over "PIPE, 4" and connecting "PIPE, 5" using the "JOINT."

| 1. | PIPE, 5 (B88-24315-00-00) |
| 2. | JOINT (4JP-21753-00-00) |
| 3. | PIPE, 4 (B88-24314-00-00) |
| 4. | PROTECTOR, PIPE (B88-24327-00-00) |

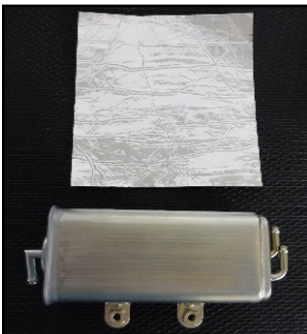
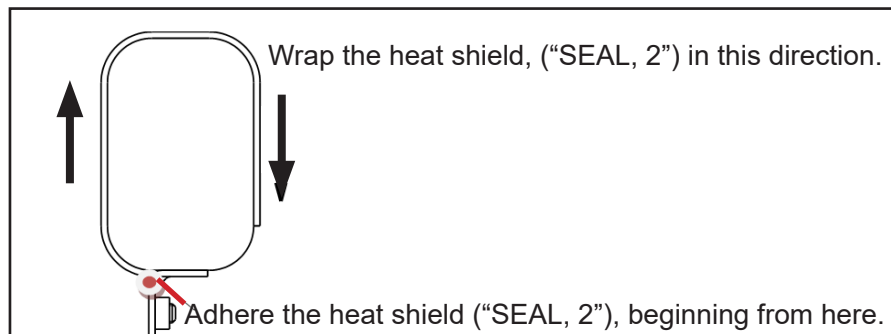
4. Adhere "SEAL2" (heat shield) to the new "CANISTER" as shown below.

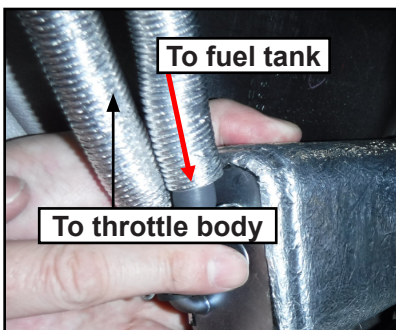
5. Connect the existing hose leading to the fuel tank to the canister as shown using new clips supplied from the kit.

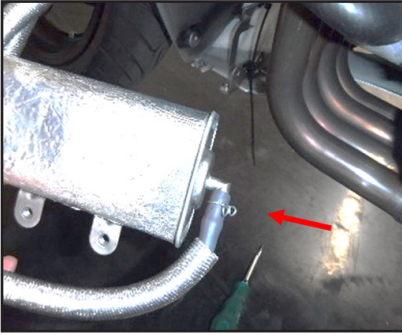
6. Attach the newly assembled "PIPE, 4" from step 3 to the opposite side of the canister as shown.

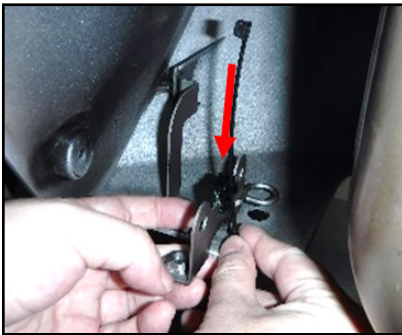
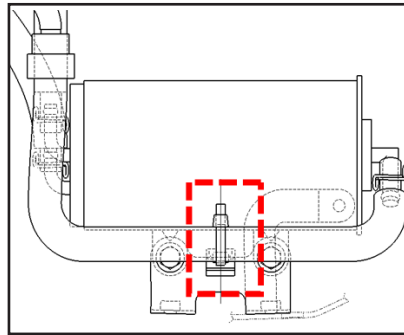
7. Put the "CLAMP" (zip tie) through the "BRACKET, CANISTER" as shown.

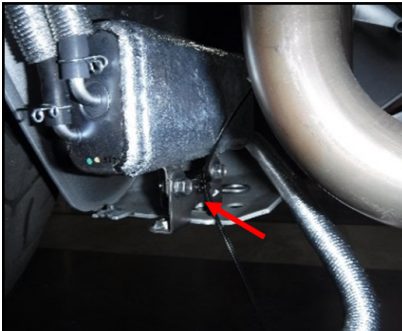
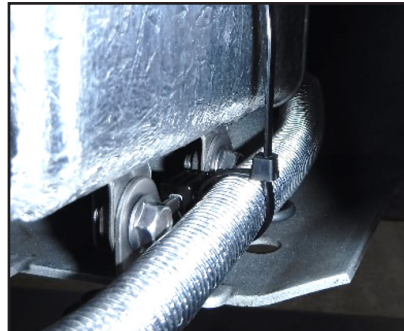
8. Install the "CANISTER" on the "BRACKET, CANISTER."

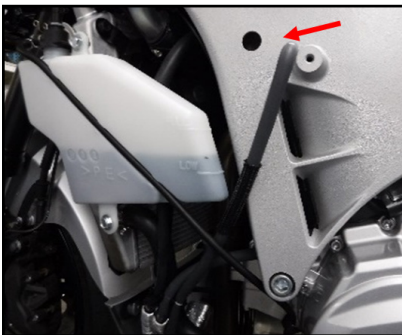
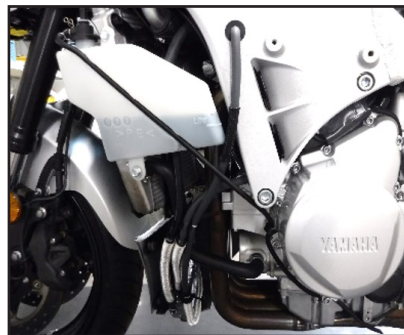
9. Insert the "GROMMET" into the existing hole of the frame as shown.

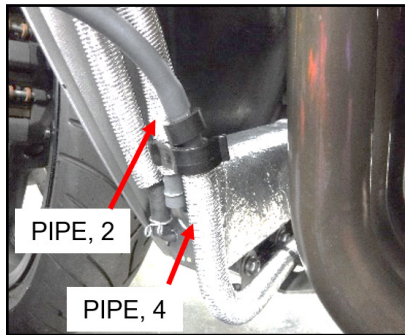
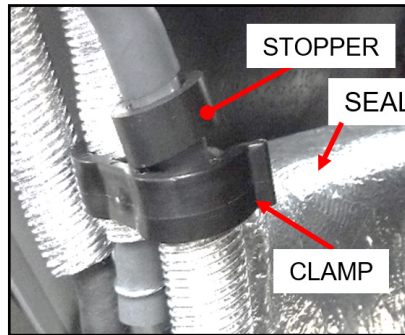
10. Install the clamp to secure "PIPE, 2" and "PIPE, 4" as shown.

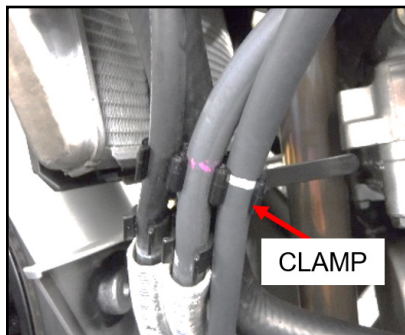
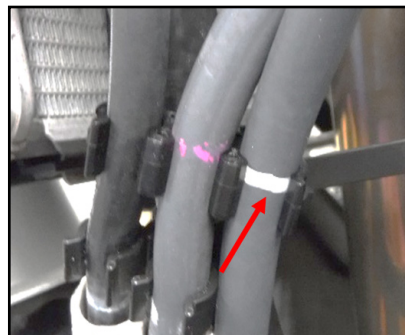
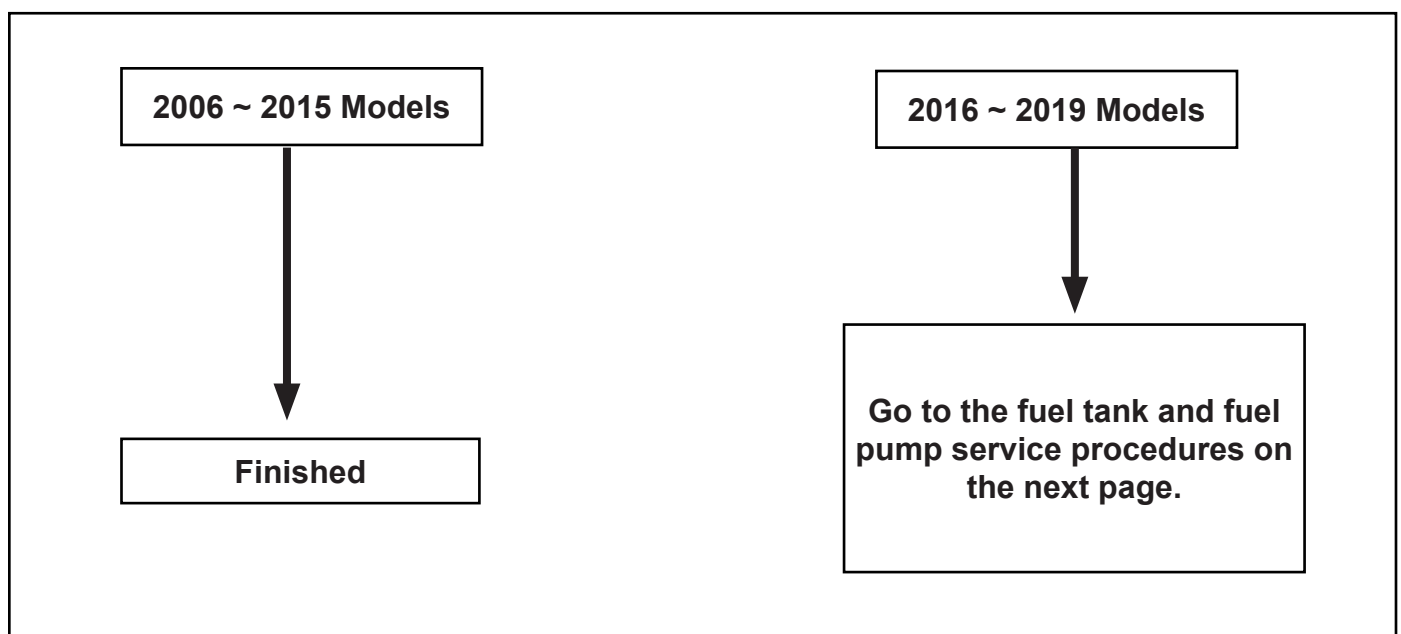
11. Clamp "PIPE, 2" and "PIPE, 5" together as shown.

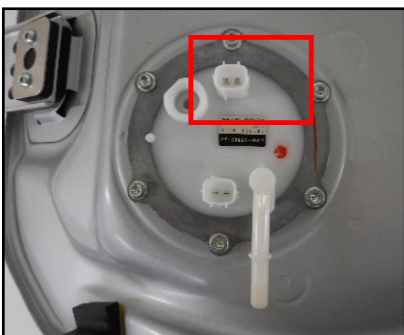
2. Drain the fuel from the tank into an appropriate clean container for re-use and remove the fuel pump from the fuel tank.
3. Test the resistance of the fuel pump's sending unit from the terminals shown below for steps 4 and 5.

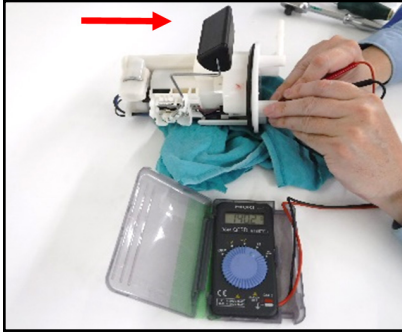
4. Measure the resistance of the sending unit's with the float in the low position.

Reference value: $140 \pm 1 \Omega$

If out of reference value, replace the fuel pump with a new one.

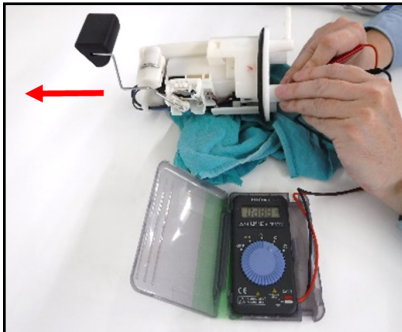
5. Measure the sending unit's resistance with the float in the upper position.

Reference value: $20 \pm 1 \Omega$

If out of reference value, replace the fuel pump with a new one.

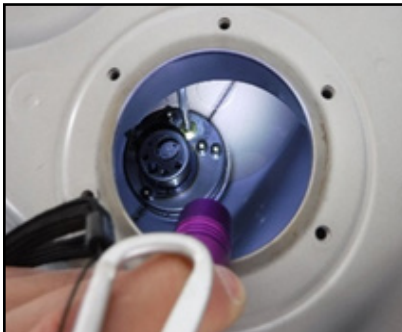
6. Check the inside of the fuel tank for rust using a flashlight.

If there is rust in the fuel tank, replace it with a new one. Be sure to install new graphics, warning label, and dampers.
