Latest Vehicle Concern Fixes

No Start Due To BCM	2018-2019 Range Rover Range Rover Sport & Velar
<p><u>Customer Voice:</u></p> <ul style="list-style-type: none">• Customer states the vehicle will not start. <p><u>Technical Description:</u></p> <ul style="list-style-type: none">• The door locks operate correctly but, when the start/stop button is pressed the vehicle does not start due to the BCM. <p><u>Status:</u></p> <ul style="list-style-type: none">• This is currently under investigation. If you should come across this issue, please submit an EPQR.

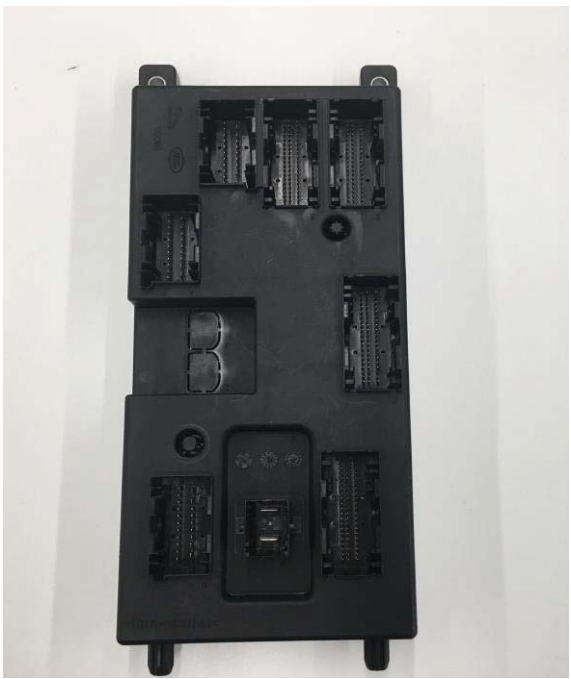
A photograph of a black plastic Body Control Module (BCM) component. It is a rectangular unit with several electrical connectors and ports on its surface, including a large multi-pin connector at the top and a smaller one at the bottom. The component is shown against a plain white background.
