# TECHNICAL SERVICE BULLETIN

Technical Service Bulletin: 20-1066

The installed icemaker water line union fitting may come apart when under water pressure.

# CEDAR CREEK – ICEMAKER UNION – REMEDY INSTRUCTIONS

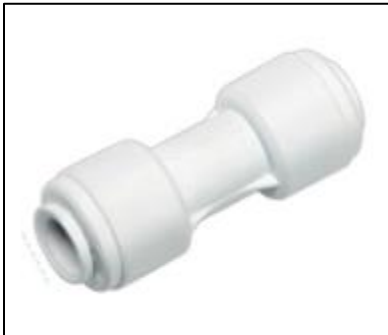
**FIGURE 1**

STEP 4: CAREFULLY PULL THE REFRIGERATOR OUT OF THE OPENING TO ACCESS THE ICEMAKER UNION (*FIGURE 1*);

STEP 5: REMOVE THE ICEMAKER UNION INSTALLED IN THE WATER LINE GOING TO THE REFRIGERATOR (*FIGURE 1*);

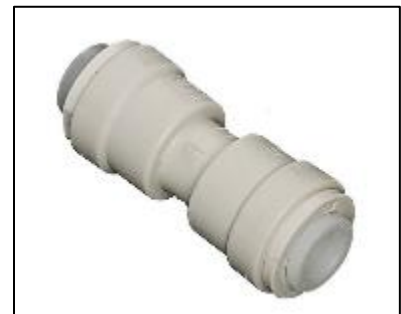
**FIGURE 2**

STEP 7: USING THE REPLACEMENT ICEMAKER WATER LINE UNION (WATTS PL-3000) PUSH THE WATER LINES INTO THE UNION ON EACH SIDE (*FIGURE 2*);

STEP 8: GENTLY PULL ON THE WATER LINE ON EACH SIDE OF THE NEW UNION TO ENSURE THE WATER LINE HAS BEEN CAPTURED IN THE UNION;
