SERVICE BULLETIN

Classification: AT18-009a	Reference: NTB18-077a	Date: August 1, 2019
------------------------------	--------------------------	-------------------------

MIL ON WITH DTC P0776, P1715 AND MAY HAVE HESITATION AND/OR LACK OF POWER

APPLIED VEHICLES: 2017-2018 Sentra Turbo (B17) with MR16DDT engine only
2017-2018 Rogue Sport (J11)

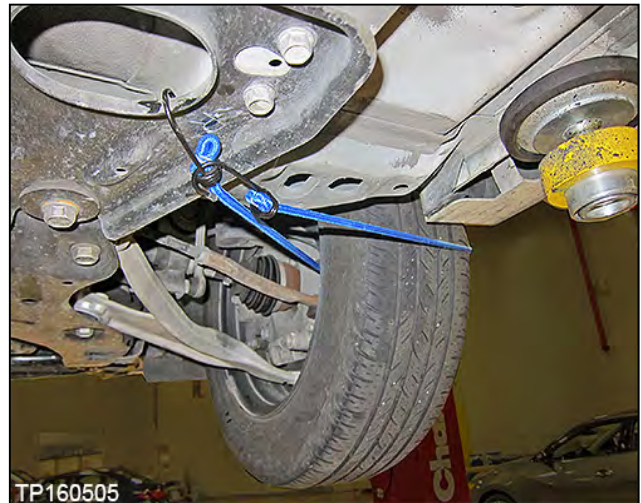
Figure 2

5. Mark the front left tire with a suitable marking.

- This will assure all 360° of the belt is inspected.

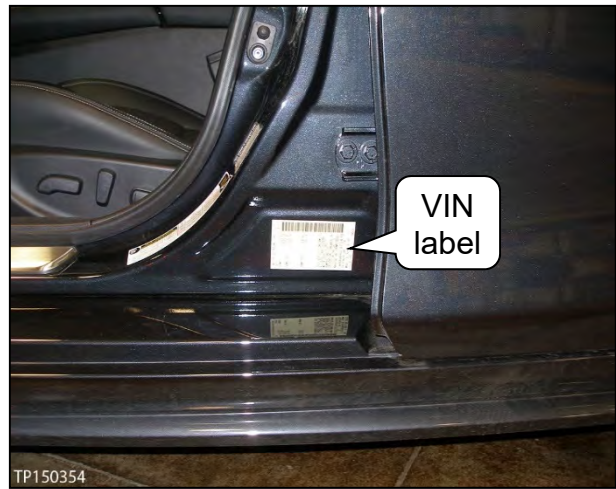
Figure 7

- f. If CVT replacement is required based on the inspection results from 6b and 6d, use borescope J-51951 to record a continuous video, 15 seconds or less, of the most severe evidence of belt slip and the VIN on the F.M.V.S.S. certification label (VIN label). See Figure 7.

NOTE: This required video must be attached to the Powertrain Call Center CVT Preauthorization Form (in ASIST) prior to calling for authorization. Failure to submit a continuous video will cause immediate denial of request for replacement.

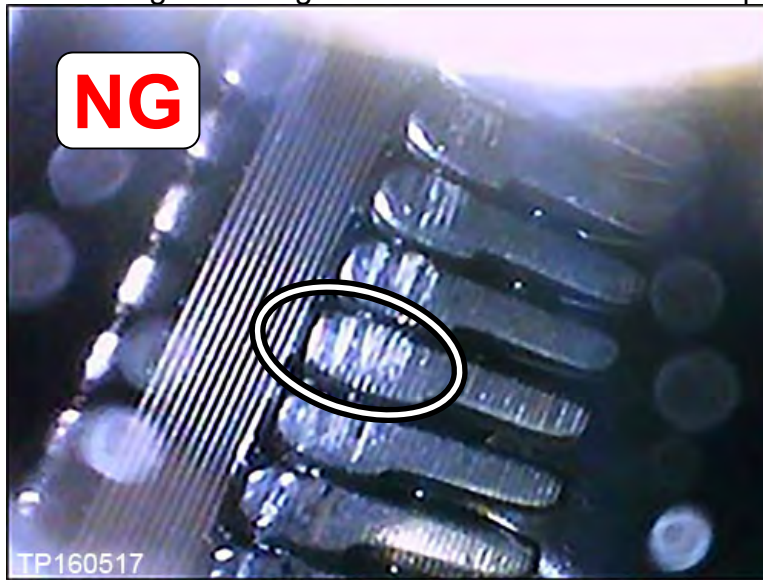
Pictures in Figure 15-Figure 17 were taken with borescope J-51951.

Figure 15: Example of NG belt

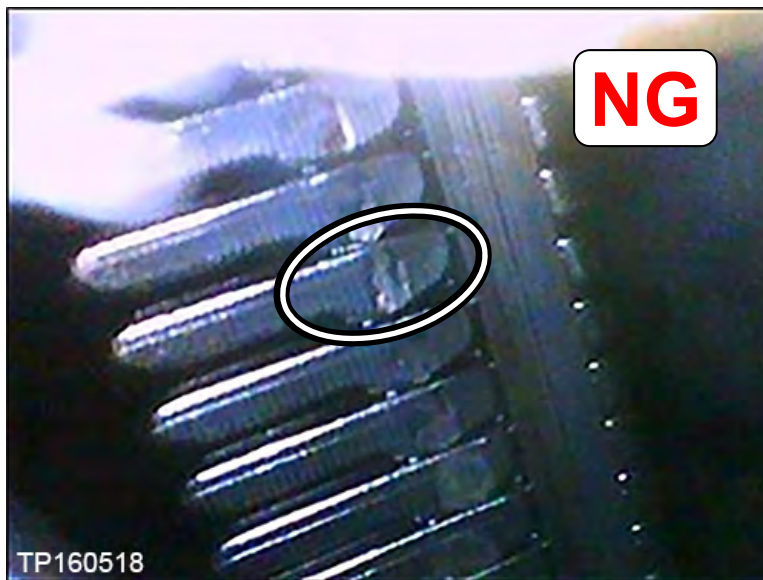
Figure 16: Example of NG belt

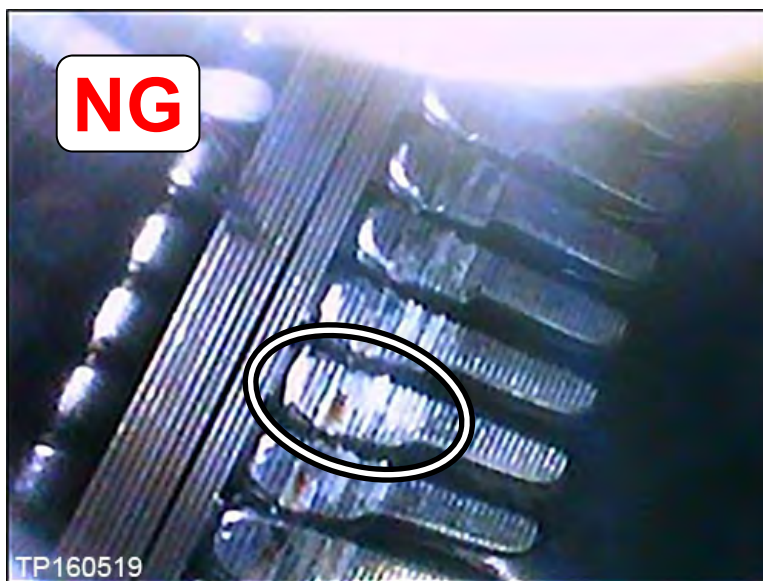
Figure 17: Example of NG belt

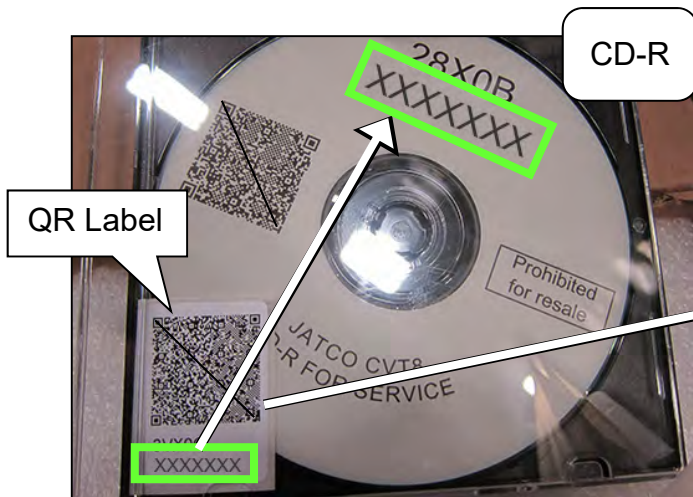
23. Attach the QR label (Figure 30) with the new calibration data onto the transmission range switch (inhibitor switch Figure 31).

- A QR Label and CD-R are included with the new valve body.
- Confirm that the QR label and the CD-R part numbers are the same (Figure 31).
